Tungsten coatings under high thermal loads in JET and Magnum-PSI

C Ruset¹, H Maier², E Grigore^a, G F Matthews³, G De Temmerman⁴, A Widdowson³
and JET-EFDA contributors⁵

Abstract

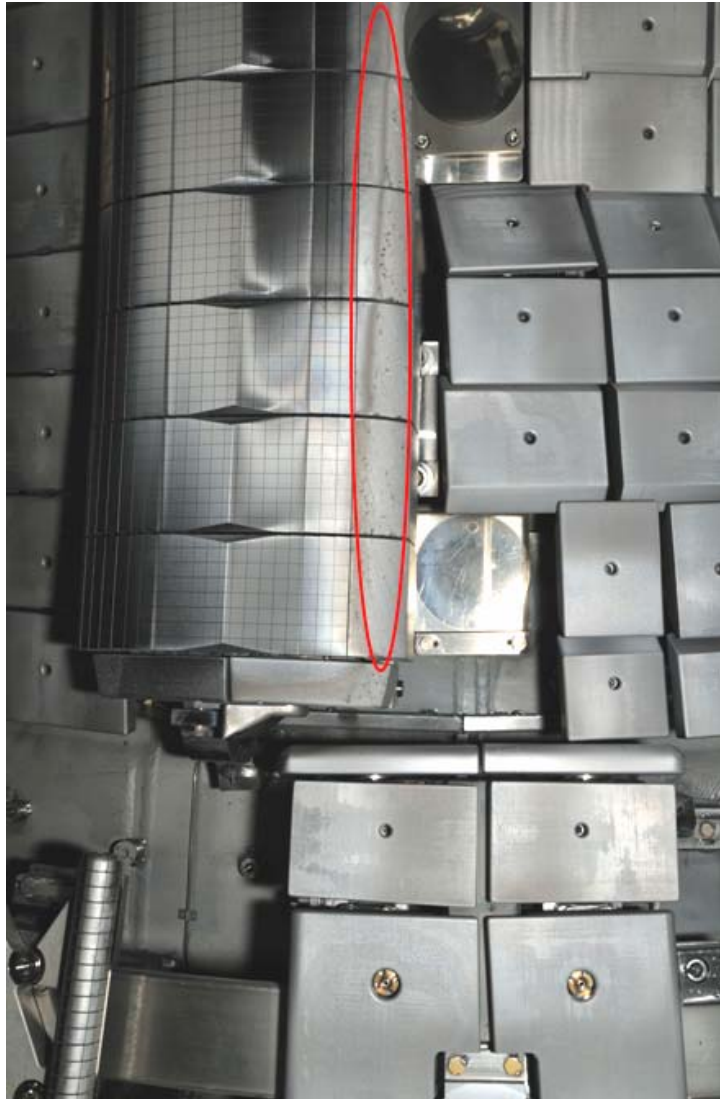
In the main chamber W coated CFC tiles were introduced in areas with the highest thermal loading. In the Inner Wall Guard Limiter (IWGL) they are near to the Be tiles. The pictures of those areas show relative thick deposits of material (probably Be) on the W coated CFC tiles (“wings”). This can be seen in Fig.3 taken in Octant 7, inner wall, bottom of the limiter beam. On the limiter there is a transition from strong erosion (in the centre area) to deposition (in the side zones). The ridge of the Be tiles was eroded or even melted in some cases [11] and material was deposited on the W-coated wing tiles. The same phenomenon has been seen in Octant 3 (inner wall, bottom of the limiter beam), Octant 5 (outer wall, mid-plane), Octant 6 (top limiter beam) and Octant 8 (top limiter beam). This is clear a pattern, specific for this type of wall. The other W coated CFC tiles shown in Fig.3 appear to be in very good condition.

Fig.3 Deposits of Be on W-coated CFC wing tiles which protect the edge of some inner wall limiters from first pass neutral beam shine-through.

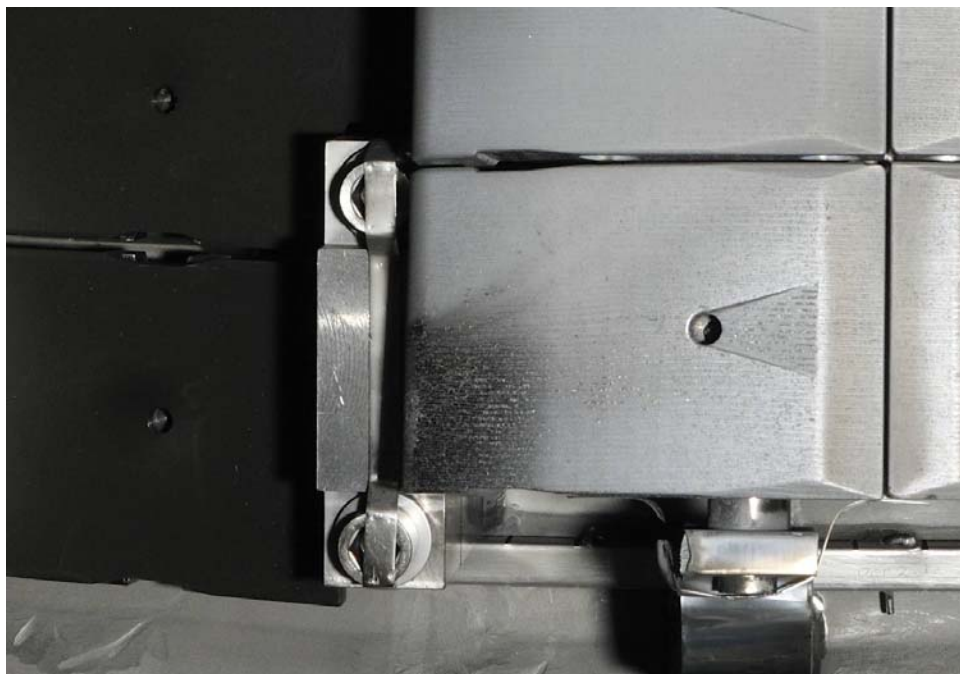
A thorough inspection of the W coated CFC tiles revealed the damage of one bottom tile, Inner Wall Guard Limiter placed in the same position in Octants 2, 5 and 7. It is shown in Fig.4. The W coating seems to be melted on the left round edge of the tile. The damage seems to be produced by the runaway electrons in the early commissioning phase of the ILW during an emergency shutdown (pulse 80263).

Fig.4 Local damage to W coatings at the bottom of the inner wall limiters which is due to the impact of runaway electrons

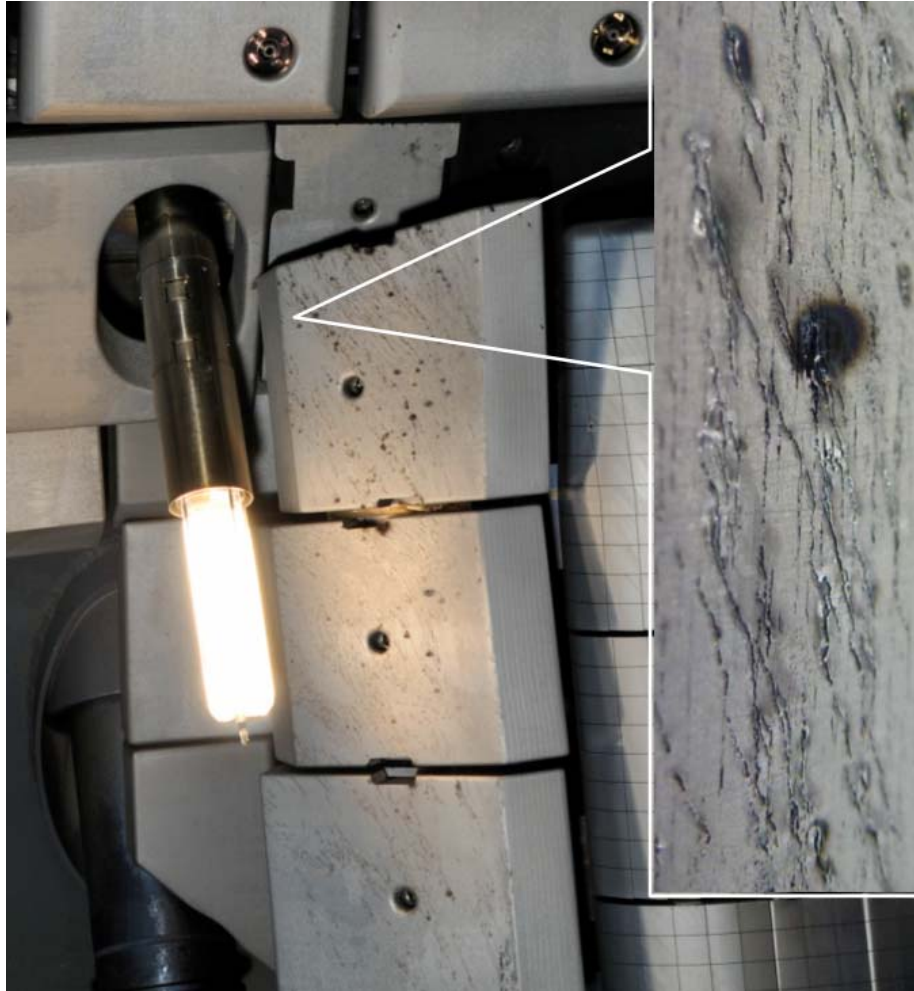
Another phenomenon which was observed after the first campaigns is arcing on some particular tiles. These are located on outer wall, shine through protection, Octants 1 and 5. An image is shown in Fig.5. The pattern of the damages is the same in both octants. Two of W-coated CFC tiles from Octant 1 were removed and inspected carefully with a high resolution camera in the BeHF. The following aspects were revealed:

- The W coating was subjected to intense arcing. This leads to delamination of the coating along the arc track and even melting of the W coating. This is evidenced in Fig.5 (inset).

- In local zones the temperature during arcing was so high that the CFC substrate was affected. Black spots surround the W melted zones indicating that carbon was eroded from the substrate and deposited onto the W coating.

A clear explanation on the arcing phenomenon on those particular tiles was not found yet. It might be associated with the presence of some small carbon particles resulting from mechanical processing of the CFC tile after W coating or related to the earthing of particular tiles to the vessel leading to local variations in potential during extreme events such as disruptions. On the other hand some tiles were hand cut after W coating to correct clashes discovered during the installation of the ILW without arc signs. More investigations are necessary in order to clarify the presence of such intense arcs on these tiles.

Fig. 5 Arcing on W coated shine-through protection tiles designed to protect outer beryllium limiters from tangential neutral beams which pass twice through the plasma

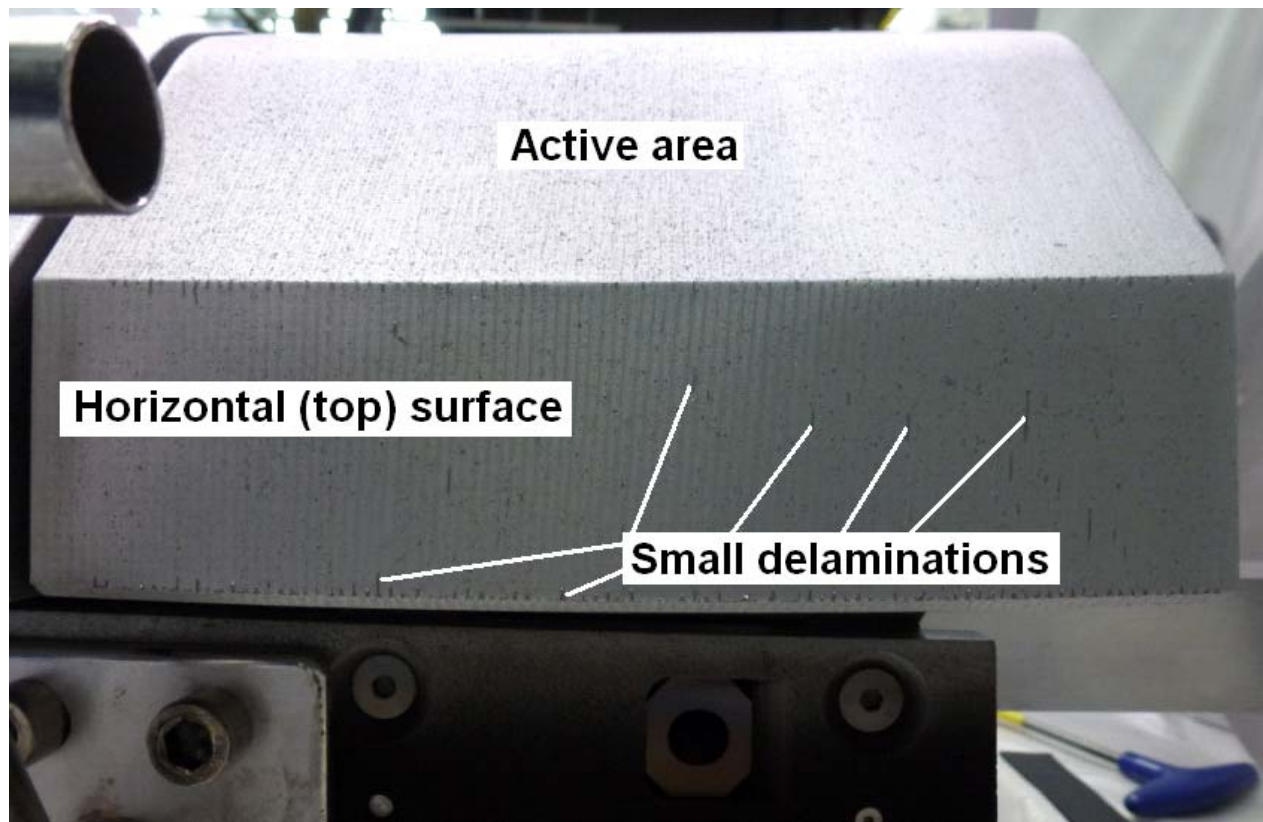
As far as the W coatings deposited on divertor tiles are concerned their current status is generally good except minor delaminations detected on a G6 tile, which are probably associated with the CFC structure and some delaminations on the top of about twenty G8 tiles, which seems to be systematic. All delaminations with a length of 1-15 mm are along the in plane fibers of the CFC material (Fig.6). The W coating is perfect on the main active area of the G8 tiles, where the thermal loading is supposed to be high, but the defects appeared only on the top of the tiles. The first signs of delamination appeared on the top of G8 in October 2011 after about two months of experiments. Examination of the pictures taken with IVIS on the same G8 tiles in Octant 8 in the period October 2011-May 2012 revealed no increase of the damages. The inspections revealed the presence of many small particles dropped on this horizontal surface of G8 tiles. Without any contact with the substrate these particles become very hot during plasma operation and in this way the temperature of the W coating is locally increased to high values. These hot spots might affect the W coating integrity. The strong erosion on the top of G8 tiles was noticed in 2007 with the carbon wall when a marker tile was used [12]. The defects on G6 and G8 appear random in that some tiles show a significant number while adjoining tiles may show none at all. This strongly suggests that plasma parameters are not the dominant factor and that variations in the CFC substrate are the dominant cause.

Fig.6 Small delaminations on the horizontal area of G8 tile; the picture was taken in the Be handling facility after removing of the tile from JET chamber
