Investigation of Tungsten Coatings on Graphite and CFC

JET ,ITER-like Wall' project:

Test of ITER material mix of PFCs: Be/W/(CFC)

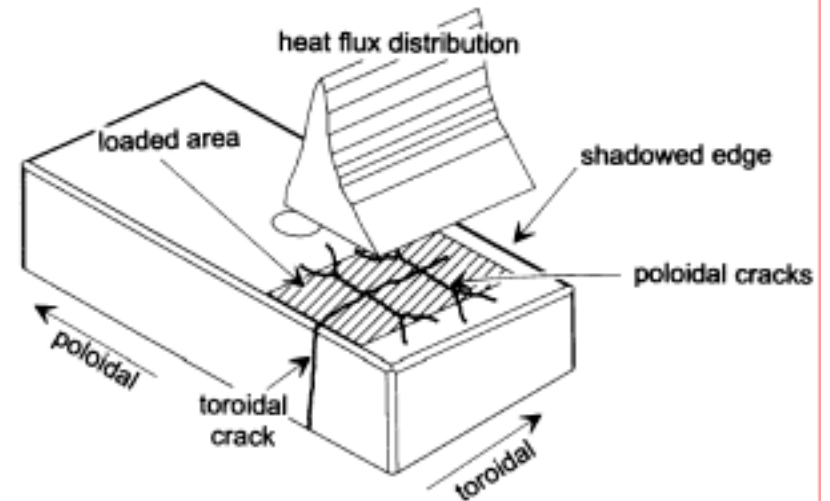
strike point tiles after campaign

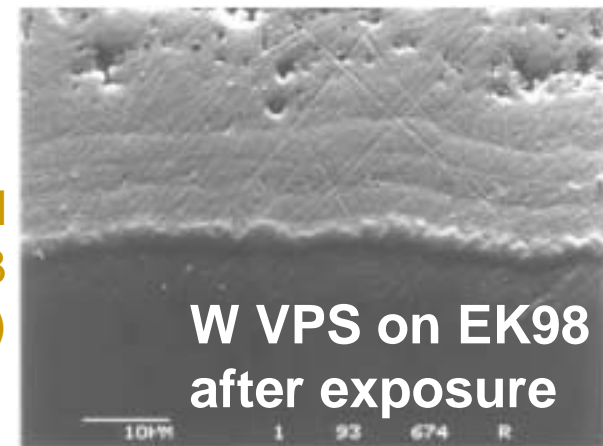
W VPS on EK98
after exposure

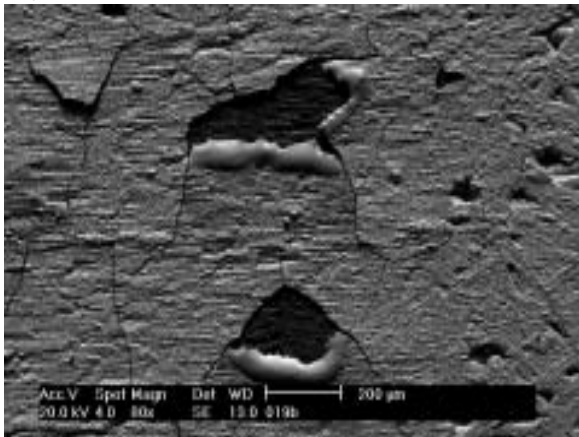
- surface temperatures $> 2000^{\circ}\text{C}$
- Higher T_{surf} of graphite samples consistent with lower therm. cond.
- **most of the coatings survived** (or failed only at 23.5 MW/m^2)
- **failure** of samples with **fibre planes || to surface** ('layout II') already at 16.5 MW/m^2

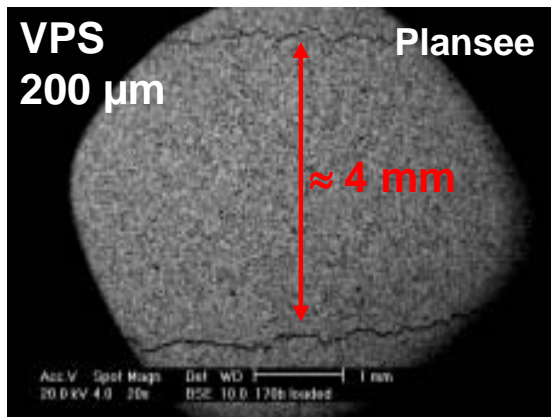
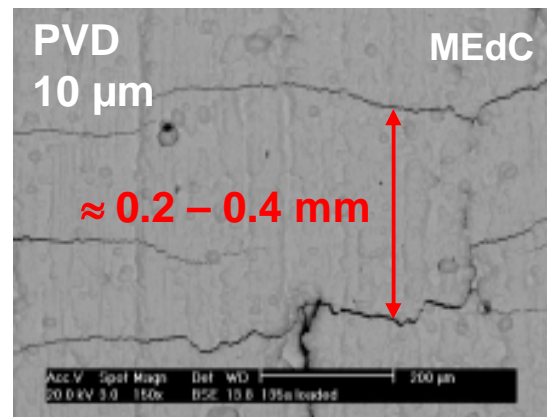
All coatings on **CFC** show typical pattern:

- regular cracks in x-direction (,failure mode 1', not regarded as problematic)
- distance depending linearly on thickness

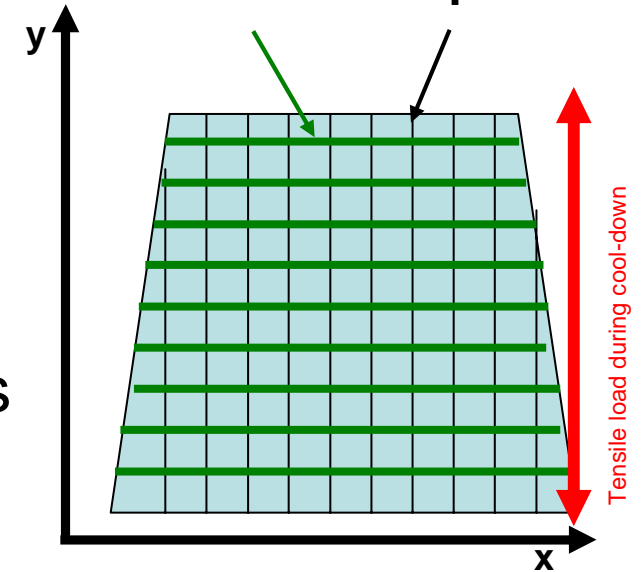
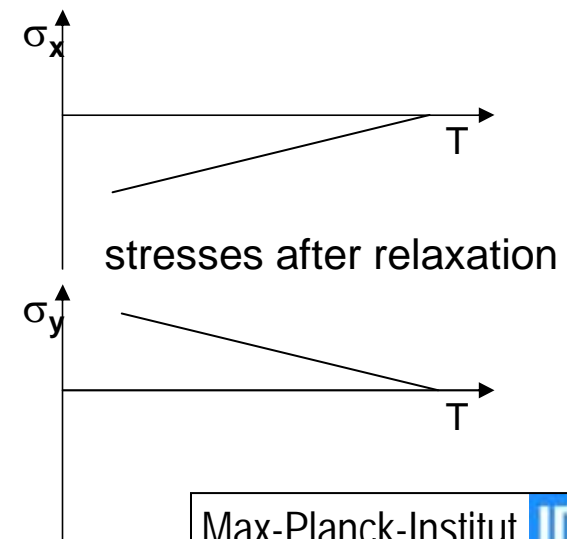
VPS Coatings on **graphite** show only very small (μm) irregular cracks

crack orientation fibre planes

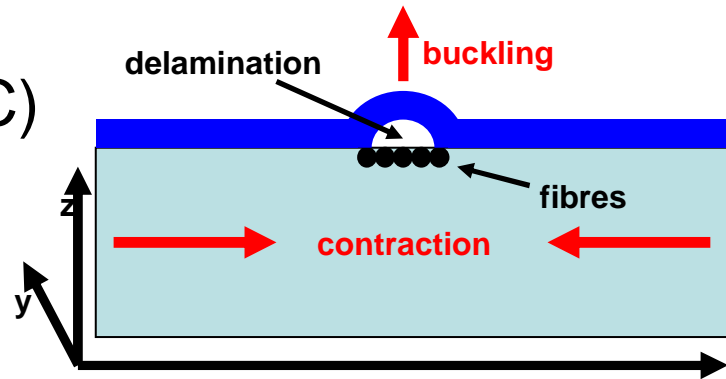
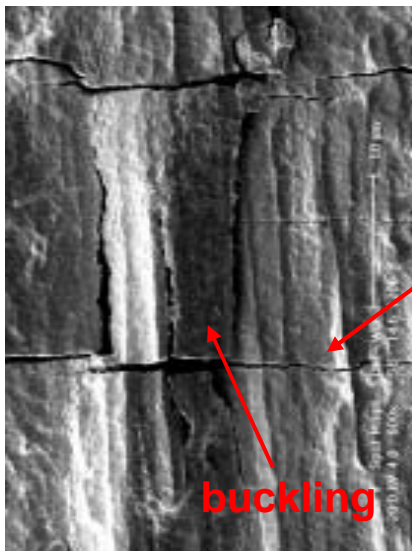
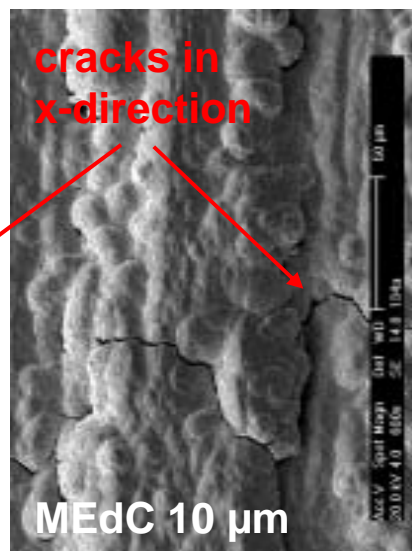
- buckling y-direction (failure mode 2', loss of thermal contact, melting)

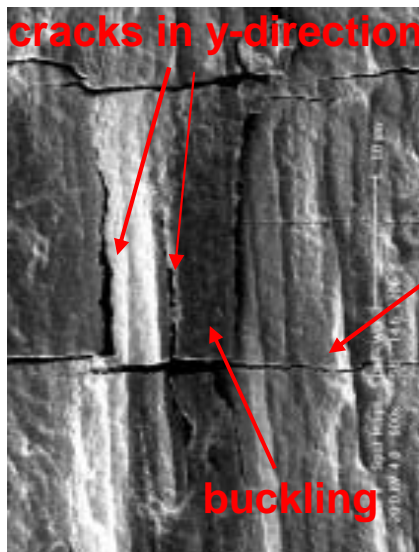
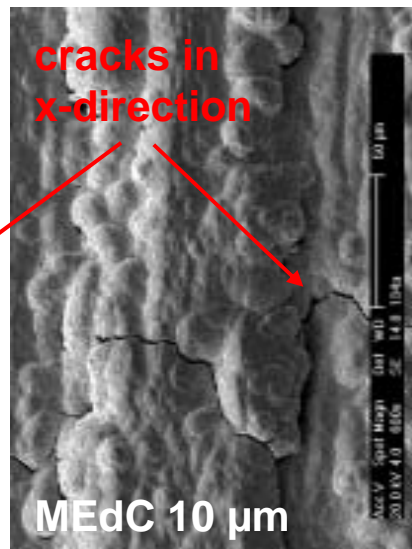
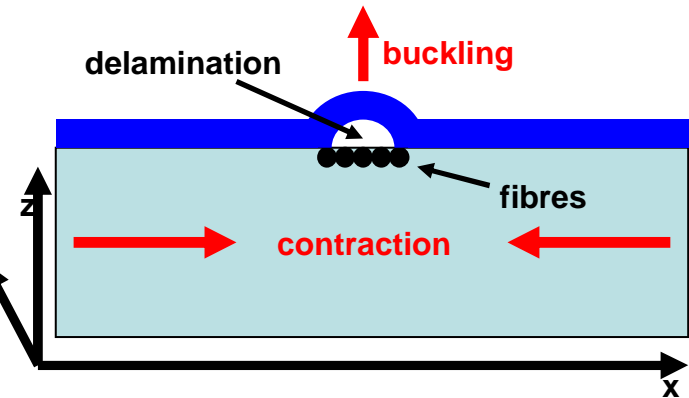
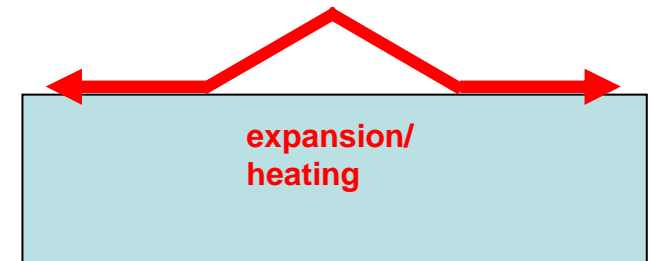
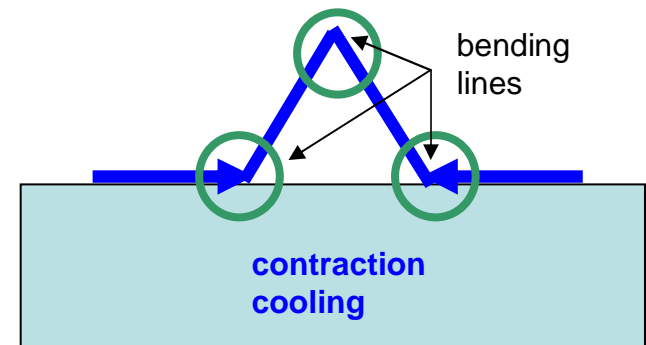
- buckling y-direction (,failure mode 2', y loss of thermal contact, melting)
- cracking in y-direction (,failure mode 3', delamination) due to fatigue

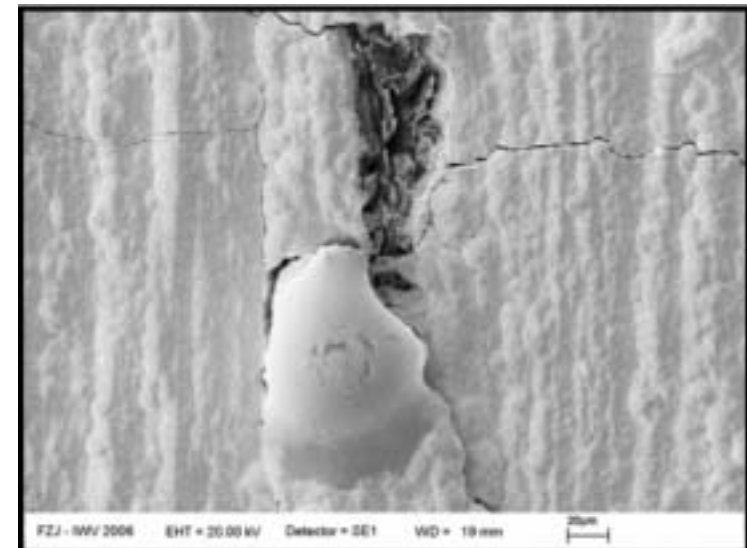
- failure mode 2 and 3 for **PVD coating**
 ⇒ **delamination and local melting**

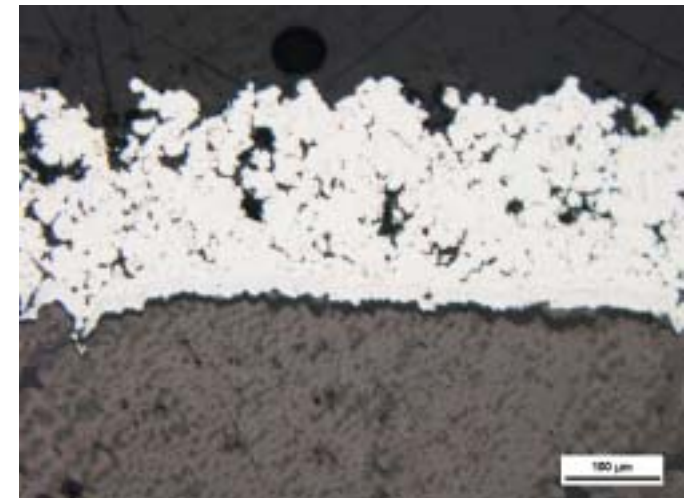
- failure mode 2 and 3 for **PVD coating**
⇒ **delamination and local melting**
- **no visible defect on VPS surfaces**
- however, metallographic cross section reveal **start of delamination** at areas with fibres parallel to surface
