Title: Global erosion and deposition patterns in JET with the ITER-like Wall.

Article Type: Special Issue: PSI 2014

## Global erosion and deposition patterns in JET with the ITER-like Wall

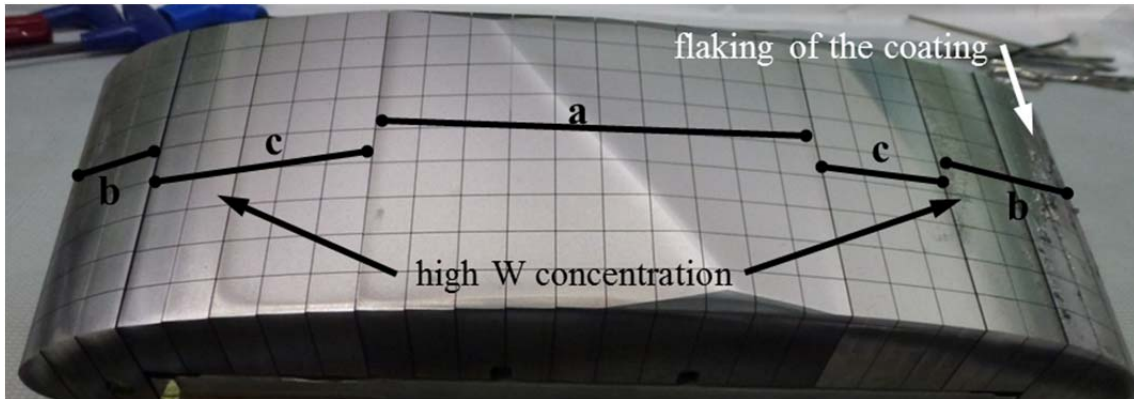
The erosion/deposition at the outer poloidal limiters (OPL) tiles is illustrated by the analyses of tiles 4D3, 4D14 and 4D23 located as indicated (Fig. 1). Visual inspection of the OPL has been reported in [3, 6]. At the centre of a tile near the midplane (4D14) the marker coating has been eroded and only bulk Be remains (Fig 2, region a). Profilometry indicates erosion of a minimum of 10  $\mu\text{m}$ . IBA shows re-deposition of Be and Ni onto both left and right sides (Fig.2, region b). However, the right side of the tile is also characterised by some flaking of the coating, which limits the validity of the IBA analysis. Nevertheless based on IBA it can be concluded that where the coating remains it is a mixture of mainly Be with Ni and W. Between the eroded area and the ends of the tile are transition regions where the surface is virtually as the original marker layer (Fig. 2, region c). Overall the analyses indicate net erosion over the tile, which if it were the same extent for the middle plane Tile 14 of each of the 8 OPL in the vessel would amount to erosion of 5g for just these tiles during the ILW campaign. Secondly, there is no indication from the RBS spectra of significant erosion or deposition on tiles 4D3 and 4D23 since the marker coating is still intact. The tiles are relatively clean, however there are traces of W, Ni, Mo, Cr, and Fe on the surface, and NRA shows some D retention. Finally, surface profilometry results confirm that any profile changes were below the detection limit ( $\pm 5\mu\text{m}$ ), so these tiles do not contribute anything to the net erosion/deposition in the vessel during the ILW.

Fig.2. Photo of OPL (4D14) after ILW campaigns 2011-2 and the marker coating evaluation. A central erosion zone (indicated by a), a left and right wing deposition zone (indicated by b), and a middle part where the marker starts appearing (indicated by c). A region of flaking film is also indicated.

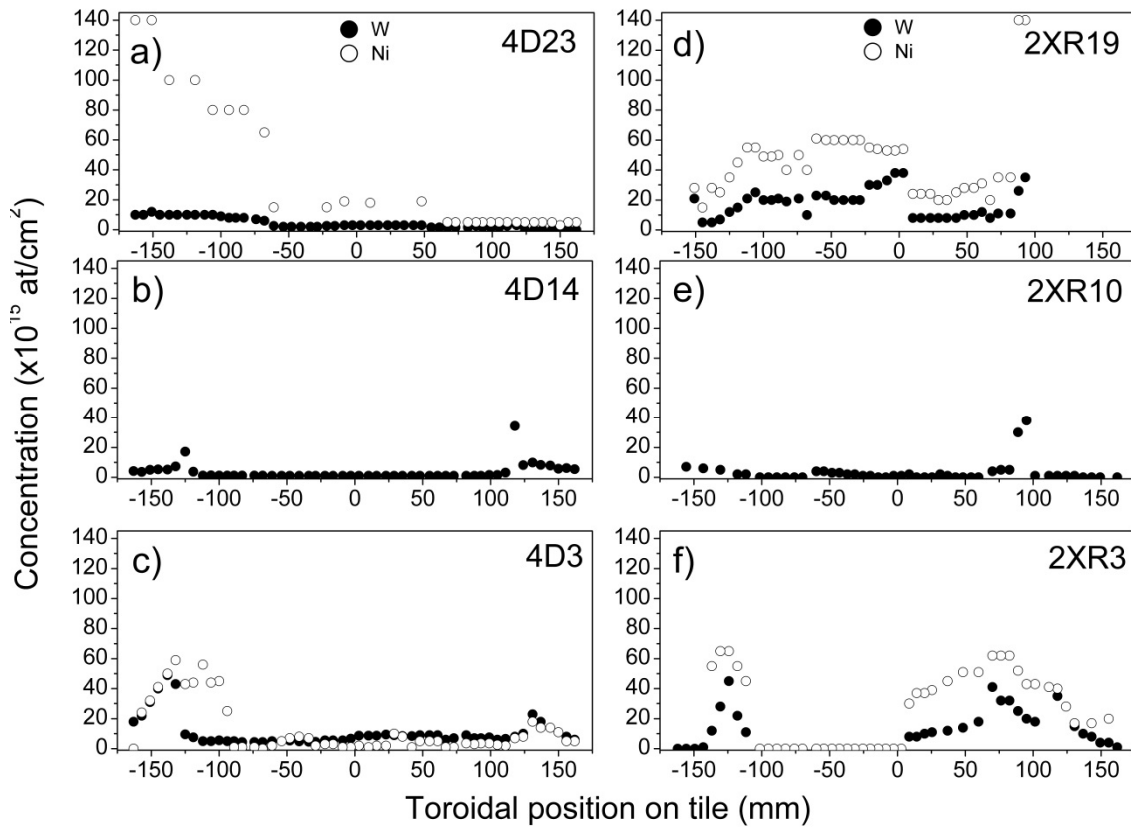
Fig.3

W and Ni impurities are present on all the tiles in the main chamber, but their concentrations can vary considerably as shown in the examples in Figure 3; Ni distributions are only shown where it is clear the Ni is present as a deposited impurity and is separate from the Ni marker interlayer. The amounts of W, Ni and also traces of Fe, Cr, Ti and Mo were calculated by combining RBS and PIXE data, and the combined amount does not exceed 0.1% of the elemental composition of the deposit. W and Ni have been found on all three investigated OPL tiles, with a higher concentration on the left-hand side of 4D3 and 4D23 (Figs 3a and 3c). Deposition of W and Ni has slightly different pattern for the 4D14 (Fig 3b): In the central part of the tile the W concentration is below  $1 \cdot 10^{15} \text{at/cm}^2$  and reaches maximum of approximately  $30 \cdot 10^{15} \text{at/cm}^2$  at the location indicated by arrow in Fig.2 . On the surface of the middle IWGL (2XR10) and the bottom (2XR3) (Figs 3e and 3f, respectively), the W surface peak signal (accompanied by Ni surface signal, not related to the underlying marker) is greater on the right-hand side of the limiter, whereas the W concentration is higher on the left-hand side of the 2XR19 (Fig 3d). Extensive melting along the poloidal ridge of the dump plate (DP) was found at all locations around the top of the machine and appears toroidally uniform in character. The melted ridge is closest to the plasma. Higher content of W has been found on the DP side where arc tracks are visible and is in the range from  $5 - 40 \cdot 10^{15} \text{at/cm}^2$  and Ni concentration varies from  $20 - 50 \cdot 10^{15} \text{at/cm}^2$ .

Fig.3. W and (in some cases) Ni impurity concentrations across the OPL and IWGL tiles analysed: a) OPL tile 4D23, b) OPL tile 4D14, c) OPL tile 4D3, d) IWGL tile 2XR19, e) IWGL tile 2XR10, f) IWGL tile 2XR3

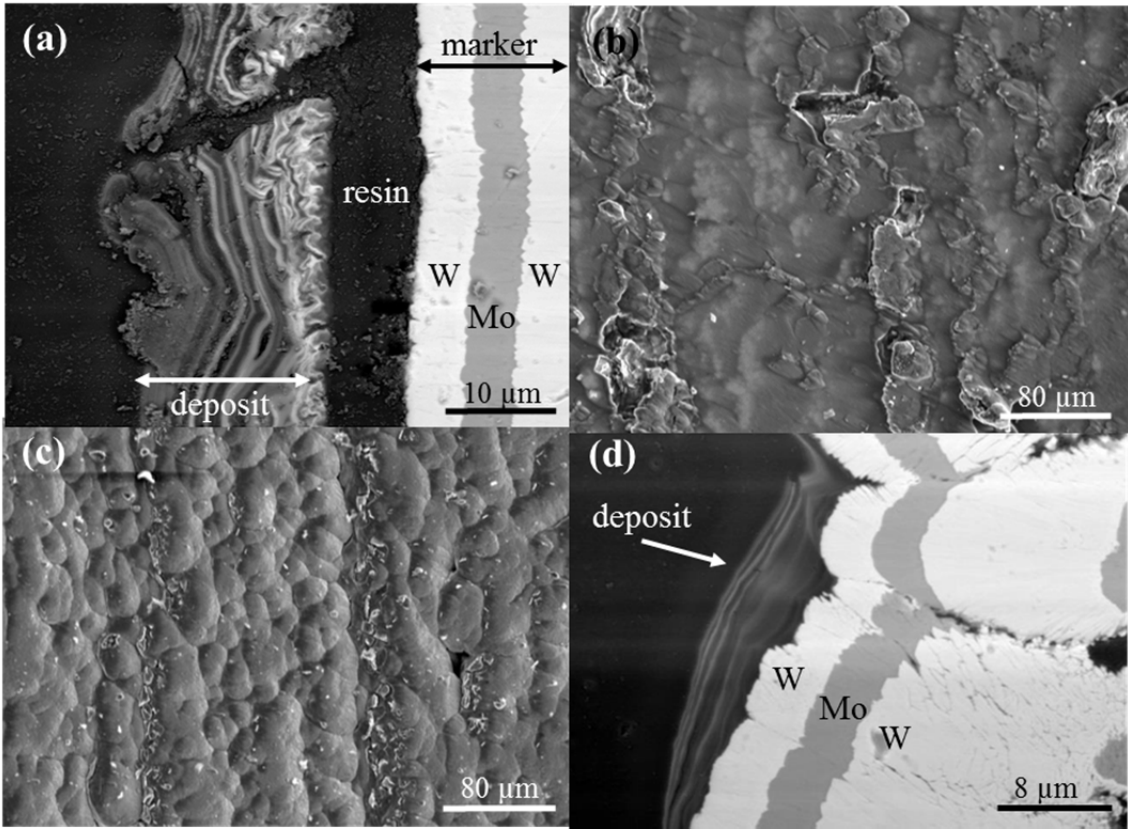
Fig.4.

material has a multi-layered structure consisting of an outer layer of pure Be and inner layer of mixed Be and W layers with W/Be ratio: 0.05 – 0.08. The oxygen concentration was not possible to evaluate directly in this work by IBA but it might be likely that the inner layer contains also a significant amount of oxygen (up to 10 %, based on NDF data fitting). The top part of Tile 1 revealed areas of non-uniformity of the deposit (small cracks), Fig. 4b, whereas the front parts of Tile 1, and Tiles 4 and 6 are characterized by a cauliflower-like morphology, as in Fig. 4c. The amount of material deposited on Tiles 4 and 6 was generally below  $\sim 2.5 \cdot 10^{18}$  at/cm<sup>2</sup>, however areas of higher deposition ( $\sim 6 \cdot 10^{18}$  at/cm<sup>2</sup> of Be over the 1 mm<sup>2</sup> beam area) were found on the slopping of these tiles. The deposit is not homogenous due to surface roughness of the CFC components and hence the W coating [13]. Whilst the thickness of the deposition on average is of the order of a hundred nanometers to 1  $\mu$ m, but optical microscopy shows that in localized spots it can increase up to 5  $\mu$ m [7]. In the thickest part of the deposit on Tile 4 it was again found that it is built up by a multi-layer structure of different intensity in the BSE image, indicating a different composition of the layers (Fig. 4d). No changes in tile profile for Tiles 3, 4, 6, 7 or 8 were resolvable with the profilometer, so any net erosion/deposition is less than a few microns. For Tiles 3, 4 and 6 the small amount of deposition observed probably offsets any erosion (despite some indications of erosion at the top of Tile 3), but one can only set an upper limit on their contribution to overall deposition in the divertor. For Tiles 7 and 8 net erosion is more likely than net deposition (as was observed in the JET-C campaigns), but the global figure is likely to be small.

Fig.4.(a) BSE image of a cross-section of the top part (apron) of Tile 1 (the deposited layer has separated from the tile surface during the mounting process), (b) BSE image of a top view of the of the Tile 1 apron surface, (c) BSE image of a cross-section of the sloped part of Tile 4 near the strike point showing deposit in the valleys, (d) BSE image of a top view of the Tile 4 surface with characteristic cauliflower morphology
