Investigation on the erosion/deposition processes in the ITER-like Wall divertor at JET using Glow Discharge Optical Emission Spectrometry technique

C. Ruset^{1*}, E. Grigore¹, C. Luculescu¹, I. Tiseanu¹, J. Likonen², M. Mayer³, M. Rubel⁴, G. F. Matthews⁵, and JET contributors⁶

EUROfusion Consortium, JET, Culham Science Centre, Abingdon, OX14 3DB, UK

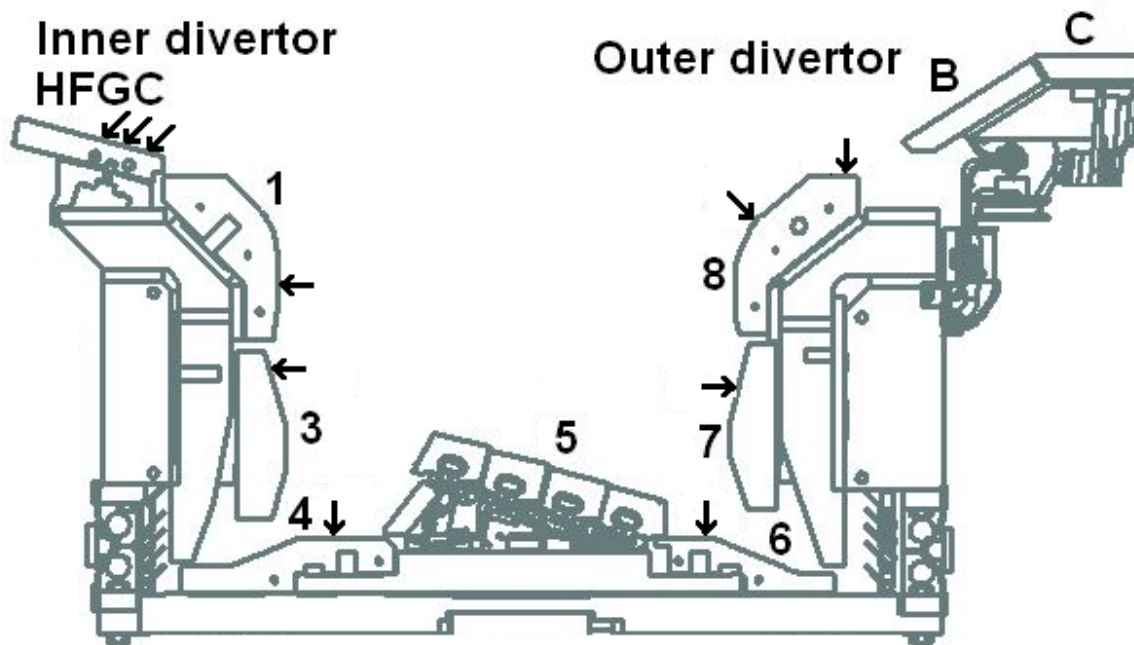
Fig. 1 JET divertor area and tiles identification; arrows show the position of the samples analyzed by GDOES

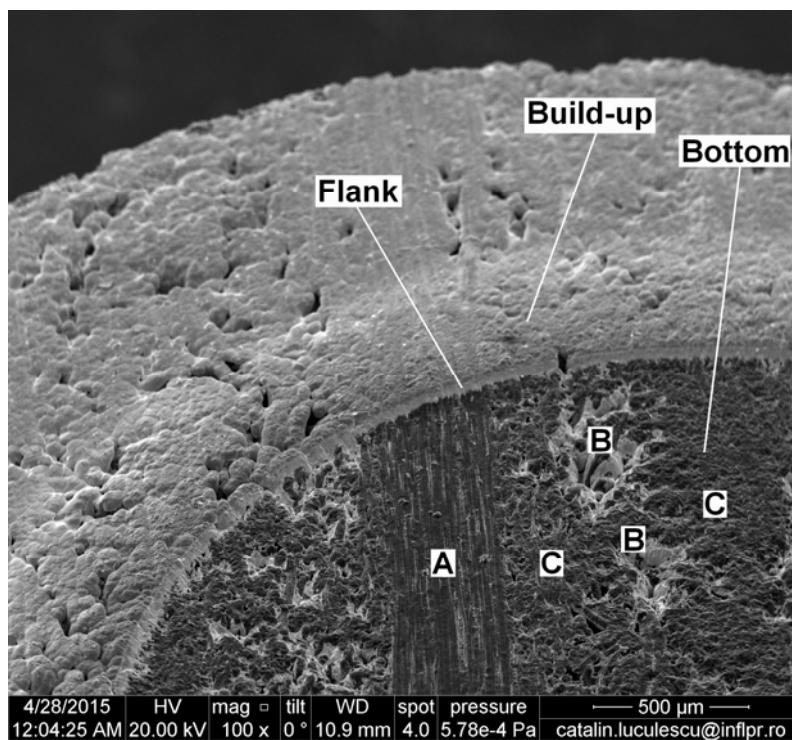
open porosity at the surface, with diameters of pores in the range of a few ten up to a few hundred μm and depths up to 250 μm . The interior of these open pores is coated with Mo and W during the coating process and with beryllium during plasma operation, see areas B in Fig. 2. It appears that to some extent even interior areas of open pores without direct line of sight to the exterior are being coated. However, more experiments are necessary to confirm this hypothesis. On the other hand the percentage of ~ 5 at.% of W at the surface indicate a low deposition of W together with Be. At the same time the decrease of the Mo concentration at the surface from 100 at.% to about 10 at.% could be associated with the local erosion of Mo. The SEM analyses confirmed the missing of Mo top layer in some areas.

Fig. 2 GDOES crater with the depth of 40 μm on Tile 3; A-carbon fibers parallel to surface; B-

carbon fibers perpendicular to surface; C-felt

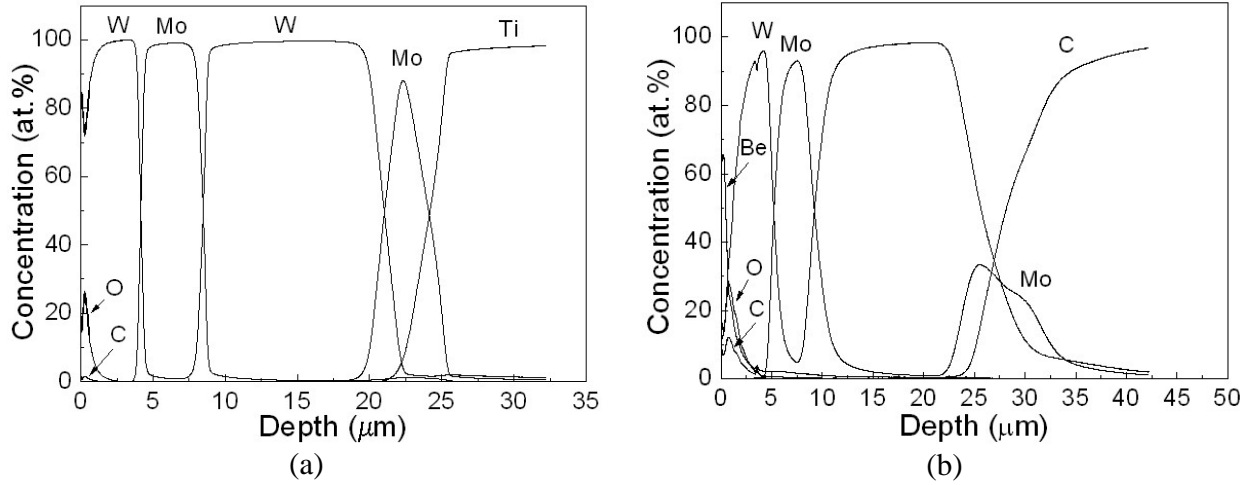
No erosion was detected on the investigated tiles in specific areas where the samples were cored from except Tile 3. A very thin layer of Be was measured on Tiles 1, 4, 7 and 8, while thicker deposits of Be were detected on Tiles 3 and 6. Typical GDOES depth profiles before and after plasma exposure are shown in Fig.3 for Tile 7. Unfortunately CFC samples coated in the same run with the real tiles installed in JET are not available so the comparison was performed between GDOES profiles obtained with Ti witness samples coated in the same run with the real JET tiles and CFC samples cored from the same tiles after their exposure in JET. As it can be seen, the profiles are quite similar except at the CFC/Mo interface where the irregularities of the CFC influence the Mo and W profiles. A sharp peak of Be appears at the surface followed by a fast drop in a few microns. Small Be “tails” like that shown in Fig. 3b were observed on Tiles 1, 4, 7 and 8. They can be explained by the roughness and porosity of the surface. Significant higher concentrations of Be (60 at.% and 75 at.%) were measured on Tiles 3 and 6. Be was detected up to a depth of 40-70 μm (Fig.4). As can be seen from Fig. 2 the CFC material shows a substantial

Fig.3 GDOES depth profiles for the W/Mo marker deposited on Ti witness sample coated in the same run with Tile 7 (before plasma exposure) (a) and on sample cored from Tile 7 after plasma exposure (b)

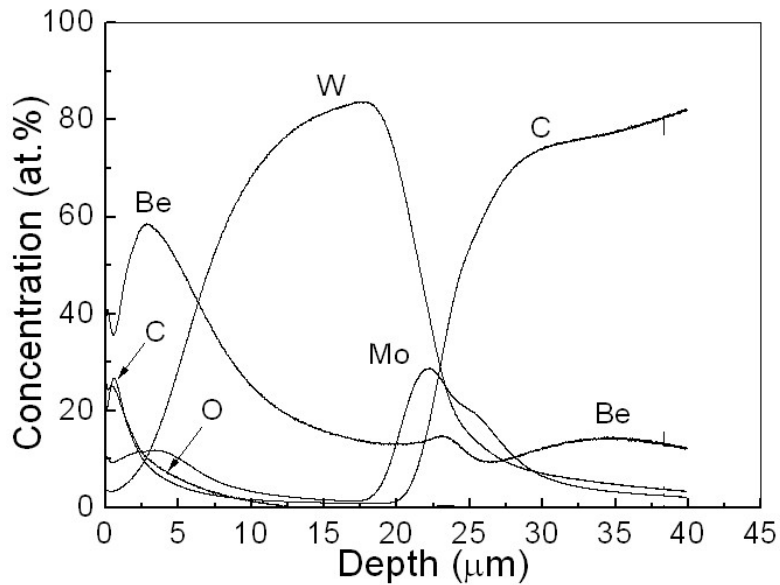
Erosion was not measured on any tile except tile 3 where the top Mo layer seems to be removed in certain areas.

Fig.4 GDOES depth profiles for the W/Mo marker deposited on Tile 3 after plasma exposure

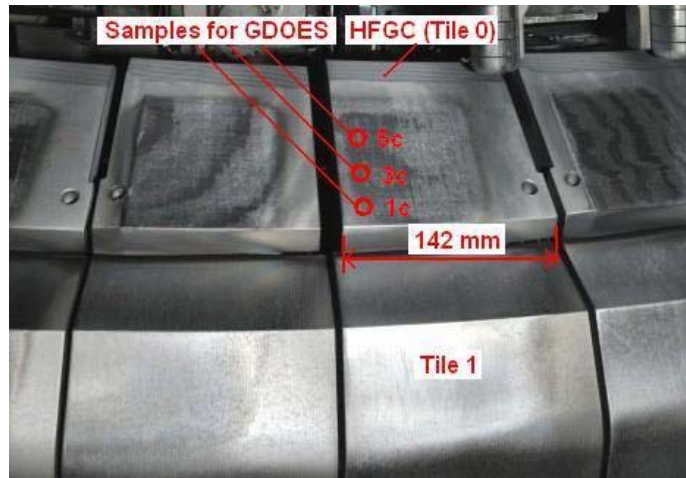
A special attention was paid to the HFGC tile where a thick layer of Be (20-25 μm) was measured on the W coating in three locations. A picture of the HFGC tile in the ILW and the positions of the samples are shown in Fig.5. A dark zone covering about 70% of the total area of the HFGC tile can be clearly seen. The samples used for GDOES analyses were cut from the dark area. Apparently the dark area on HFGC in Fig. 5 could be interpreted as a strong erosion area where the W was removed from the CFC substrate. However, in accordance with the GDOES results shown in Fig. 6 this is an area with a strong Be deposition on W coating. Be but also W and Mo was detected up to a depth of 100 μm . This large depth does not represent the coating thickness, but it is due to the porosity, roughness and imperfections of the CFC material as it is shown in Fig.7. The pores dimensions are in the range of a few tens-hundreds of microns with the depth reaching sometimes 0.25 mm. This was demonstrated by X-ray micro-tomography [4]. The GDOES results are in agreement with those obtained by RBS on the same tiles [2].

Fig.5 Tiles HFGC in JET wall

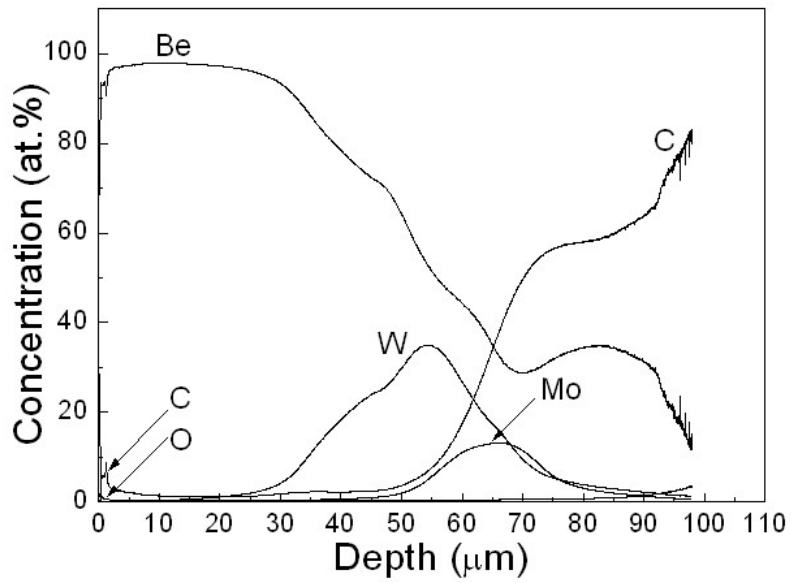
Fig. 6 GDOES depth profiles for the W-coated CFC sample (3c) cut from HFGC tile exposed in JET

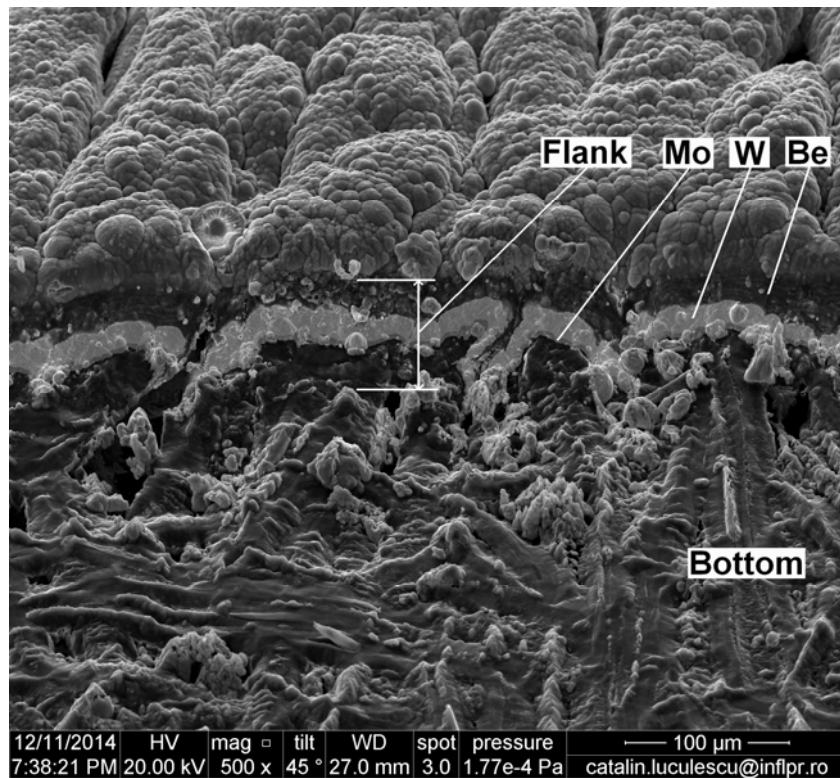
Fig.7 SEM image of the GDOES crater (flank and bottom) for a sample cored from HFGC tile
