Implementation of ferritic steel as in vessel wall:

Lessons learnt and follow up

I. Zammuto^a, L. Giannone^a, A. Herrmann^a, A. Houben^b, A. Kallenbach^a, K.H. Schuhbeck^a, B. Sieglin^a, S. Vorbrugg^a and the ASDEX Upgrade Team

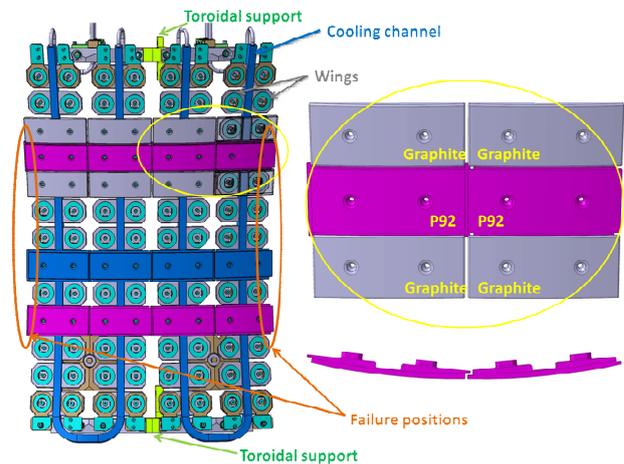
At first, our thoughts were completely focused on the new material. A deep examination of the damage configuration revealed that the HS supporting structure was moving inside AUG. In fact, the above mentioned damages were all placed between 2 VV octants (orange regions in Figure 2). Broadening our view, it was assumed that during a disruption with plasma displacement, the variation of the radial field could induce a current flowing in 2 adjacent HS supporting structures.

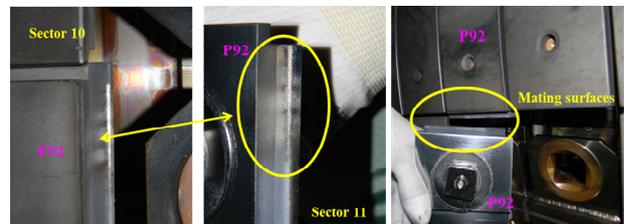
After the first campaign with the 2 steel rows, the inspection of the in vessel components disclosed some unexpected damage of the HS tiles. In particular, some steel tiles exhibited a coating failure as clear indication of a possible contact against the adjacent tiles. Some of them were burned along their poloidal edges. These damages are shown in Figure 3. Some of these steel tiles also had melted areas in the sectors placed opposite to Neutral Beam Injectors. The striking findings were observed on the graphite tiles adjacent to the P92 tiles. In many locations, the graphite tiles showed notches and in 5 positions their edges were broken (e.g. in Figure 4).

Figure 3 Damages on the P92 tiles in AUG: on the left hand side are shown the arc damages and on the right hand side the mating contact surface between tiles.

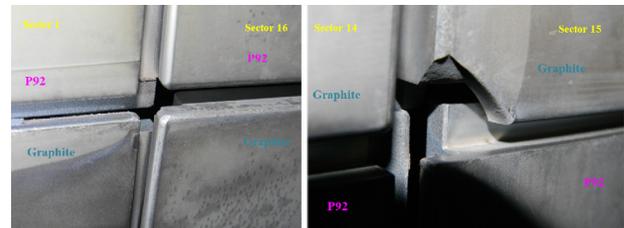
Figure 4 Damages on the graphite tiles adjacent to the P92 tiles in AUG: on the left hand side is shown an example of the notches and on the right hand side a representation of the broken edge of one graphite tile.

Since the labyrinth feature creates an overlap between the adjacent tiles reducing the radial gap to 3 mm, this gap is easily closed during a disruption where a theoretical relative displacement of 10 mm is calculated. The energy introduced in the structure leads to severe and sudden impacts between graphite and steel tiles which caused the damage of the weakest material.

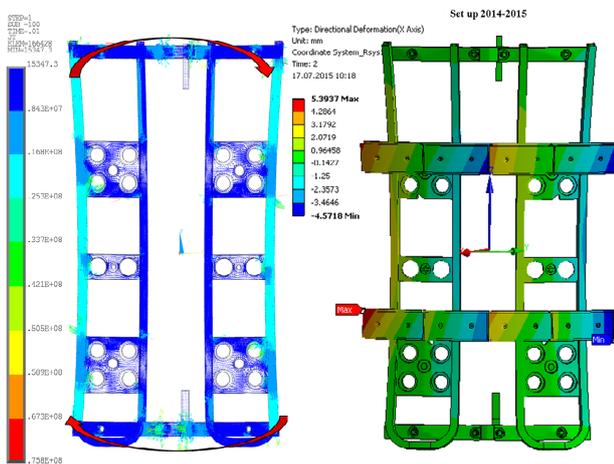
To quantify the induced current electromagnetic analyses were carried out. Assuming a uniform variation of the radial field of 50 T/s, the corresponding magnetic vector potential was applied to the structures. The current path in term of density current is illustrated in Figure 5.

Indeed the current passes through the extreme poloidal legs of 2 contiguous HS cooling channel and it crosses the toroidal stiffeners and supports in the upper and lower positions. The calculated induced current is of the order of 7 kA, which for a toroidal magnetic field of 3 T at the plasma center, gives rise to radial forces of the order of 35 kN. These forces are acting on opposite directions into the extreme poloidal legs of the 2 contiguous cooling channels. The 2 forces end up producing a poloidal moment acting on the whole structure which is responsible for its rotation. This moment gives rise to a maximum relative free displacement between the extreme tiles of about 10 mm, as indicated on the right hand side of Figure 5.

Figure 5 On the left: current density path through the HS structure for a uniform variation of radial field. On the right: corresponding displacement [mm] caused by 35 kN radial forces.

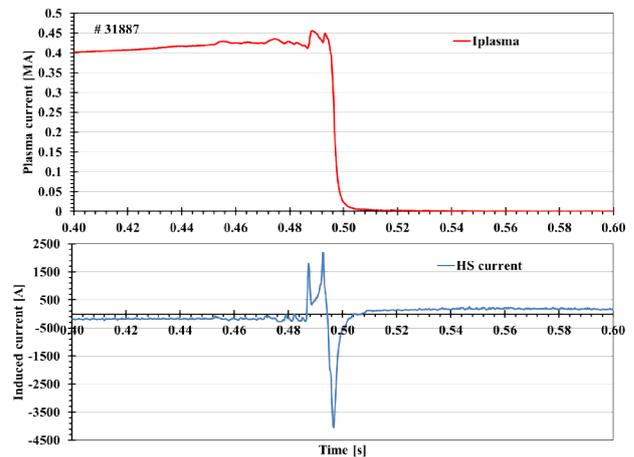
This new diagnostic aimed to confirm the hypothesis of the current loop in the HS support structure. In Figure 7, the measured current for the shot #31899 is reported. In this case the plasma current was quite low and a value of about 4 kA is recorded. A maximum value of 7.5 kA has been measured, perfectly in agreement with the calculations.

Figure 7 Induced current in the HS measured by the Rogowski coil for the shot # 31887: in correspondence of the plasma current disruption the current in the frame support increases.

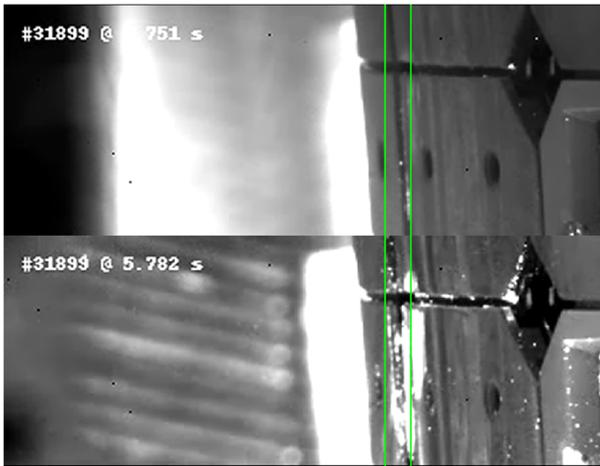
Being aware of the problem caused by the HS movement, a fast infrared camera [4] from time to time was pointing to the inner column. In Figure 8, two freeze frames of a video are reported. Comparing the position of the HS in still condition on the top, and during a disruption, on the bottom, a displacement can be observed in the region between the green lines.

A better understanding of the sudden movement of the HS is given unambiguously by the video footage. The sudden movement of the HS provokes the collision between adjacent tiles leading to the rupture of the graphite.

Figure 8 Infrared camera view of the HS for the shot # 31899: comparison between still condition on the top and in movement on the bottom. The green lines are limiting the displaced regions of the tiles.

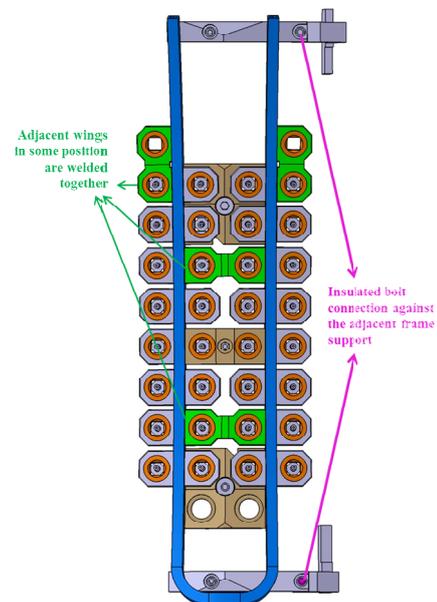
Figure 9 Modifications to the HS supporting structure are highlighted: in green welding between adjacent wings and in pink the electrical insulation between adjacent HS.

To reduce the induced current in the HS frame an electrical insulation will provide the separation of current path between the 2 adjacent supporting frames. In Figure 9 the insulated bolt connections are indicated in pink. The insulation is made with silicon nitride already used in other components inside AUG. With this precaution, the induced current will flow just on a single frame and the current should be reduced to a calculated value of 2.5 kA. Reducing the current means a reduction of the forces and therefore a decrease of the relative displacement of the tiles.

Nevertheless a stiffening of the supporting structure is required in order to cope with the additional electromagnetic forces arising in the ferromagnetic tiles: green wings in Figure 9 are welded together.

With the new set up, a relative tile movement less than 1 mm is expected, which would avoid the collision between tiles. A qualification of the welding process has been carried out to verify that the deformation given by the process would remain within acceptable limits. The reinforcement of the HS with welding is still ongoing, but most of the structures are already available for installation.
