Measures to overcome deep cracks of tungsten tiles in the ASDEX Upgrade divertor

I. Zammuto^a, A. Herrmann^a, N. Jaksic^a, M. Li^a, M. Balden^a, V. Rohde^a, S. Vorbrugg^a, H. Greuner^a, R. Neu^{a,b}, A. Kallenbach^a, the ASDEX Upgrade Team^a

^aMax-Planck-Institut für Plasmaphysik, D-85748, Garching, Germany

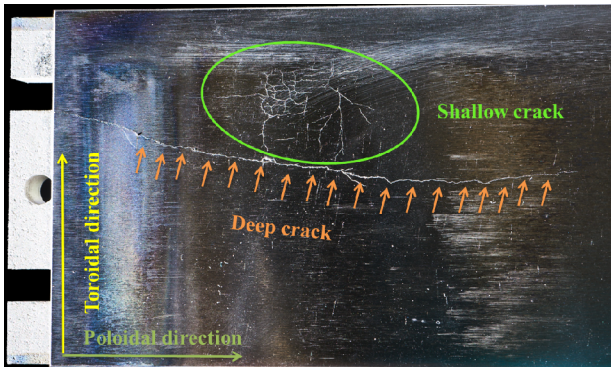
Preliminary experiments in the high heat flux test facility GLADIS [4] and studies based on FEM analyses did not prevent problems related to deep cracks in the bulk tungsten tiles [5][6]. In fact, after just one experimental campaign, almost all the tungsten tiles showed severe damage. A typical crack pattern is shown in Fig. 2. In this picture the two main categories of cracks are identified: 1) shallow cracks, localized in the most loaded region of the tile, clearly characterized by a dense ramification of few μm depth cracks 2) deep cracks, running in poloidal direction of the tungsten tiles and in most of the cases passing through the entire thickness of the tile.

Fig. 2. Typical crack pattern in a tungsten tile: shallow cracks are identified by a dense superficial network, while the deep crack runs in poloidal direction from the lower part (left side) of the tile to the central one extending through the entire tile thickness.

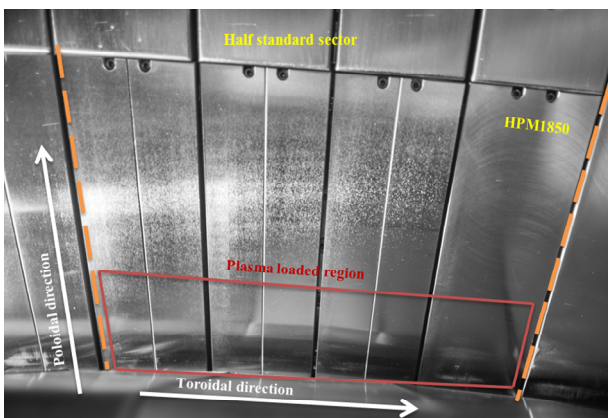
- Standard sectors: no deep cracks in the tungsten tiles are occurred. Noteworthy is the HPM1850 integrity that was placed in the most loaded positions of the outer divertor (see Fig. 3).
- Sector 16: visually the castellated tiles appeared safe and sound as can be seen in Fig. 4. Nevertheless, after a thorough examination, the tiles reveal deep cracks in all of them. In particular, one is completely separated by a deep crack running along the groove of the castellation, as reported in Fig. 5.
- Sector 15: no cracks were found.
- Sector 7: 5 tiles out of 8 had deep cracks with their standard appearance.

Fig. 3 Picture of half standard outer divertor: no cracks are visible on the split tiles; also the HPM1850 integrity is noteworthy. None roughening of the tiles is observed, but the gray spots on the picture are given by some reflection effect.

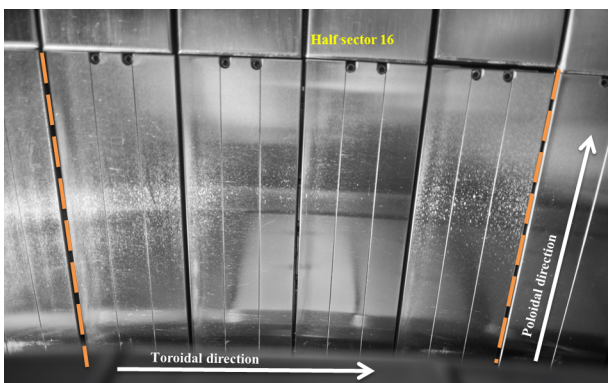
Fig. 4. Picture castellated tiles of half outer divertor: apparently no cracks are visible on the tungsten tiles. None roughening of the tiles is observed, but the gray spots on the picture are given by some reflection effect.

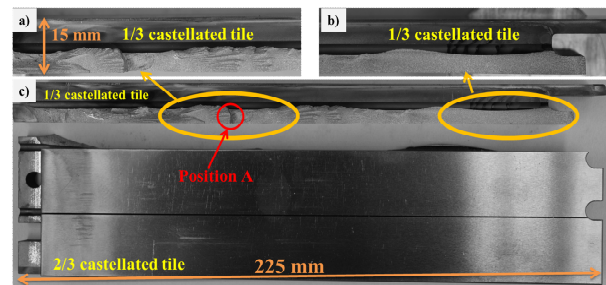
The rupture surface of the castellated tiles was investigated macroscopically and microscopically by Scanning Electron Microscopy (SEM). A naked eye inspection reveals a fracture surface with a pronounced slant appearance and with strong change in roughness due to cracks propagation. Two main regions are distinguished: the left part of the tile shown in Fig. 5, where many crack lines are visible; while on the right part of the tile in the same picture, the surface showed a shiny highly reflecting texture, without marks.

It appears that cracks started on the left part of the tiles, where the striking line of the plasma actually is. The cracks grow progressively for thermal fatigue, till the reduction of the cross section makes the tile incapable to withstand the disruption load, causing a sudden tile failure. Cracks seem to be originated in different positions: 1) as underlined by the prominent change of the crack plane identified in position A of Fig. 5; 2) as suggested by the marks close to the castellation tip.

Fig. 5. Dismounted castellated tile belonging to sector 16: the deep crack has completely split up the tile in 2 parts: in figure c) to the left is the thermally loaded region, the right side is almost thermally unloaded.

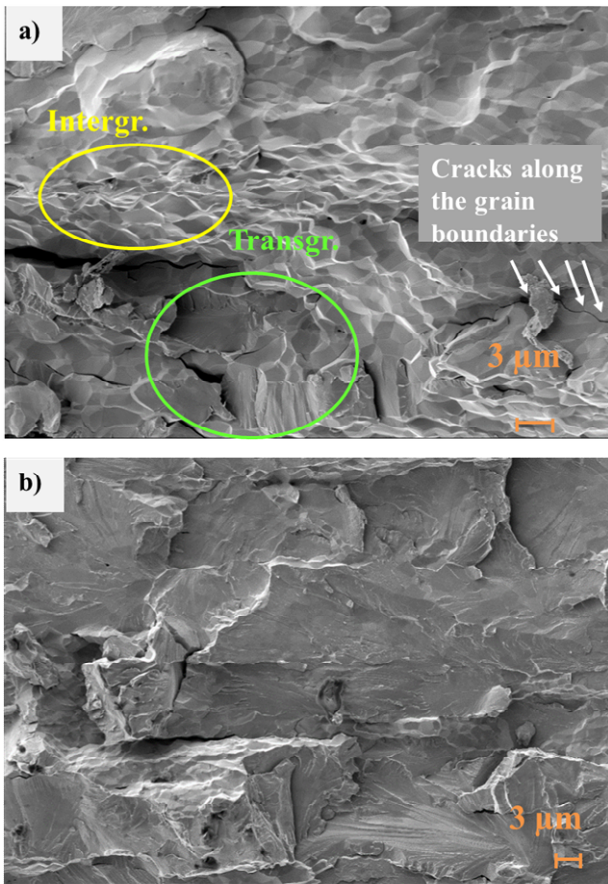
Fig. 6 (a) illustrates the microstructure of the fracture surface in the heat loaded region: the zoom-in emphasizes the presence of: 1) intergranular fracture (fracture along the grain boundaries), to note the several flat separated grains; 2) transgranular fracture visible by cleavage facets. The microscopic view of the thermally unloaded part is given in Fig. 6 (b): in this case it seems that the tungsten section fails mainly for transgranular cleavage. Similar fracture behaviour is observed in the thermally loaded region for the castellated tile produced by the other manufacturing company.

Fig. 6. Fractograph of the broken castellated tile: a) related to the thermally loaded region where intergranular and transgranular ruptures are identified; b) refer to the thermally unloaded part of the tile where mainly cleavage failures are visible.

Fractographic studies of the castellated tiles showed thermal fatigue behaviour in the plasma loaded region. This is the first time that thermal fatigue marks are clearly exhibited in the AUG tungsten tiles. It's very likely that micro-cracks (few tens of μm) were introduced on the tip of the castellation during the manufacturing process [12]. During the operation superficial cracks were progressively growing under plasma load, till the tile suddenly fractures due to a disruption load. Fractographic studies [13][14] have investigated the failure mode of polycrystalline tungsten for specimens extracted along the rolling direction. It was shown that longitudinal specimens with crack in perpendicular direction are associated with transgranular cleavage at room temperature and intergranular failure at elevated temperatures. This would be consistent with the observation on the castellated tile if it were not the fact that the groove would act as a crack along the rolling direction. Most probably the difference is given by the production of the ground material: the tungsten tiles were produced by a rolled tungsten plate while the specimens tested in the paper were produced by a rolled tungsten rod.

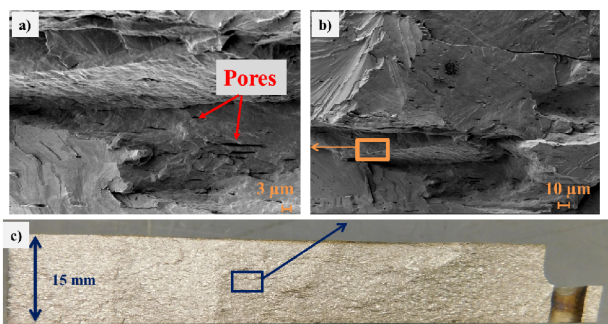
Fig. 7. Fractograph of a wide tile installed in the AUG outer divertor till the 2016 campaign: cleavage and intergranular rupture can be seen together with many elongated pores.

The fracture surface of a wide tile, installed in the AUG outer divertor till 2016 campaign, appears homogeneous, shiny and reflecting, with just few imperceptible marks as reported in Fig. 7. Microscopic analyses of the fractured surface reveal intergranular and transgranular fractures together with elongated pores. Macroscopically and microscopically, the wide tiles with titanium clamps in sector 7 have shown the typical crack path observed in the previous batch of tiles. On the positive side, the tiles in this sector lasted longer without cracks than tungsten tiles with stainless steel clamps. From past experience, it is known that some tile got broken after 200 shots. Positive performances are recorded by the heavy tungsten alloy. After examination of these findings, just small changes were setup for the 2018 AUG campaign; the sectors with damaged tiles were replaced by the standard divertor setup and all the stainless steel clamps were replaced with the titanium grade 5, combining the positive effects of both proposals. It is worth mentioning that, for this first year of experiment no differences are recorded between the two tiles suppliers.
