# Inspection of W 7-X plasma-facing components after the operation phase OP1.2b: observations and first assessments

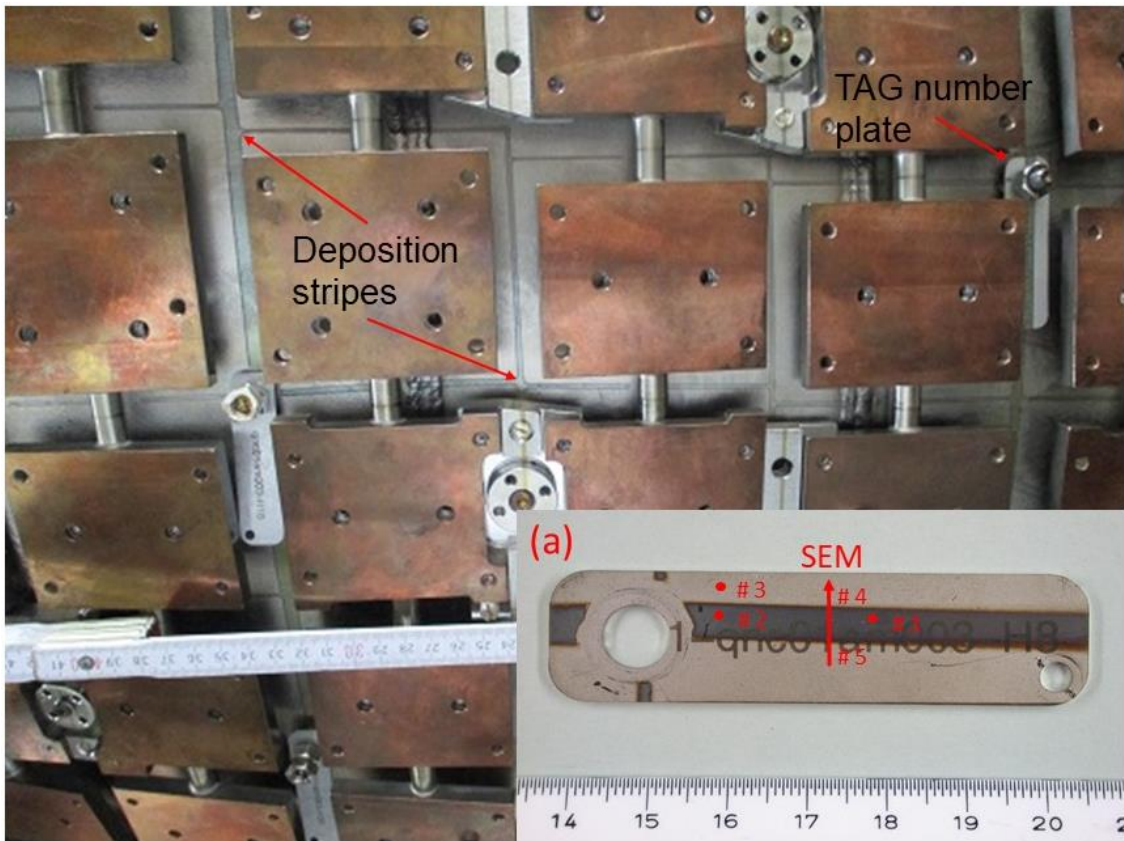
On the whole inboard side plasma vessel wall behind the graphite tiles, sharp deposition stripes were observed, located at the gaps between the tiles as shown in figure 2. These depositions appeared also on a TAG number plate (see fig. 2 inset (a)) incidentally fixed at the stripe location. This was removed and analyzed with EBS. The measured areal densities are shown in table 1. By comparing the values on the base material (#3) to the stripe regions (#1 and #2), the deposited material was found to consist mainly of C with small amount of O and traces of B (H is not measured by the technique used). Along a line perpendicular to the deposition stripe (see fig. 2 inset (a)), SEM/EDX measurements were done (see figure 3). The EDX measurements are difficult to quantify due to the layered structure, but provide a qualitative confirmation of the EBS results. The deposition in the stripe is constant (as already indicated by the constant color), while the edges of the stripe are relatively sharp with widths of less than 1 mm. Here, compared to the base material (Fe) deposition of C is seen at both sides of the stripe. With the measured width of the stripes and the known distance between the neighboring stripes, an array was generated for the whole inboard side of plasma vessel (where the stripes were observed) and the fraction of deposited area (3.23 m<sup>2</sup>) compared to the total

area ( $89.9 \text{ m}^2$ ) was estimated. Further, with the measured thickness, the total amount of deposited C ( $1.39 \times 10^{22}$  atoms) was estimated to be 0.3 g. Deposition is also expected on the sides of the tiles forming the gap through which C travelled up to the vessel wall. These tiles are presently being investigated.

Figure 2. View of the inboard side plasma vessel showing the Cu-Cr-Zr support plates after removing the graphite tiles installed on these plates. The deposition stripes on the vessel wall are visible behind the support plates, inset (a) shows a TAG number plate installed on the vessel on which the stripes were also deposited. Results for the numbered measuring positions are given in table 1 and fig. 3.

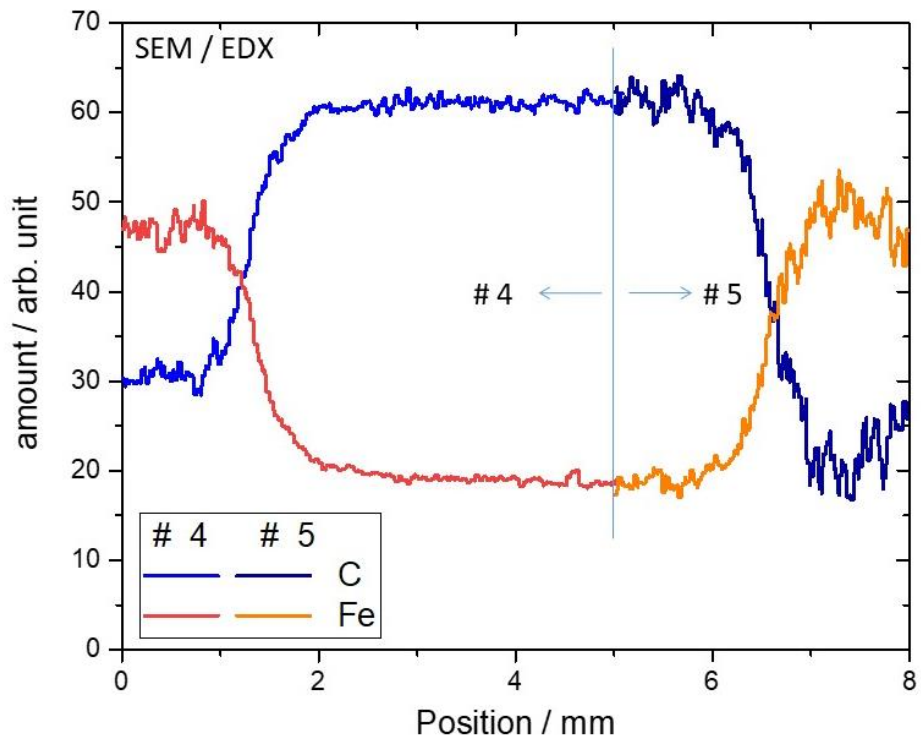
Figure 3. SEM/EDX measurements on the TAG number plate at the line crossing the deposition stripe at the locations # 4 and # 5 shown in figure 2 showing the thickness homogeneity and the sharpness of the stripe edges.

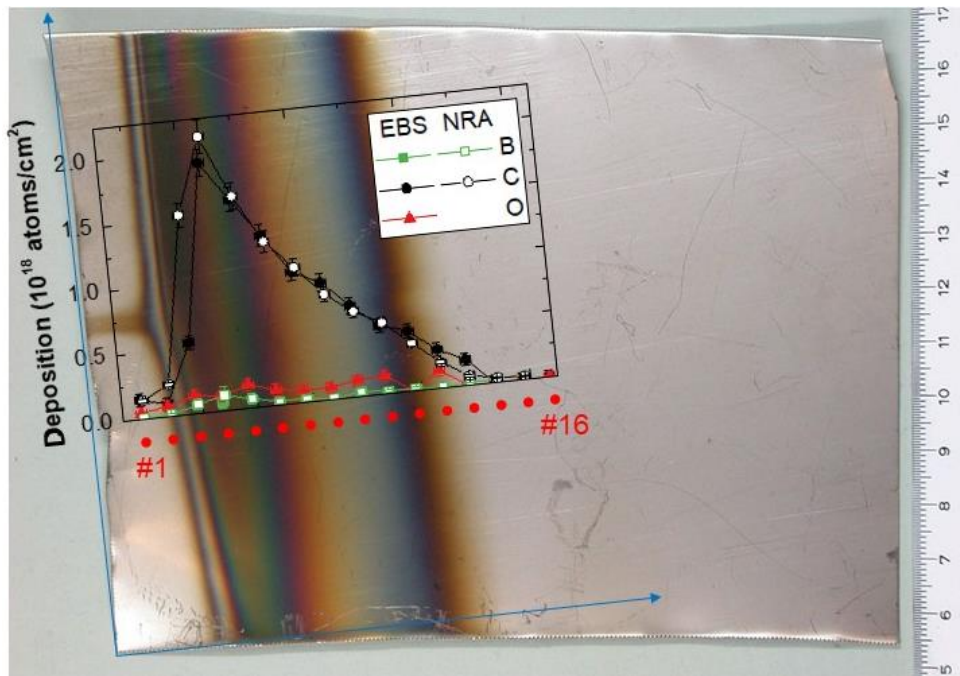
The space behind the TDUs were closed using 0.5 mm thin SS plates named as inner divertor closures. When the TDUs were removed for installing the water cooled high heat flux divertors, depositions were seen on these closures. These depositions were analyzed using EBS and NRA. In fig. 4, the plot of EBS/NRA measurements superimposed at the 16 measuring positions on the plate, shows variation of deposited layer thicknesses. A gradient of deposition was observed with peak values of about  $2 \times 10^{18}$  atoms/cm<sup>2</sup> for C, the amounts of O and B were relatively small. The observed depositions were accumulated during two experimental campaigns, i.e., OP1.2a and OP1.2b. Most likely, these deposits were created during OP1.2a operation mimicking the scraper configurations, when the strike lines were moved close to the pumping gap panels and some of the convective loads could reach the closures. For OP1.2b, however, these loads were blocked by modified graphite baffle tiles (L-shaped tiles) in this region. Further analysis will be carried out to clarify if any deposition took place during OP1.2b as well. Significant footprints of three boronizations were not seen at these interior locations. These closures have been removed, for the next phase of operations, together with the new divertor, new closures will be installed.

Figure 4. Inner divertor closure plate removed after OP1.2b from the lower TDU in module-2. Deposition layers are visible on the left side of the plate. The plot of EBS/NRA measurements superimposed at the 16 measuring positions (red dots) on the plate, shows variation of deposited layer thicknesses.

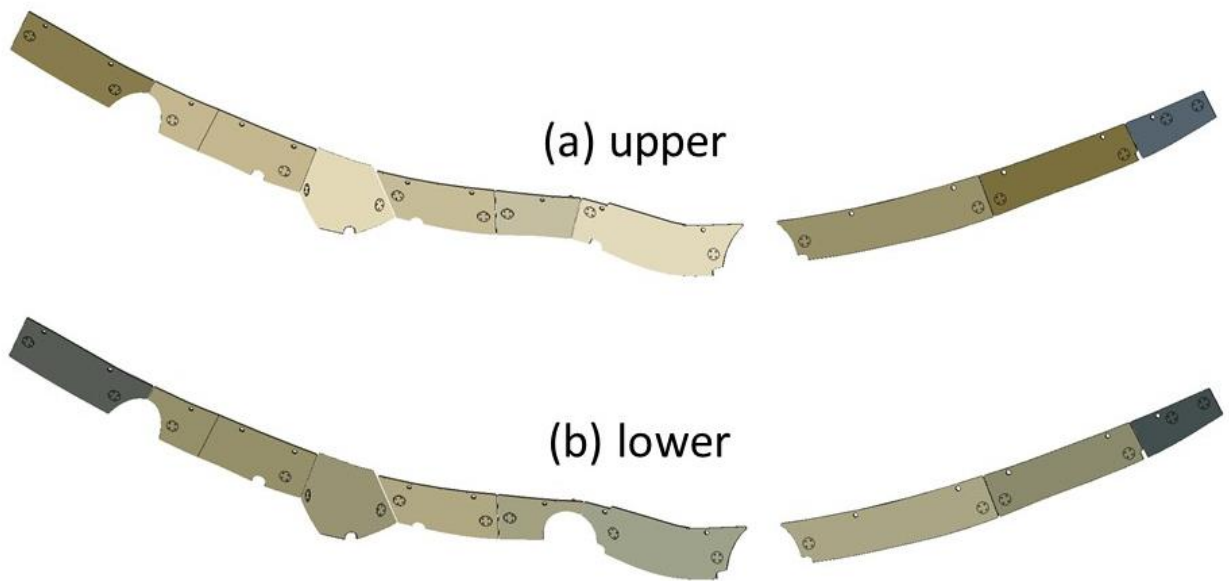
During the inspection, deposits were observed on the SS outer wall panels, on the pumping gap panels installed between the horizontal and vertical part of TDUs and on the poloidal closures. Optical reflection measurements were performed on all the panels around the torus. The thickness profile on the wall panels shows a definitive pattern with the thickest deposition around the interface between the modules and the thinnest in the middle of the modules [8]. One such area of thicker deposition on the wall panels close to the toroidal closure along the torus is visible in fig. 1. From the deposition pattern it is hard to distinguish the differences due to the scraper elements. Depositions were seen only on certain areas of pumping gap panels as well. Interesting deposition patterns were observed on the poloidal closures (see fig. 5), with thicker depositions at the edges, which are located close to the area of thicker depositions on the wall panels (see fig. 1). Different depositions on upper and lower closures of a module indicate up-down asymmetry with the comparatively larger number of panels at the lower poloidal closures experiencing thicker depositions. Such asymmetries were observed in all five modules.

Figure 5. Views of the upper (a) and lower (b) poloidal closures from module 4. The difference in colors of both indicates the up down asymmetry of the depositions.

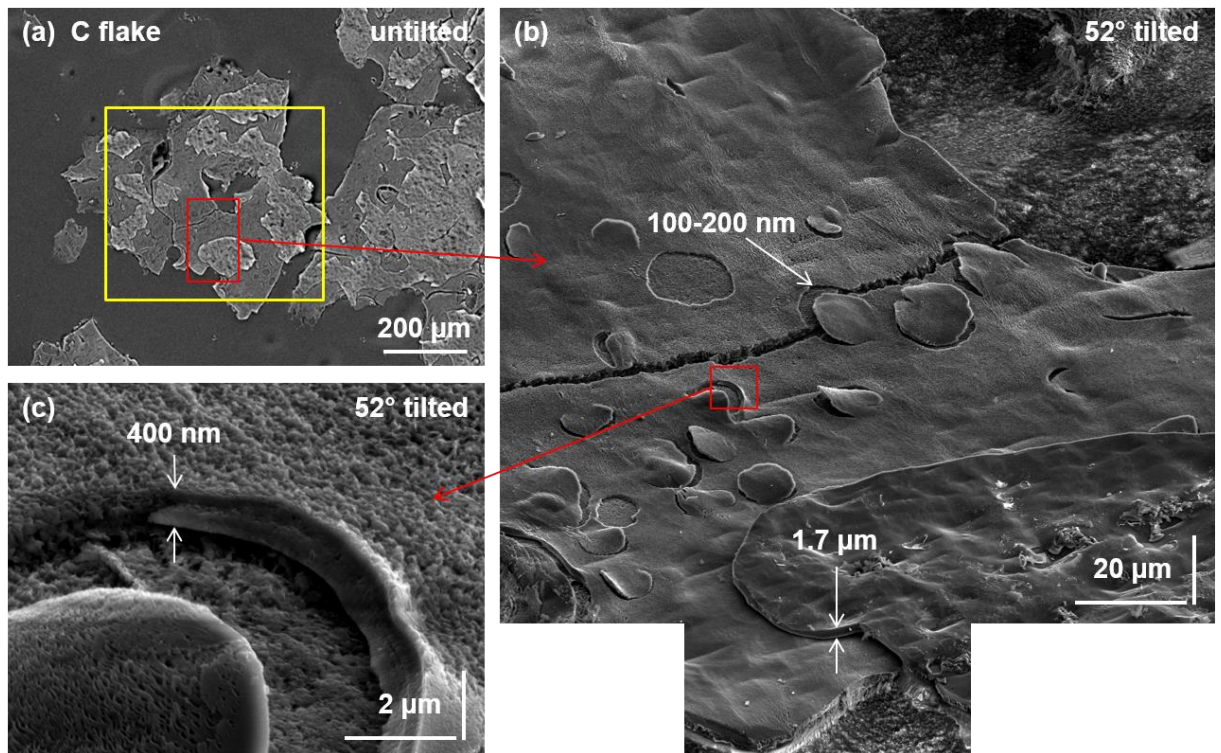
The samples were analyzed using SEM/EDX. Fig. 6 shows as an example a C-flake and in fig. 7 the EDX images of a selected area from fig. 6 (a) are given. From the measurements, the observed particles could be mainly classified in three categories: C-dominated flakes, Fe particles with Cr, Ni and Mn traces and Al-Cu particles. C originates mainly from the erosion of test divertor units and debris of graphite parts and Fe, Cr, Ni and Mn from the SS panels and structures. Cu is present in the Cu-Cr-Zr support structure of graphite tiles for the baffles, heat shields and toroidal closures. For Al the possible sources could be ceramic feedthroughs made from  $\text{Al}_2\text{O}_3$  or glass windows. Since three boronizations were carried out for reducing the C and O impurities, it was explored whether boron was present in these samples, however it was found to be below measurable levels.

Figure 6. SEM images of a C-flake sample collected from a tile with increasing magnification from (a) to (c). (a) is plain view and (b) and (c) are tilted by 52°. Layered structure with the thickness of layers, e.g., 100-200 nm, 400 nm and 1.7  $\mu\text{m}$  are shown in (b) and (c). EDX images of the area marked by the yellow rectangle in (a) is shown in fig. 7.

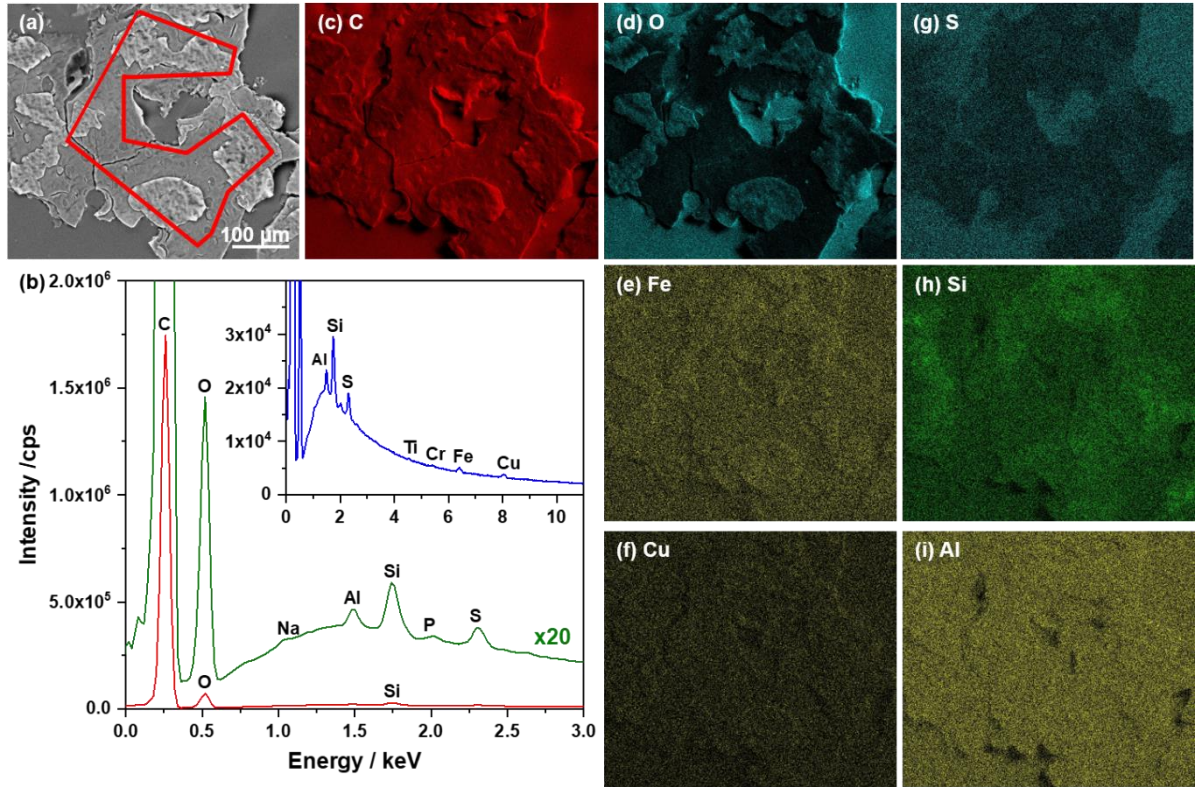
Figure 7. EDX analysis of C-flakes from the area shown in fig. 6 (a) marked by the yellow rectangle there. (a) SEM image recorded with backscatter detector; (b) EDX spectrum of marked area in (a) in different scalings; (c) – (i) EDX intensity maps of various elements after background removal and peak deconvolution. The C-flakes contain partly O and Si and traces of metals (Fe, Cu, Al), while the S and the Na (not shown as maps) originated from the glue of the sticky probe.

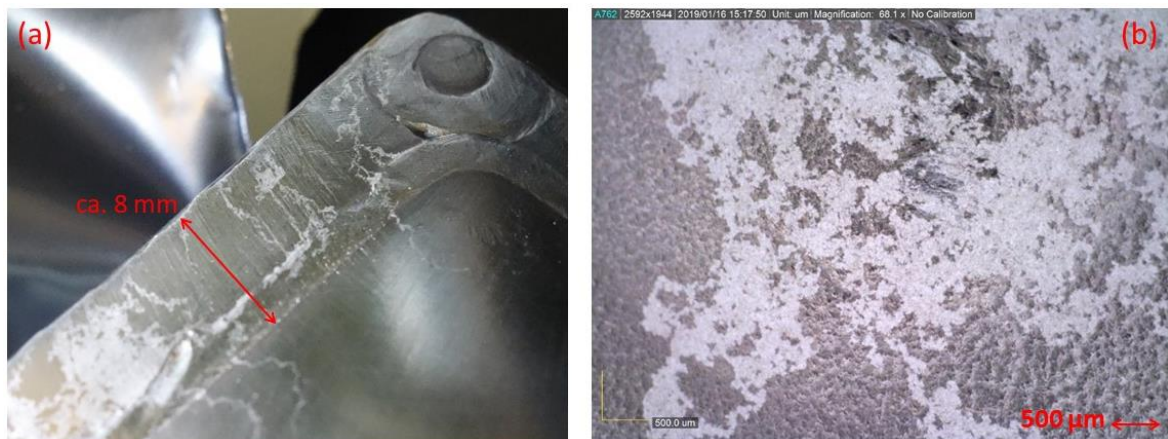
Material erosion due to arcing has been observed in fusion machines e.g. ASDEX Upgrade [10], DIII-D [11], JT60-U and LHD [12]. Such investigations were made after OP1.2b for the first time in W7-X. Altogether 212 positions with arc traces have been found on the panels, ports, plasma vessel and the tile supports. Out of these, 158 were observed on the plasma-facing side and the rest on the back side. Typical arc traces observed on the backside of a panel and an enlarged view of an area with random arc traces with optical microscope are shown in fig. 8. The length of these traces varies from 1-2 cm up to about 0.5 m. Only a small fraction i.e. <10% of these have been found to follow  $-j \times B$  direction due to the magnetic field generated by the main superconducting coils. The majority of the tracks are oriented in random directions. Besides, about 25% of these arcs even occurred on non-plasma-facing sides, indicating the origin of these arcs to be due to the glow discharges. The depth of these traces appears to be very small and no observable material erosion in the form of fine dust was seen around these positions. The observed arc traces were accumulated over the three campaigns, now this investigation will be repeated after every campaign to study the evolution over different operation phases.

Figure 8. Typical arc trace observed on the backside of a panel (a) and an enlarged view of a random arc trace taken with an optical microscope (b).

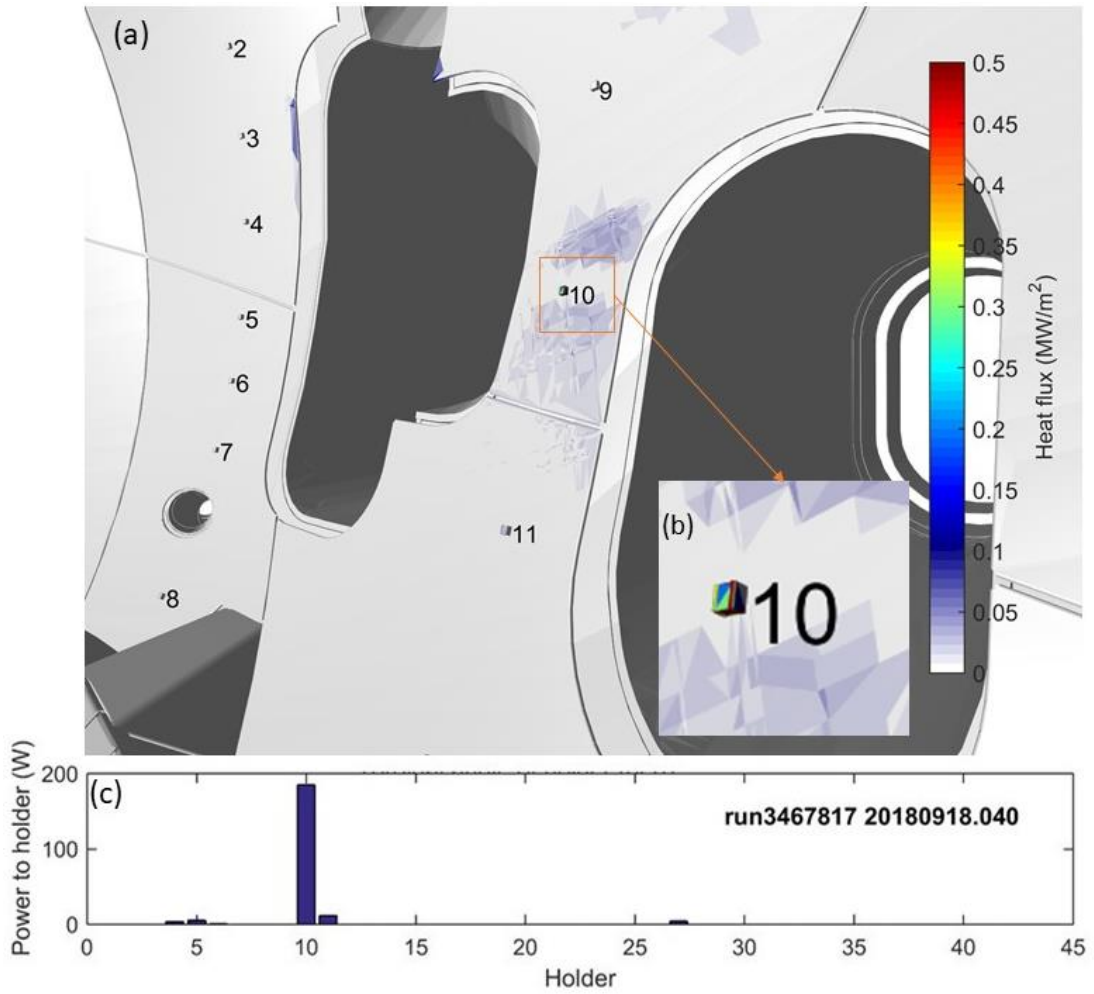
Forty-four pieces of long term deposition probes of three different types, i.e. Si-wafer, directional material and cavity probes [13, 14] were installed at the outboard wall as well as at the pumping gap panels in module 4 (see fig. 1) for monitoring depositions on these low power loaded components. One of the edges of a SS probe holding the Si-wafer installed around the mid-plane was found to be molten. All the other probes were intact, despite some of these located on the pumping gap panels, being closer to the plasma. The role of neutral beam injected fast ion orbit losses was investigated for this melting event, using the ASCOT suit of code which has been used to study a range of Neutral Beam Injection (NBI) experiments in W7-X. Details of the simulations are presented in ref. [15]. These simulations covered experiments from the various W7-X plasma configurations enumerated in the beginning of chapter 2. The simulations utilized accurate experiment geometry for the NBI

injectors, magnetic field and plasma-facing components and followed NBI injected fast ions from ionization, through the slowing down process, until cooled down to thermal energy or hitting the wall. The simulation results showed, firstly, that only the molten holder received significant heat load from NBI orbit losses, and, secondly, the load was high only in the simulation of the standard configuration [16]. Figure 9 presents results from these simulations, and they are to be perceived as typical values for various NBI experiments during the campaign, not for quantitative assessment of this particular melting event: the investigated plasma shot #20180918.040 was fueled with H<sub>2</sub> and heated with ECRH (5.52 MW) and NBI (1.8 MW). The estimated fast ion heat load at the surfaces of the 44 probes are shown in fig. 9(c), and the maximum load of ca. 180 W (5 MW/m<sup>2</sup> x 36x10<sup>-6</sup> m<sup>2</sup>) is to the molten probe (fig. 9(a) and (b)) number 10. According to the mass of the molten SS part, this load was sufficient for the observed melting. Except for the probe number 11 with loads around 10 W, on all the other probes the estimated loads are far below 10 W. For future operations, no probe will be installed at this location, besides, in order to account for the plasma operations with reversed magnetic field, another probe at the mirror opposite location will be removed as well.

Figure 9. (a) Estimations from the ASCOT code for the NBI fast ion orbit loss heat loads on the wall panels of module 4. The locations of some of the wafer probes, including the location 10 obtaining the highest load, are shown. (b) Enlarged view of the wafer probe number 10 marked with orange rectangle in (a). (c) Estimated fast ion heat load profile on all the 44 wafer probes are shown. The molten probe holder (number 10) received maximum loads around 180 W.
