# Recovery from a hot water leakage at the Tokamak ASDEX Upgrade

Volker Rohde, Albrecht Herrmann, Martin Balden, Detlef Bösser,  
Katja Hunger, Gerd Schall, Michaela Uhlmann, Thomas Vierle and ASDEX Upgrade Team

*Max Planck Institut für Plasmaphysik, Boltzmannstrasse 2, 85478 Garching, Germany*

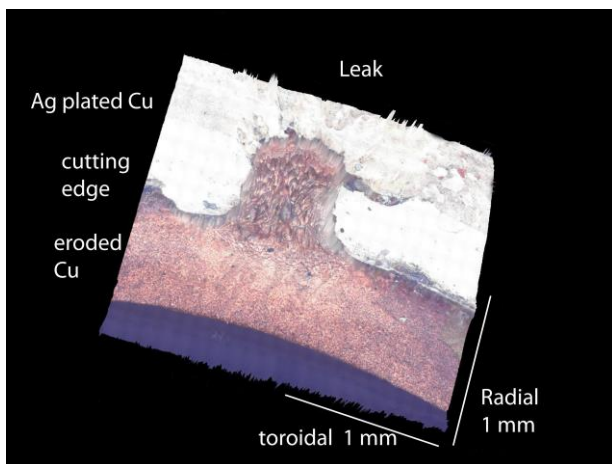
Fig. 1 Microscopic 3D-view of the gasket under an angle of 45° from top. The position of the cutting edge is at the transition from the Cu (brown) to the Ag (white). In the middle strong erosion of the gasket indicates the leak.

Here a Cu gasket of 20 mm diameter with Ag coating in a CF like flange was used. The failed gasket was strongly eroded: only 0.1 mm of originally 2 mm thick Cu were left. Figure 1 shows a microscopic 3D view of the eroded Cu gasket at the position leading to the leak. It turned out that the erosion was due to the use of deionized water, which was required during plasma operation and was also used during baking. By uptake of CO<sub>2</sub> from the air the water got a pH-value of about 5, which caused erosion during the high temperature phase of the baking procedure. The Ag coating, which should prevent erosion, did not really help. As the last replacement of the sealing was not documented, the total lifetime of this sealing is not exactly known, but it was operated for at least 10 years and about 2500 h at baking temperature.

To prevent erosion of Cu gaskets in the future, the cooling system was extended so that the in-vessel water channels can be emptied during baking. Moreover, NaOH is now added during baking to adjust the water to pH ~ 9.

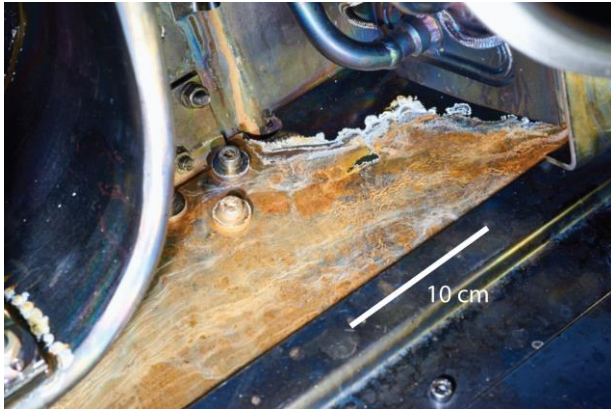
After the incident an in-vessel inspection revealed about 100 l of water found mostly below the lower divertor structure. Condensed clear water was also found at remote areas that were connected to the vacuum vessel during the event. At the PFCs, which were coated by a borohydride layer for wall conditioning [4], white crystals were found. Obviously, the layers were dissolved by the hot water steam, producing boric acid. A fraction of this acid was dried during a 48 h venting in preparation of a personnel access to the vessel. Figure 2 shows a stainless steel protection plate at the low field side midplane. White crystals are borate, the brownish layers turned out to be rust produced from stainless steel by the hot boric acid.

Fig. 2 The Status of the vessel after the opening. A stainless steel protection at the low field side midplane is shown. The white crystals are borate, brownish layers are rust.

In a first step most of the water was removed using a vacuum cleaner. The layers could be removed by a commercial water steam cleaner in combination with a vacuum cleaner. During this time the staff working inside the vessel used breathing masks and personal protection gloves.

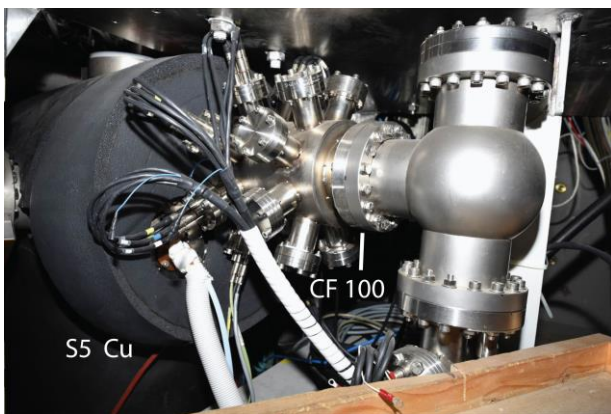
Fig. 3 One of the flanges used for the connection of the SXR cameras.

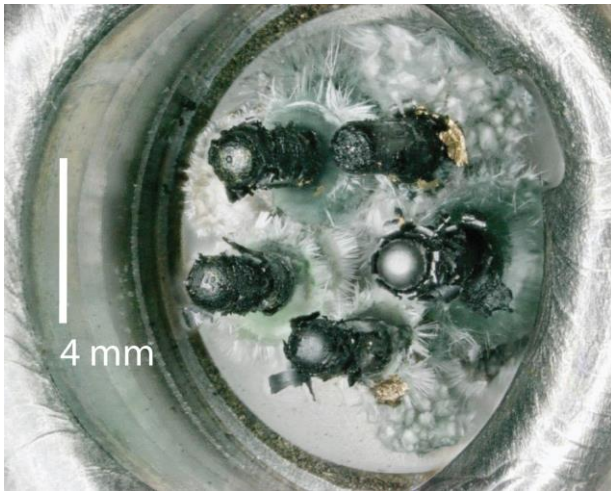
Fig. 4 Electrical feed through with Mo pins. The white crystals are Molybdenum Oxides, remnants of the Au plating are also found.

It turned out that the consequences for the feed through depended on the materials used for the pins. Brazing of pins into an  $\text{Al}_2\text{O}_3$  ceramic requires a match of the thermal expansion, so only some materials are suitable. Whereas for pins produced out of BeCu or Kovar almost no oxidation is observed, Mo pins were strongly affected. Even Au plating did not help to protect the material from oxidation. An example is shown in Figure 4. The white crystals are molybdenum oxides which strongly influence the resistance of the contacts. After cleaning and sand blasting of the insulation and the pins the electrical properties could be restored, but vacuum tests showed that the brazing may leak due to strong erosion of the Mo close to the brazing location. So all flanges with this kind of feed through, in total 92 flanges with typically 6 connectors and up to 10 pins per connector, were disassembled and tested. Whereas only 3 % of flanges

removed and dried within 4 weeks after the event showed a leakage, about 51 % of flanges removed after 20 weeks were damaged. Clearly the vessel has to be dried within 4 weeks to avoid oxidation of feed through containing Mo. All the affected feed throughs were replaced.

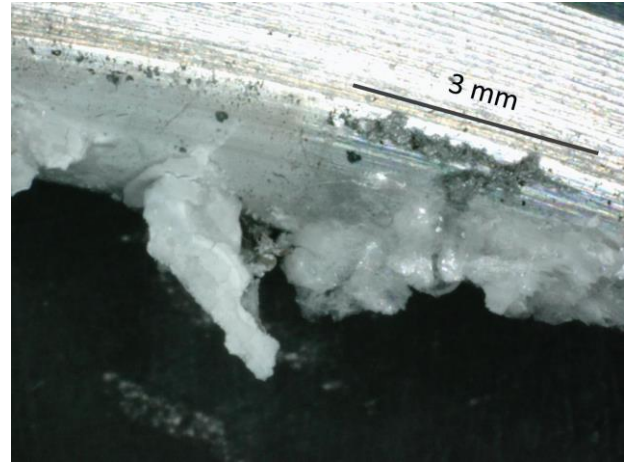
Fig. 5 Damaged Helicoflex gasket. Erosion and  $\text{Al}(\text{OH})_3$  were found

Gaskets, which showed a leakage, were covered by white foam which turned out to be  $\text{Al}(\text{OH})_3$ . Figure 5 shows a picture of the damaged helicoflex gasket. Due to this oxidation, Al showed erosion traces, which finally caused a failure of the gaskets. Water plays a major role for the oxidation. Helicoflex gaskets, mounted at the main ports in the mid-plane, where the water was removed within some days, were not damaged. Tests with unused Al gaskets showed that they were not eroded within 3 months with clean water only. If some acid, as produced by the boron, was added or the Al was in contact with stainless steel, oxide production was found after some weeks. Even though the mechanism is not fully understood, it is clear that Al gaskets have to be dried within one week to avoid damages.

To remove these gaskets special equipment was developed to open the flanges and remount them with new gaskets. Unfortunately, all electrical and optical connections, which are using these ports, had to be disassembled.

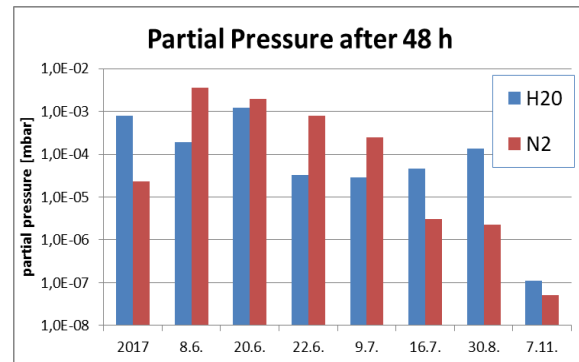
Fig. 6 Development of the water and nitrogen partial pressures for the different pump down cycles. For reference data for 2017 before the final leak fixing and for plasma operation (7.11.) are shown.

During these pump – leak test – repair – pump cycles the pressure decreased continuously, as shown in figure 6, and the sensitivity for leak detection rose. Finally, leaks were found in another type of electrical feed through, which are used for in-vessel magnetic pick-up coils. At AUG 17 flanges of this type, with up to 27 bipolar feed through are installed. Analysis showed that the pins themselves were not affected but a brazing, which is needed to interface the stainless steel to the Mo, was eroded. As the magnetic pick-up coils are needed for plasma control the flanges had to be replaced before plasma operation.

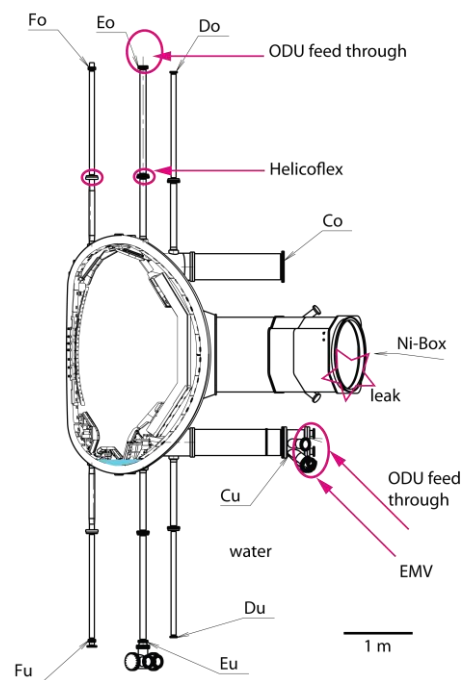
The vacuum vessel of AUG consists of 16 segments [2], each has 3 vertical ports on the top and bottom, respectively, and up to 4 horizontal ports at the low field side. Figure 7 shows a poloidal cross section of AUG with the ports. The vacuum vessel of AUG is fixed inside the toroidal field coil system, which is supported by a cast-iron shell. Outside of this shell, the poloidal control coils are installed, supported by a steel structure. The ports are welded onto the vessel and the first flange is located inside the poloidal field coil system. The ports are extended to allow access from outside the poloidal field support structure, where more space is available for the

Fig. 7 cross section of AUG showing the position of the damages
