Review of the Acceptance Tests of the W7-X Superconducting Magnets

H. Ehmler¹, J. Baldzuhn¹, L. Genin², K. Heyn³, C. Sborchia¹, T. Schild², and W7-X Team¹

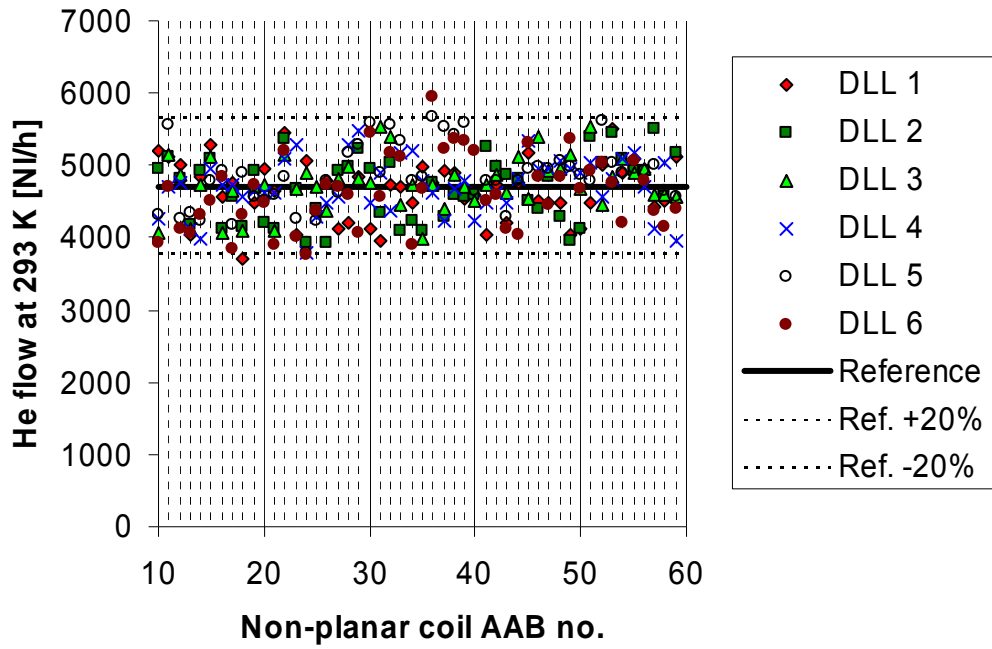
All non-planar winding packs have been produced. The helium flow of each has been measured at room temperature. Each of the six double layer lengths (DLL) has been measured individually at the manufacturer. The data of Figure 1 refer to an inlet pressure of 20 bar at 293 K. Almost all flow rates lie within a tolerance band of $\pm 20\%$ around the reference value of 4700 NI/h. For the planar coils, the production of the winding packs is not yet finished. Some results of the flow measurements at cryogenic temperature are given in [3]

Figure 1: Helium flow rates of the non-planar winding packs. Each double layer length (DLL) has been measured individually.

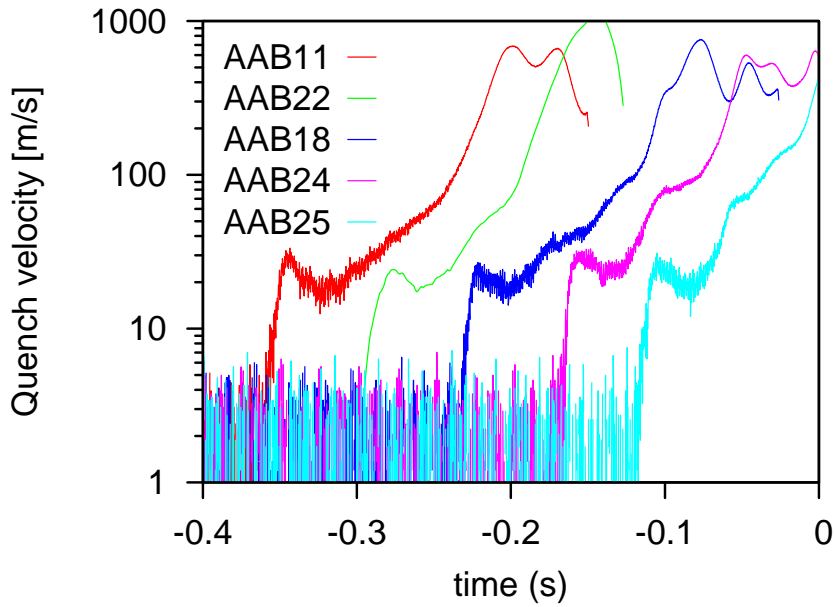
Figure 2: The speed of normal-conducting zone evolution (quench velocity), plotted for all five types of non-planar coils, shows a uniform behavior.

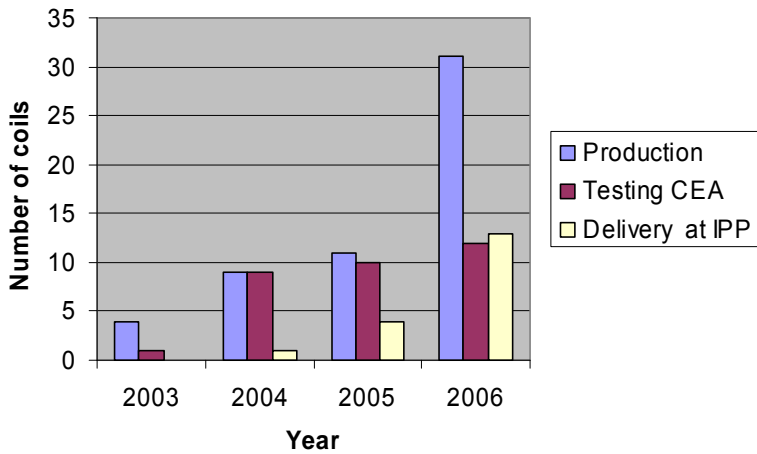
In the beginning of the project, a production rate of two non-planar and one planar coil per month and a testing rate of 20 coils per year was envisaged. It was assumed that the rate of coil acceptance would be only slightly lower to the rate of testing. All assumptions have not been met in reality. The delays have been due to the quality issues and design changes [10] within the coils themselves on the one hand and technical failures in the test facility on the other hand. In 2005, the test facility had been idle for ½ year due to a lack of coils, whereas in 2006 cold tests could not be performed for five months due to the turbine failure. The delays in production and the failures of the test facility do not have the same impact on the total project schedule. The latter is based on the availability of accepted coils for further assembly. Since not all types are needed at the same time, the order of testing has been optimized with respect to the demands of assembly. From the present experience it can be concluded that the initial projection of 20 coils per year can be reached, provided that the testing proceeds without major failures and the full test capacity is used. Figure 4 shows the present status (July 2006) and the time planning for 2006, where the production rate will exceed by far the rate of testing. In consequence, the coil testing will be one bottleneck for the total project schedule within the next years.

Figure 4: Production, tests and delivery of all W7-X coils (status from July 2006, total numbers for 2006 planned).
