# A hot steam leak during baking of ASDEX Upgrade – consequences and lessons learned

A. Herrmann, V. Rohde, G. Schall, M. Balden, D. Bösser, K. Hegele, K. Hunger, J. Stober, T. Vierle, S. Vorbrugg,  
and the ASDEX Upgrade team

*Max-Planck-Institut für Plasmaphysik, D-85748 Garching, Germany*

Keywords: ASDEX Upgrade, steam event, vessel baking, safety

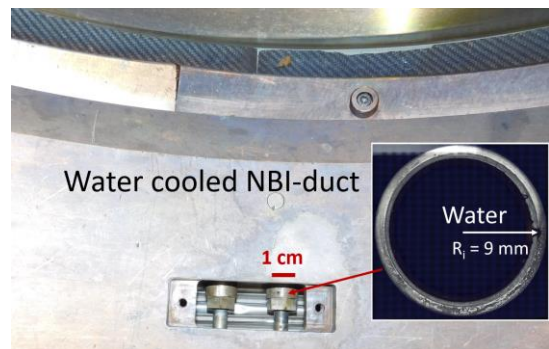
100 A small copper seal deep in an NBI-port duct was  
 101 identified as the origin of the leak. The NBI port duct is  
 102 water cooled to remove the heat due to reionization losses  
 103 in the duct. The VCR<sup>®</sup> (metal gasket face seal) like seal  
 104 was hidden behind a protection plate Fig. 3. It was never  
 105 touched over more than 10 years and more than 26 baking  
 106 cycles.

107 Microscopic inspection revealed strong erosion of the  
 108 copper seal and a gap causing the leak, see Fig. 3 and Fig.  
 109 1 in [2]. The erosion of the copper is attributed to the  
 110 acidic pH-value of pH=5 found by analysing the water  
 111 from the baking circuit.  
 112

114 Fig. 3 (left) VCR<sup>®</sup> (metal gasket face seal) like seal in the NBI  
 115 duct cooling pipes behind a protection plate (removed), (right)  
 116 photo of the Cu-seal and the leak location (arrows).

117 Acidic water is not used by intention. Usually  
 118 deionized water is used for the cooling of the in-vessel  
 119 structure to ensure a low electrical conductance of the  
 120 water. A conductance below 5μS/cm is required to  
 121 avoid an electrical by-pass over the insulating gaps  
 122 installed in the water circuits to minimize forces due to  
 123 electrical currents induced during disruptions.  
 124 Unfortunately, the deionized water reacts with CO<sub>2</sub>  
 125 from air at the baking temperature of 150°C.

306 Erosion of copper seals will be minimized by  
307 increasing the water pH to  $\text{pH} = 8.5$  by adding NaOH  
308 during baking.

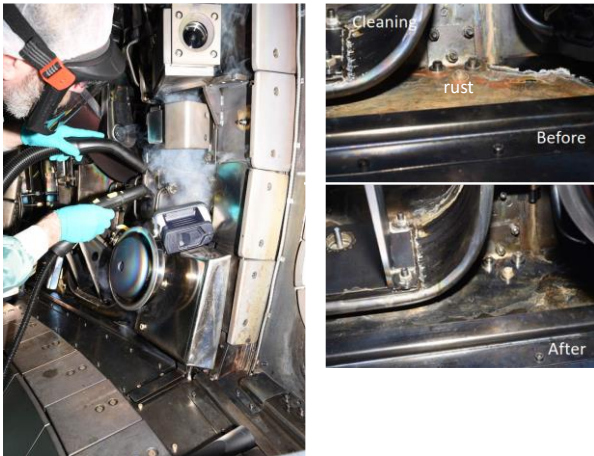
152 Fig. 4 (left) Combination of steam and vacuum cleaning. (right)  
153 Situation before and after the vessel cleaning.

144 Before the dedicated refurbishing of diagnostics and  
145 other remote components was started, the main vessel  
146 was cleaned by using a combination of steam and  
147 vacuum cleaning. This way salts and other remnants  
148 could be removed, whereas the rust removal was  
149 supported by mechanical methods, see Fig. 4.

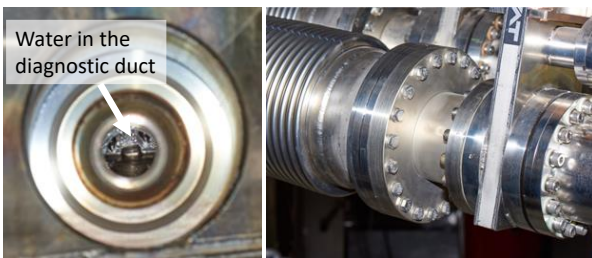
167 A significant amount of water and salts were detected  
168 inside diagnostic ports and the corresponding valves. To  
169 refurbish the components the adapter between the AUG  
170 vessel and the corresponding diagnostic was  
171 disassembled to get access to the valve corpus. The  
172 components were steam and vacuum cleaned, dried and  
173 reinstalled. A typical installation is shown in Fig. 5

176 Fig. 5 (left) View into a diagnostic port with a closed valve  
177 showing condensed water. (right) External view to the  
178 diagnostic tubes and the valve for diagnostic separation.

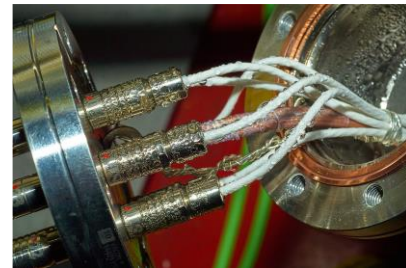
180 Nearly all flanges used for electrical signals in  
181 particular for bolometer diagnostics and vessel  
182 protection systems, such as thermocouples and strain  
183 gauges were inspected. A typical finding is shown in  
184 Fig. 6. The steam was interacting with layers and  
185 deposits of the vessel and the condensed water was  
186 polluted by boron and boron salts. This aggressive water  
187 has dissolved Molybdenum pins of the vacuum feed-  
188 through and results in leaks in many flanges. For  
189 refurbishing, the flanges were disassembled, afterwards  
190 sand-blasted, cleaned in an ultra-sonic bath, dried and  
191 finally leak tested. This procedure was applied to more  
192 than 85 flanges. 25 out of them showed a leak and were  
193 replaced by new ones.

196 Fig. 6 Flange with electrical feedthroughs before cleaning.

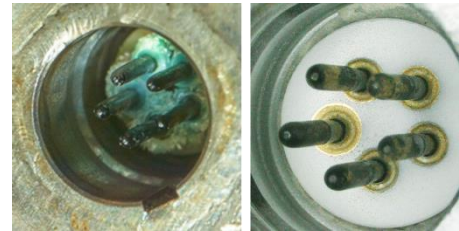
198 Fig. 7 (left) 5 pin electrical feed through showing the corrosion  
199 at the Molybdenum pins (see also fig. 4 [2]). (right)  
200 Refurbished feed-through.

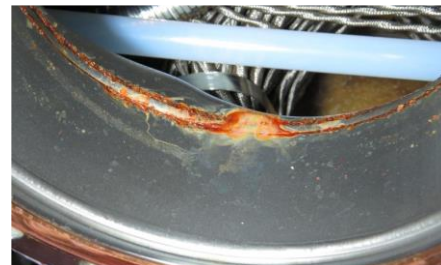
202 AUG is made from stainless steel and rust is initially  
203 not expected. Nevertheless, it was found on both sides  
204 of welding seams where the material structure is  
205 modified due to the welding. Rust was predominantly  
206 found in the pump ducts (Fig. 8) that were  
207 manufactured by a company different from the vacuum  
208 vessel manufacturer.

211 Fig. 8 Rust at both sides of a welding seam in a pump duct.

232 Pitting corrosion cannot be completely excluded for  
 233 the remaining rust in pump ducts that are not, or only with  
 234 huge effort, accessible. That's why a few flanges were  
 235 identified that will be opened at the end of scheduled shut  
 236 downs to monitor a potential pitting corrosion. Control  
 237 inspections done during the two subsequent shut downs  
 238 revealed no further evolution of rust.

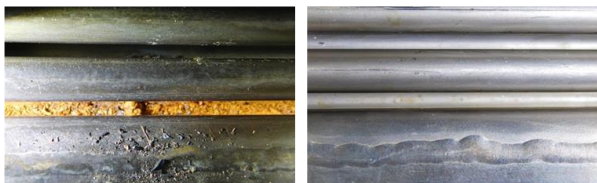
212 More critical was the existence of rust in the lower  
213 part of the 1.2 mm thin bellows of the vacuum barrier  
214 connecting the eight otherwise electrically insulated  
215 AUG octants (Fig. 9). Pitting corrosion could result in a  
216 leak in a component that can't be replaced. The rust was

217 detected occasional in folds of the bellows and not at the  
 218 welding seems itself. The origin were small particles  
 219 laying in the bottom of the folds. SEM analysis of  
 220 particles reveals that they contain iron, either in metallic  
 221 or oxidic state. The source of these small particles was  
 222 identified. They were fallen down during an  
 223 installation/drilling years ago.  
 224 In these places the particles were taken out and the rust  
 225 was mechanical removed, followed by cleaning with  
 226 purified water and drying. This way the rust could be  
 227 removed completely as shown in Fig. 9.  
 228

229  
 230 Fig. 9 (left) Bellow with deposited rust in a single fold. (right)  
 231 Bellow after refurbishing.

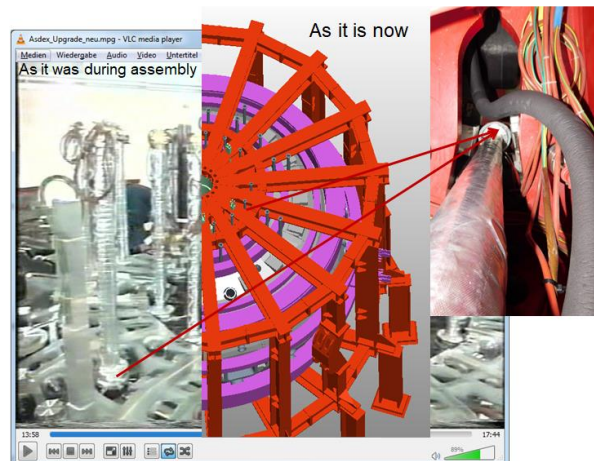
255 most flange is only possible through a 10 cm wide gap,  
 256 whereas the flange itself is about 80 cm below the support  
 257 structure. Tools with extensions were used to open the  
 258 flanges and to inspect and remove the seals (see Fig. 10).  
 259 Afterwards the flange surfaces were cleaned and polished  
 260 using extensions. In addition, the Helicoflex flange at the  
 261 extension tube was modified to provide a narrow sheet  
 262 metal strip that holds the gasket in position during  
 263 assembly.

264  
 265 Fig. 10 (left) Top view of AUG during assembly, before the  
 266 installation of the poloidal field coils and the support structure.  
 267 The long extension tubes are already mounted. (middle) CAD  
 268 view with the poloidal field support structure. The critical  
 269 ports are placed inside the inner triangles with about 10 cm  
 270 gap size. (right) Photo of the real situation on top of AUG.

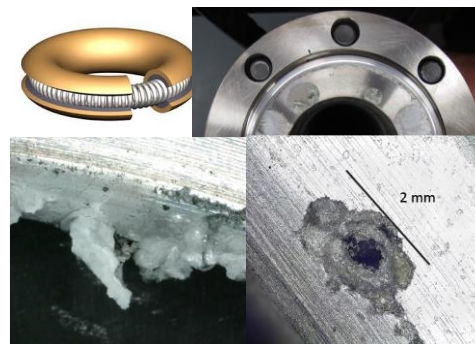
271 The Aluminium material of the Helicoflex seals  
 272 show a strong erosion resulting in pitting, as shown in  
 273 Fig. 11. The vertical ports at AUG are mostly used for  
 274 electrical cables but also for optical fibres. Whereas  
 275 electrical cables can be disconnected at the flange,  
 276 optical fibres cannot. Removing them would require  
 277 man access to the vessel. Instead of replacing all  
 278 Helicoflex seals, seals with leaks were identified and  
 279 replaced iteratively until the leak rate was below  $1e^{-7}$   
 280 mbar.l/s. Three pump downs and the replacement of 23  
 281 seals were necessary (see Fig. 1).  
 282

283  
 284 Fig. 11 Helicoflex seal. (clockwise, starting upper left).  
 285 Scheme of a Helicoflex seal, Flange showing deposits,  
 286 microscopic picture of a seal with whole and deposited salt.
