Erosion and redeposition pattern on the W7-X graphite test divertor unit tile

Elzbieta Fortuna-Zalesna^{a*}, Witold Zielinski^a, Łukasz Ciupiński^a, Maciej Spychalski^a, Chandra Prakash Dhard^b, Dirk Naujoks^b, Marcin Rasinski^c, Sebastijan Brezinsek^c and W7-X Team^d

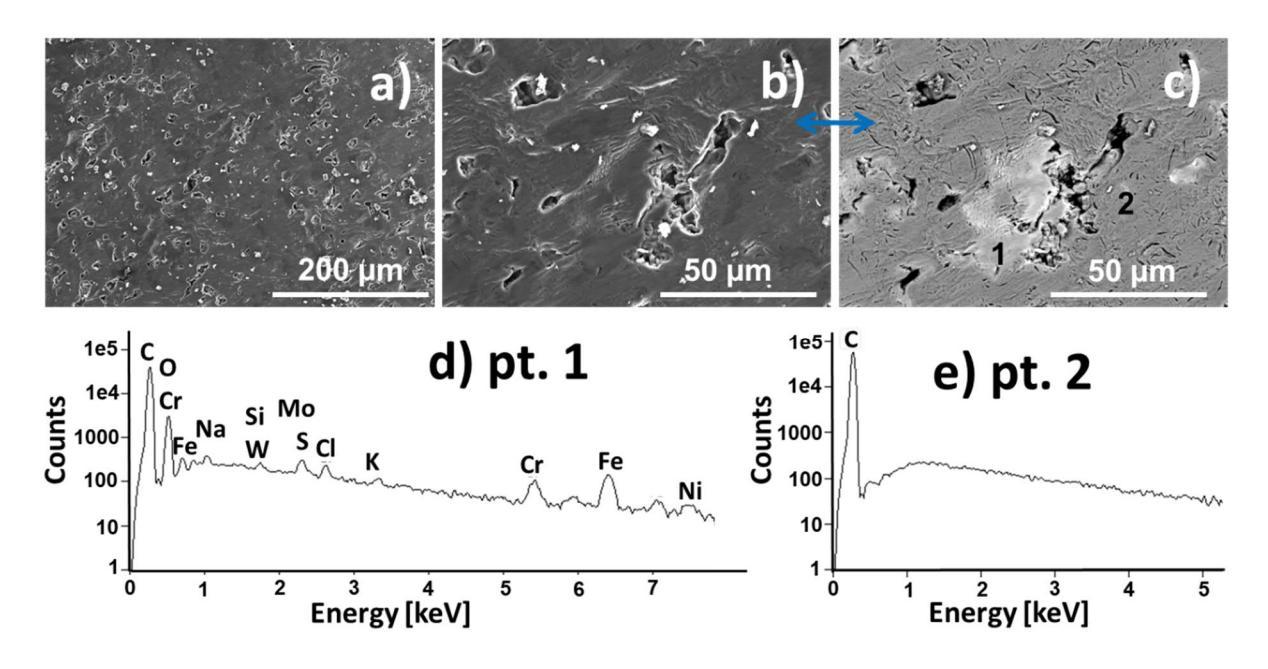
The erosion zone was observed on samples P5, P6T1, and P7. Micrographs that displayed surface features of this area in conjunction with EDX spectra are shown in Fig. 3. The surface of the material in this region was smoothened with traces of impurities in the shallow cavities at the surface (shadowed areas). This effect was also observed in the eroded areas of the graphite limiters from the TEXTOR tokamak [24]. EDX spectra showed only a carbon peak at the eroded zones (Fig. 3e), whereas peaks related to oxygen and small ones from other elements (like Fe, Cl, S) were observed inside the shallow cavities (visible in bright contrast in the backscattered electrons (BSE) image) (Fig. 3d). This peak erosion zone was located at approx. s=150 mm, at the location of the inner strike line in standard divertor configuration (with s coordinate origin at the pumping gap of the horizontal target on sample P0 in the middle).

Fig. 3. SEM images of sample P6T1 morphology (a-c) with corresponding EDX spectra (d-e) at points 1 and 2 marked in (c), from the erosion zone. Point 1 is located in the shallow cavity, while point 2 is at the flat surface. Images 3c and 3d show the same location imaged in SE and BSE modes, respectively.

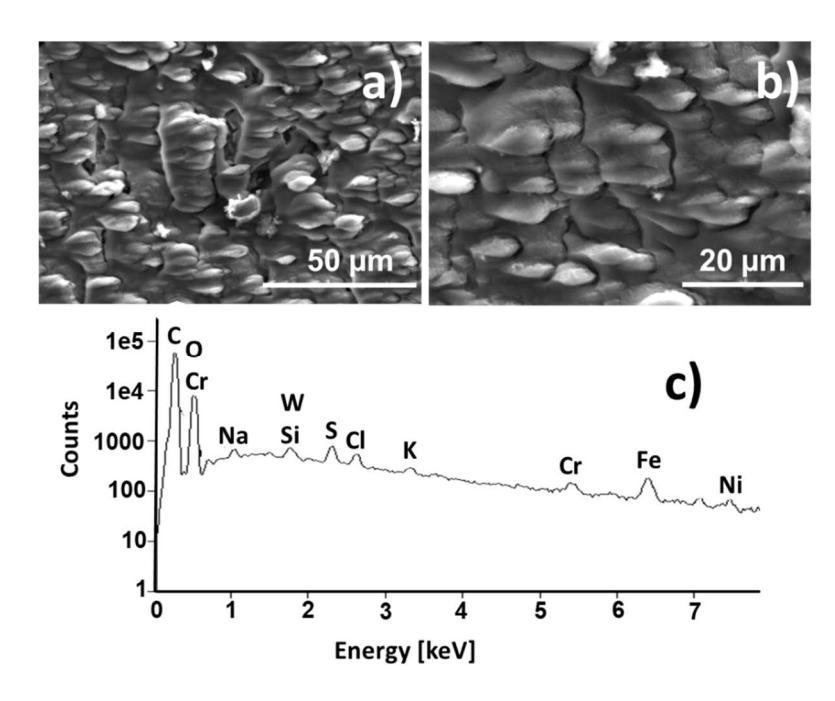
The deposition zone was located adjacent to the erosion zone. As shown in Figs. 4a–b, the surface of samples P8 and P9T1 were covered with a distinct, thick, scale-like deposit. In the case of sample P10, a relatively flat and thinner scale was observed. The registered EDX spectra proved that the main deposit constituents were carbon and oxygen. Additionally, the

deposit included a small amount of iron and other steel components along with other impurities (S, Cl, and Na). It should be noted that S and Cl were not determined as exogenous impurities but were found in the deposits of the limiters after OP1.1 campaign [25].

Fig. 4. SEM images of sample P9T1 morphology (a-b) with corresponding EDX spectrum of area (c), in the deposition zone.

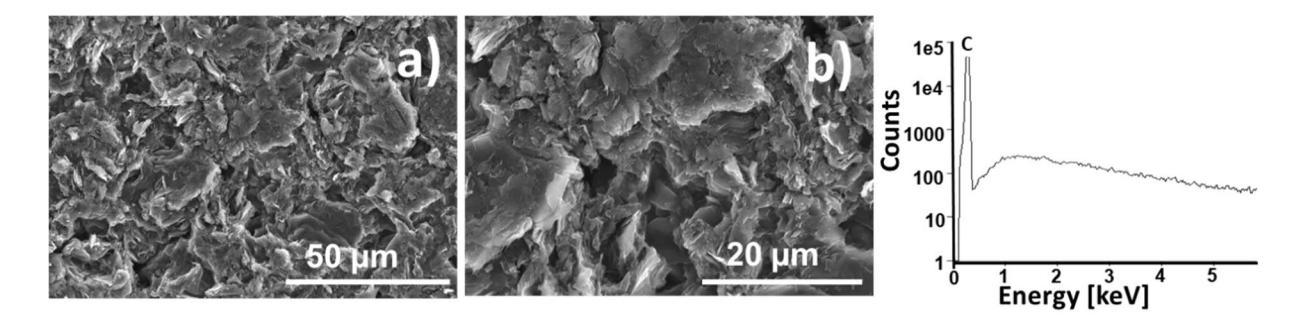
It was found that the target finger substructures located close to the outboard side did not show any evidence of redeposition or erosion (samples P17-P22). As shown in Fig. 5a–b, sample P21 possessed a tile surface in this zone, which was strongly developed, porous, and without characteristic directionality. The obtained EDX spectra showed only the presence of C signal (Fig. 5c). Hence, it was assumed that the morphology of the material in this area was similar to the original plate surface.

Fig. 5. SEM images of sample P21 morphology (a-b) with corresponding EDX spectrum of area (c), located in the region without direct plasma contact.

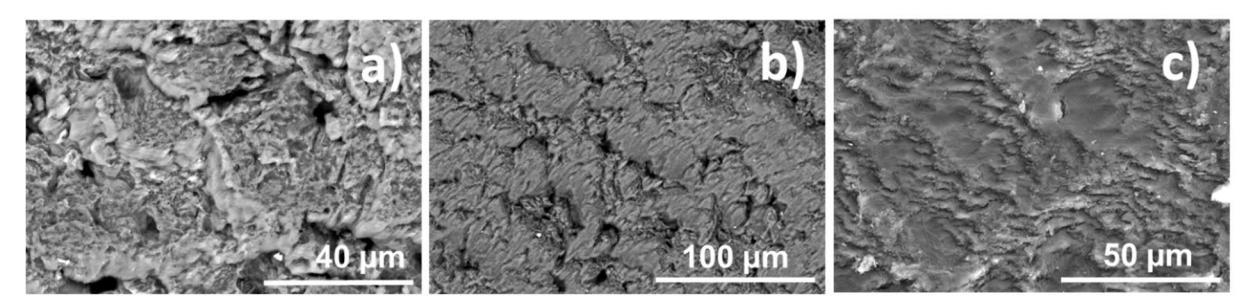
In addition to the above-described regions, two transition zones were localized: (i) on the left from the erosion zone, towards the pumping gap side, and (ii) on the right from the region with strong redeposition. The first transition zone comprised of samples P0–P4. It should be noted that the surface morphology in this region was diversified (Fig. 6). In the case of sample P0, neither a clear layer of deposit nor a strongly eroded surface was detected. However, at the edges of the pores/surface cavities, a concentration of impurities was observed. Sample P1 was covered by a deposit. Sample P2 was partially eroded, although EDX measurements confirmed the presence of impurities on the surface indicating redeposition. Sample P3 showed another type of morphology, where the surface appeared to be trimmed with a razor. Part of sample P4 surface was significantly eroded, whereas another part had similar morphology to sample P3. In all cases, the characteristic surface directionality (the same direction as for the eroded areas) was determined.

Fig. 6. SEM images of the surface morphology in the first transition zone: a) sample P0, b) sample P1, c) sample P3.

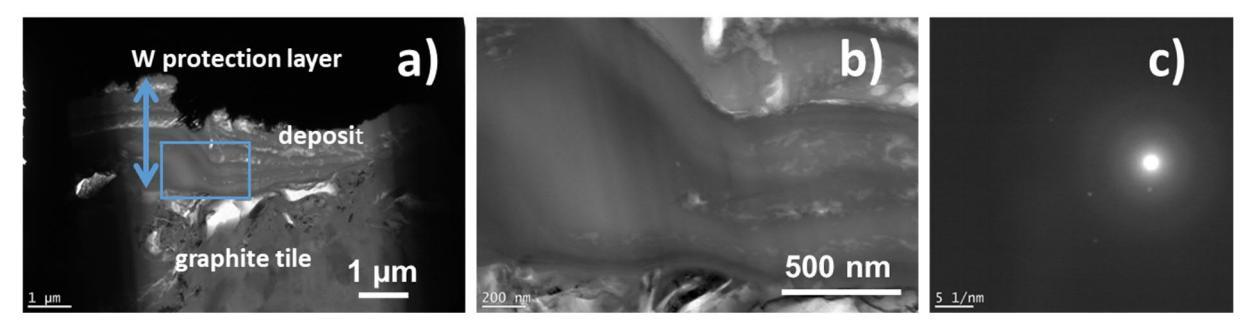
TEM images showing the structure of deposit grown on the surface of sample P9T1 and the corresponding electron diffraction pattern are presented in Fig. 7. The structure of the deposit was inhomogeneous and contained areas with significantly different porosity. Additionally, the layered structure of the deposit material was obvious. The deposit layer thickness was

determined by TEM images and reached 2.7 μm. The electron diffraction pattern shown in Fig. 7c, displays weak, diffused rings that indicated the material's amorphous structure.

Fig. 7. TEM images of the deposit structure (a-b) with the corresponding electron diffraction pattern (c), sample P9T1. Fig. b shows an enlarged image of the deposit marked with a frame in Fig. a.

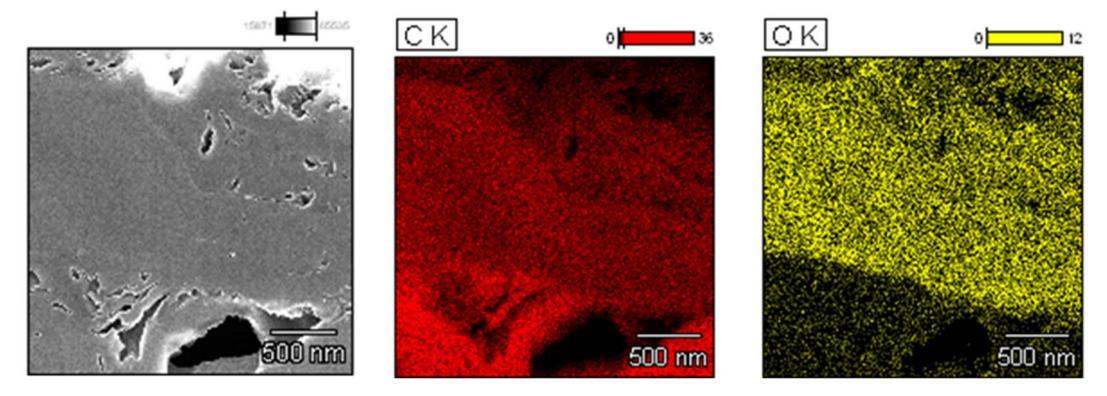
TEM analysis was complemented by EDX elemental mapping shown in Fig. 8, which displays the distribution of the main deposit constituents, carbon and oxygen, and revealed the enrichment of the deposit layer with oxygen. A comparable increase was reported previously [12]. The obtained result was consistent with the measurements carried out in the micro-areas on the surface.

Fig. 8. Distribution of carbon and oxygen in the deposit area, thin foil, sample P9T1.

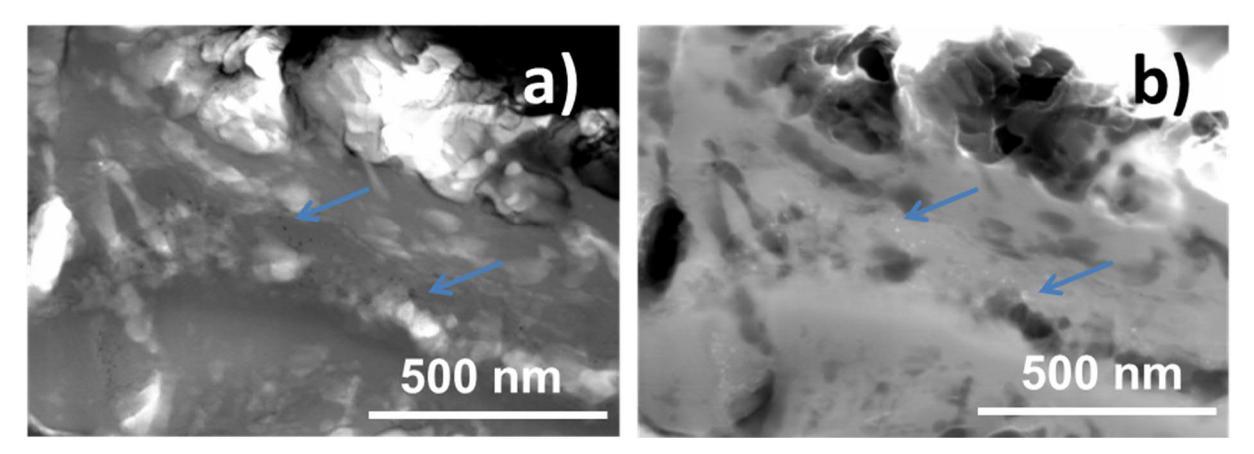
The bright and dark field STEM images recorded at 30 kV shown in Fig. 9 revealed that a certain amount of small particles were located in the porous layers of the deposit, but their precise identification was difficult. However, we supposed that these particles may be Feenriched regions. The iron enrichment was revealed in the iron profile of the redeposition zone at the divertor target (Fig. 14 in S. Sereda et al. [15]). The observed increase was related to He glow-discharge cleaning being performed frequently before boronization.

Fig. 9. STEM images of the deposit structure on sample P9T1, recorded in a) bright and b) dark field. The arrows indicate the deposited particles.

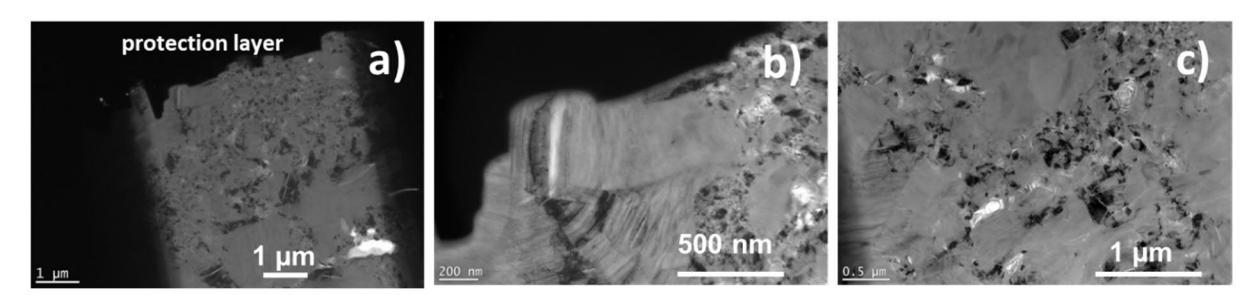
To examine the subsurface structure of the samples from the unchanged zone located close to the outboard side, a thin foil was cut out for TEM observation of sample P19T1. Images shown in Fig. 10 display both the sub-surface and graphite matrix structure. No deposit on the surface of the material was observed.

Fig. 10. TEM images of the structure of the material cut out from sample P19T1 from the region without direct plasma contact.

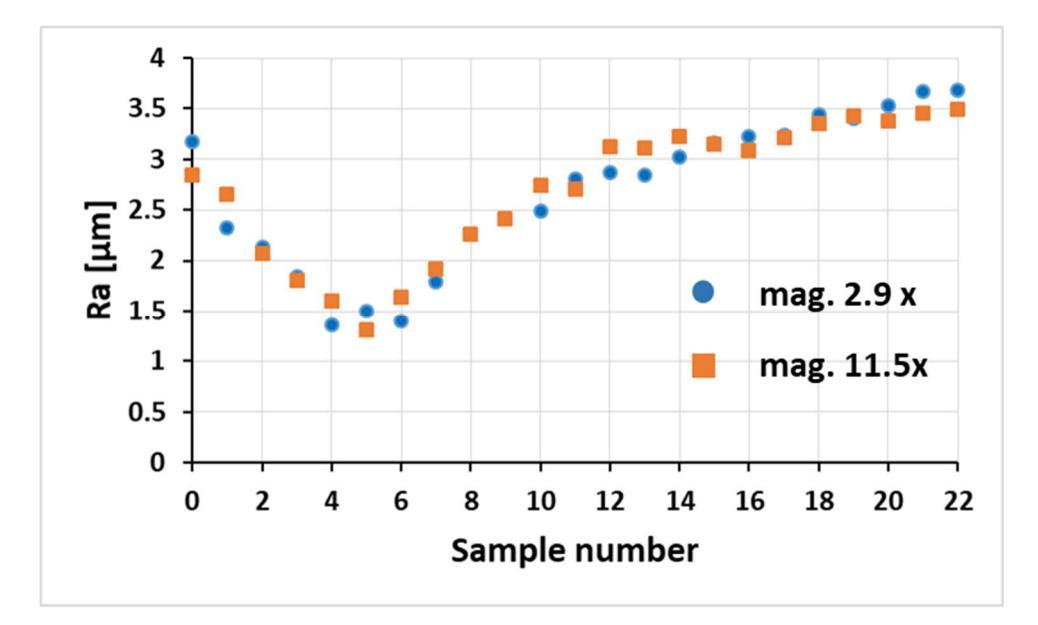
The image shown in Fig. 11 described changes in the surface roughness along the length of the tile at two magnifications $2.9 \times$ and $11.5 \times$. For the executed series of measurements, the values of standard deviation were relatively small and therefore were excluded from the graph. These amounted to 0.06 and 0.13 µm on average for magnifications of 2.9× and 11.5×, respectively.

The obtained results showed very good agreement for the roughness distribution for both magnifications. The study revealed significant differences in surface roughness values along the length of the tile. Ra parameter for the strongly eroded zone reached the lowest level of 1.6–1.9 μ m (mag. 11.5×). The value showed a slight increase for the area with a deposit (2.3–2.5 μ m), whereas the areas that did not show significant surface damage were characterized by relatively high surface roughness, exceeding 3 μ m.

Fig. 11. Changes in surface roughness, Ra along the length of the tile. Measurements carried out at the magnifications of 2.9 and 11.5 show good agreement.
