## Machine safety issues with respect to the extension of ECRH systems at ASDEX Upgrade

**Abstract.** The beam intensity of electron cyclotron resonance heating at ASDEX Upgrade has the potential to seriously damage in-vessel components, whenever not fully absorbed by the plasma. Operation is, therefore, interlocked with both plasma current and density above a given threshold. Microwave protection detectors installed in several ports on the low field side switch the heating system off, in case the stray radiation exceeds a given threshold. During regular inspections, however, damages were reported in the vicinity of the launchers and in particular around the tiles of the heat shield. On one hand, it was found that insulating material, which may not face the plasma, degraded due to millimetre wave absorption. The waves entered the free space behind the heat shield through gaps. On the other hand, local damage even of metallic components was observed on surfaces, which were directly exposed to the microwave beam. Polarisation errors, which led to a local shine through of significant beam power, were responsible. We note that this happened mainly on the high field side in a certain d

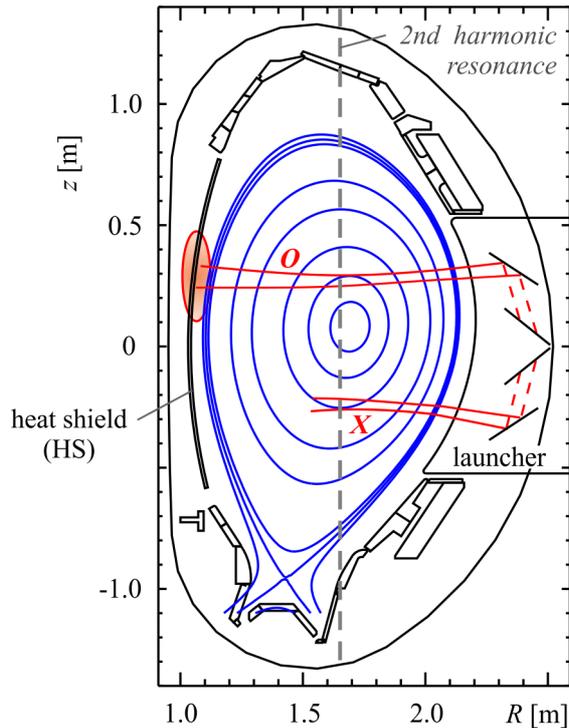
**Figure 1.** Schematic AUG cross section with two ECRH launchers on the low field side. Mainly the 2<sup>nd</sup> harmonic is used. An O-mode content due to incorrect beam polarisation will have a shine through on the heat shield (HS), as indicated for the upper beam. For a pure X-mode polarisation the optical thickness can reach values of  $\tau=100$  [3]. In that case > 99% of the beam power is absorbed by the plasma.

The majority of AUG experiments uses X-2 heating (Figure 1), where plasma absorption reaches values of 99% [3]. ECRH operation is, therefore, interlocked with plasma current and density above a given threshold. The plasma density, however, may dynamically increase up to the X-mode cut-off ( $n_e = 1.2 \cdot 10^{20}$  m<sup>-3</sup> at  $B = 2.5$  T). In that case the wave is reflected and ends up as stray

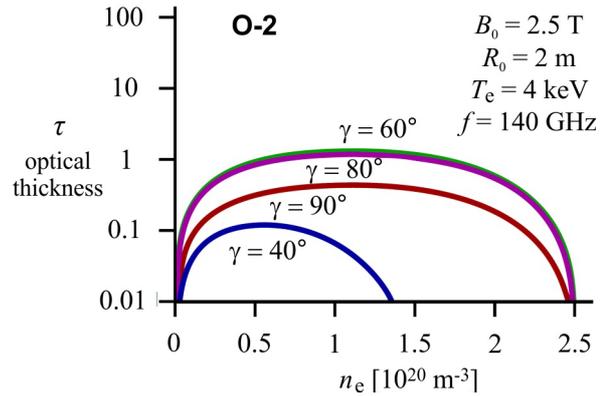
**Figure 2.** Optical thickness  $\tau$  of the O-2 mode [3] as a function of the plasma electron density  $n_e$  and launch angle  $\gamma$ . The shine through fraction after the first pass is  $\propto \exp(-\tau)$ .

Electron cyclotron resonance heating (ECRH) power at ASDEX Upgrade (AUG) will be increased [1] and its operational space is being extended [2]. When using O-2 or X-3 mode, the optical thickness of typical AUG plasmas can be moderate (Figures 1 and 2). Incomplete absorption gives rise to a shine through on AUG's heat shield (HS). We would like to point out, that even in the most commonly used X-2 scheme with a nominal absorption beyond 99% [3], a polarisation error causes a shine through, since the cross polarisation is indeed O-2.

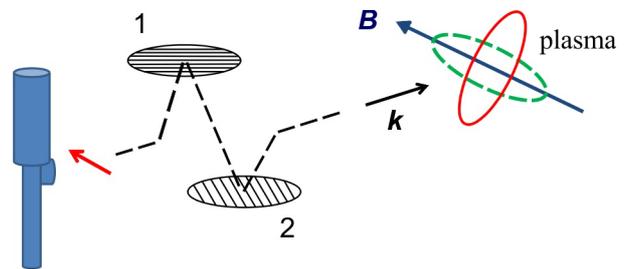
**Figure 3.** Schematic polarisation system in an ECRH beamline. Two rotatable polarisers **1** and **2** allow to match any elliptical polarisation, defined by the magnetic field vector  $\mathbf{B}$ , the beam vector  $\mathbf{k}$  and the mode. Aligned in direction of  $\mathbf{B}$  (dashed ellipse) is the ordinary (O) mode, while the (solid) ellipse  $\perp \mathbf{B}$  corresponds to the extraordinary (X) mode. The angle between  $\mathbf{k}$  and  $\mathbf{B}$  determines the ellipticity and  $\mathbf{k} \perp \mathbf{B}$  corresponds to a linear polarisation.

Beam polarisation at the Gyrotron output window is linear. A pure wave mode in the plasma requires an elliptical polarisation at the vacuum plasma interface (Figure 3), depending on the angle between the beam vector  $\mathbf{k}$  and the magnetic field vector  $\mathbf{B}$ . Two polarisers, rotatable grooved mirrors, are used to adjust the polarisation in each beamline.

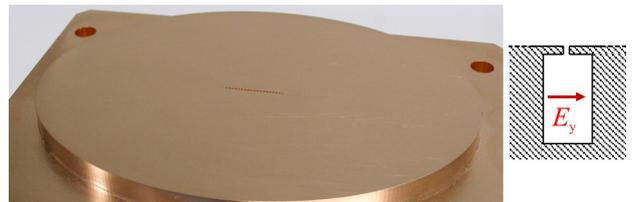
**Figure 4.** Mitre bend mirror surface (left) with built-in directional coupler (coupling holes in the center). Only one component of the electric field can generate a propagating mode in the pick-up waveguide below the mirror surface.

In the multi-frequency ECRH system at AUG, the polarisation of the launched wave can be modelled [7] as a function of the frequency and of the two polariser angles. Directional couplers, sensitive to one component of the wave electric field, are installed in the last mitre bend (Figure 4), close to the launcher. The consistency of the polarisation can be checked, if the appropriate component of the model electric field is compared to the

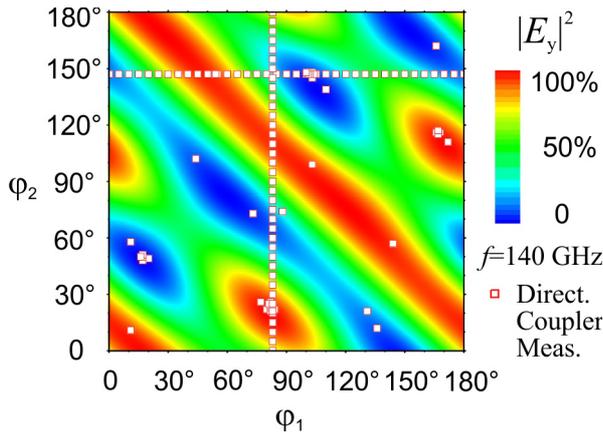
**Figure 5.** ECRH #6: Square of the normalized electric field component perpendicular to  $k$  and parallel to the mirror surface, function of the two polariser angles. The model value (color map) for a given input power can be compared to the directional coupler measurement (small squares). Measurement values are not shown. More details in [7].

measurement as a function of the two polariser angles (Figure 5) for each frequency. This is done at least once for each new beamline or Gyrotron.

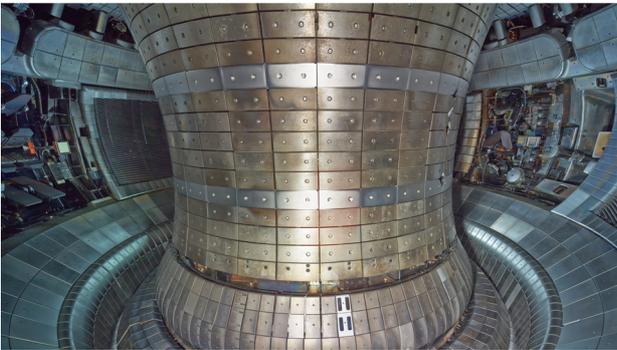
**Figure 6.** The heat shield (HS): tungsten coated graphite tiles cover the central column. Two horizontal rings (slightly brighter) are made of P92 steel for material testing. There is a nominal gap of four millimetres between the tiles.

AUG's heat shield was originally designed to withstand the heat flow out of the scrape-off layer plasma at this position. As it is shown in Figures 6 and 7, the HS consists of tiles, mounted on an actively cooled rectangular cooling pipe. In the original design there is a nominal gap of 4 mm around each tile, which allows the 140 GHz millimetre wave to pass through. Electric installations in the free space behind the tiles have suffered damage (see section 5).

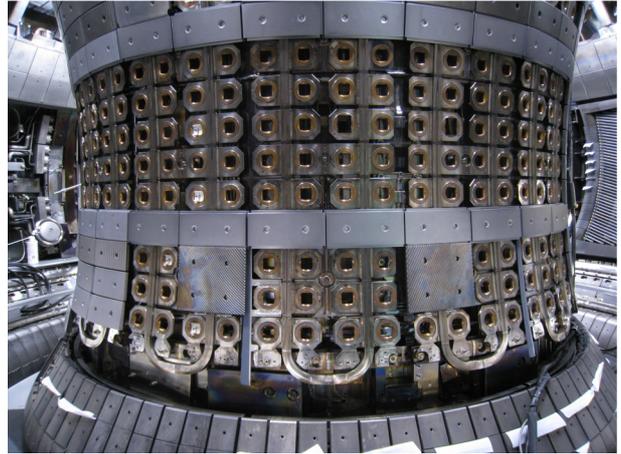
**Figure 7.** Partly disassembled heat shield. Ear-shaped fittings for the tiles are attached to vertical (U-shape) cooling pipes. Free space behind the fittings is used for electric installations. The two rings of P92 steel tiles are mounted. The edges of these tiles have a newly designed overlapping structure.

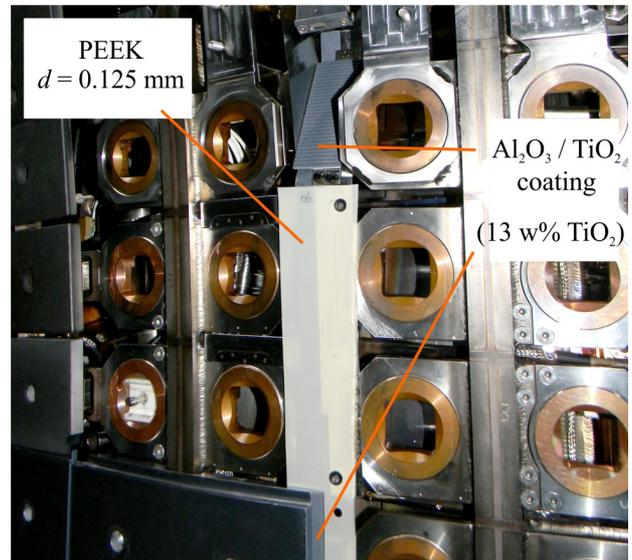
**Figure 8.** Test of millimetre wave protection: ceramic coating absorbs wave power near the opening of a sensitive pinhole camera and in the overlapping structure of the P92 steel tiles. PEEK strips serve as markers for absorbed power.

In 2013 during vacuum vessel maintenance several radiation protective measures were installed in sectors where high power millimetre waves are launched. Metal strips coated with a ceramic  $\text{Al}_2\text{O}_3 / \text{TiO}_2$  layer, as well as PEEK foil strips were attached to the fittings, bridging the gap between the tiles (Figure 8) behind the HS. The ceramic coating significantly absorbs millimetre waves, while the PEEK strips are used as markers. PEEK will change its colour and finally carbonize, when heated up by millimetre wave absorption. The used PEEK foil has a thickness of  $d = 0.125$  mm, density  $\rho = 1.3$  g cm $^{-3}$  and a specific heat  $c = 0.32$  J g $^{-1}$  K $^{-1}$ . Temperature stability is specified until 300 °C.

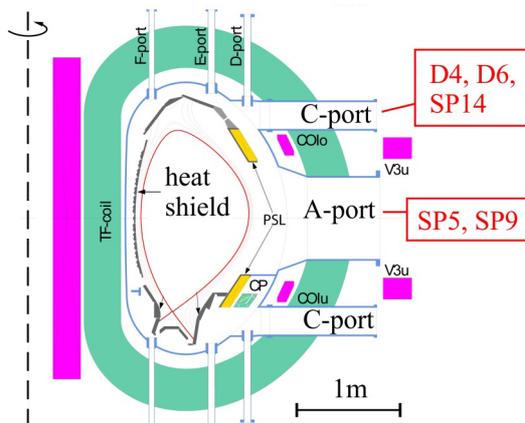
**Figure 9.** Schematic cross section with ports on the low field side of AUG. The positions of millimetre wave stray radiation detectors are indicated. 'SP' denotes a Sniffer sphere and 'D' a simple D-band pick-up waveguide with a beam-lead diode, mounted behind a quartz vacuum window. The number indicates the vessel sector (see also Figure 10).

Several millimetre wave detectors, installed in ports on the low field side (Figure 9) are distributed around the torus (Figure 10). An interlock circuit switches the ECRH off, if the detected (unabsorbed) power is above a given threshold. Different detector types have been investigated [8]. We note that SP5, SP9 and SP14 are Sniffer probes [9], while D4 and D6 are D-band pick-up waveguides, mounted onto a quartz vacuum window. Typical detector signals will be shown in section 6.

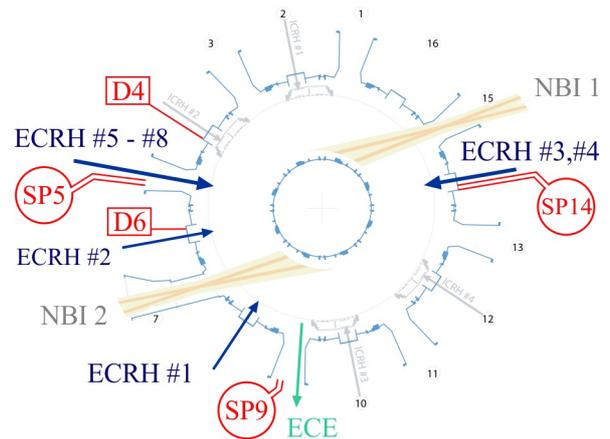
**Figure 10.** Top View of an equatorial cross section through the AUG vacuum vessel, indicating the position of heating systems and millimetre wave detectors (SP $n$ , D $n$ ). ECE is the electron cyclotron emission measurement system, which includes also a power measurement of the stray radiation. Detector positions are close to the ECRH launchers. 'D4' and 'D6' have been installed recently in order to enlarge the monitored region around the ECRH launchers #5 - #8.

The signals of the stray radiation monitors were investigated. At that time, only SP5, SP9 and SP14 were in operation (see Figure 10). Notably, the signal of SP5 was far below the interlock level, although the used launcher ECRH #7 is located in the same port as SP5. Due to the large toroidal angle, the beam shine through and stray radiation ended up in sectors 4 and 3, far enough from sector 5. We note also that the signal of SP14 was clearly elevated, but still below the interlock

level. We conclude that the distance between ECRH #7 and SP14 was too large for a reliable stray radiation detection and, therefore, initiated the installation of the new D4 detector [10].

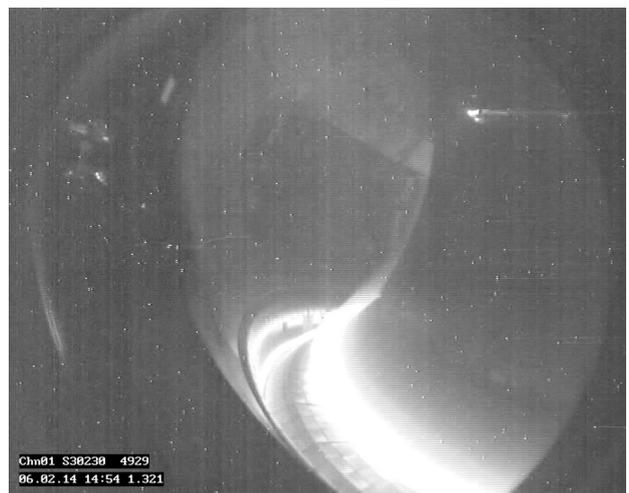
During plasma experiments, situations occurred with a transient and local ECRH shine through on the heat shield. In this case the electric field strength was large enough to ignite an arc, visible in the video recording (Figure 11). The arc is characterised by a small and bright spot on the heat shield in an area which is dark under normal conditions.

**Figure 11.** Video snapshot from AUG experiment #30230. In the upper right corner an arc can be seen on the HS. This was ignited by an ECRH beam shine through. Under normal conditions this area is dark. Most of the light comes from the divertor region at the bottom of the machine.

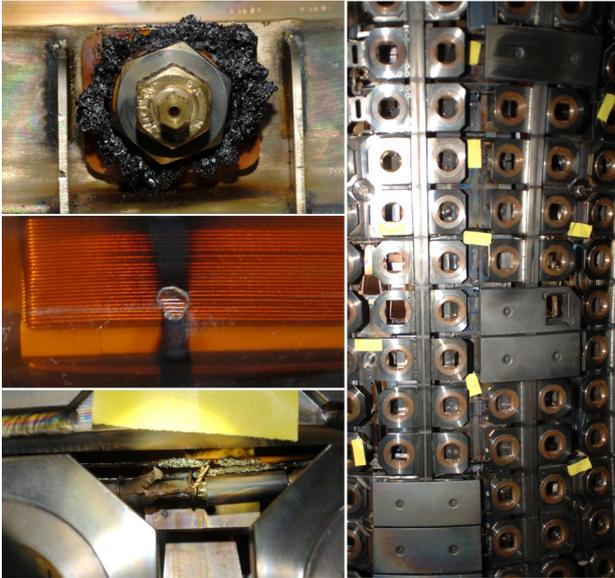
During regular maintenance phases, the vacuum vessel interior is inspected carefully in order to identify and repair damages. Since millimetre waves can penetrate through the gaps between tiles, the heat shield is partly disassembled. Figure 12 shows a set of typical minor damages. Insulating material that significantly absorbs millimetre waves is concerned in particular. Most of these issues could be repaired easily, given the required maintenance access.

**Figure 12.** Left: various ECRH related damage. Insulating material that absorbs millimetre waves can be carbonized and evaporated, as it is shown in the two upper photos on the left. Even the shadow of the gap between tiles is visible as a vertical black stripe on the Kapton foil (second photo). A damaged cable is shown in the lower photo. Right: Part of the disassembled heat shield with yellow tape markers for any damage that was found during inspection.

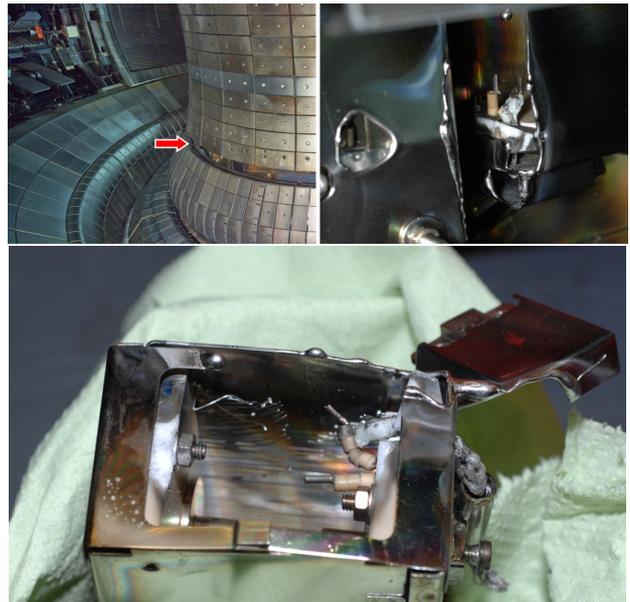
In 2012 a more serious damage occurred during experiment #28017. Figure 13 shows the location in sector 4, the open space below the heat shield. Here, a magnetic pick-up coil was mounted behind a thin stainless steel cover. Due to an accidental O-mode polarisation and a specific beam geometry with co-ECCD close to the plasma edge, the beam shine through directly hit the cover, damaged it and also destroyed the coil inside the casing (see also Figure 13). The power on-time of ECRH was 2.5 seconds.

The investigation revealed also that the previous discharge #28016 was a ctr-ECCD experiment with the same absolute value but opposite sign of the toroidal beam angle. From #28016 to #28017 the toroidal beam angle had been flipped, but not the polarisation. All necessary modifications including the new polarisation were correctly written in the lab journal, but the settings were, however, not realized. Most likely the operator in charge had been disturbed while entering the new parameters into the control system. Switching the toroidal angle without changing the polarisers resulted in an almost pure O-mode.

**Figure 13.** In 2012 a pick-up coil was destroyed by a 2.5 sec ECCD pulse, which had an accidental O-Mode polarisation and, thus, a shine through at the indicated position.

Since human errors cannot be excluded, we conclude that polarisation should be automatically controlled. This requires, however, extended input for the control system, including the planned beam geometry  $\mathbf{k}$ , the planned magnetic field vector  $\mathbf{B}$  and the planned mode of the ECRH beam. The automated module then should check whether the polarisation defined by  $\mathbf{k}$  and  $\mathbf{B}$  is consistent with the planned mode.

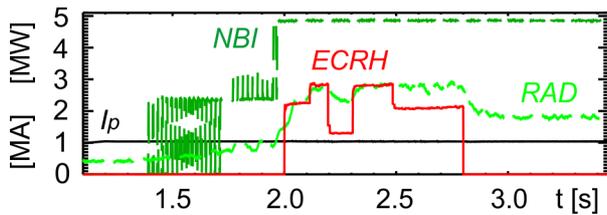
As another example we show the result of a stray radiation measurement in AUG discharge #30587. All four launchers (ECRH #5-#8, Figure 10) in sector 5 were in operation. They injected up to 2.8 MW in X-2 mode (Figure 14). The beam vectors  $\mathbf{k}$  were perpendicular to the magnetic field vector  $\mathbf{B}$ . The stray radiation intensity is highest in the launching port itself and reaches values up to 6 W/cm<sup>2</sup> (Figure 15). This includes diffraction losses from the finite-sized focussing and launching mirrors at this end of the transmission line. In any adjacent sector, the intensity is less than -10 dB (Figure 15). This indicates that even the diffuse and scattered stray radiation can be confined within one sector, and it corroborates the need of a sufficient number of measurement channels in different sectors.

**Figure 14.** AUG #30587: injected ECRH and NBI power. Radiation loss and flat-top plasma current  $I_p$  are overlotted.

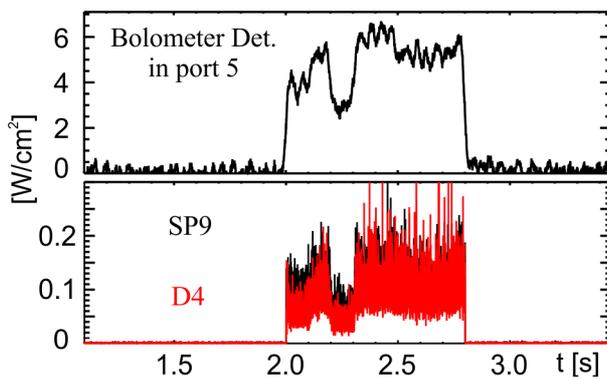
Figure 15 shows also that the measurement results from the calibrated Sniffer probe SP9 are essentially the same as those from the pick-up D-band waveguide D4. The neighbouring D6 yielded similar results. Both D4 and D6 were calibrated, using the power measured by the detector diode, divided by the waveguide cross section. With respect to this simple operation, the calibration of the Sniffer probe needed much more elaboration [11].

**Figure 15.** AUG #30587: measured ECRH stray radiation. Top: Calibrated Bolometer detector [8,11] installed near SP5. Bottom: Calibrated measurements with 0.2 ms sliding average from SP9 (black) and D4 (red).

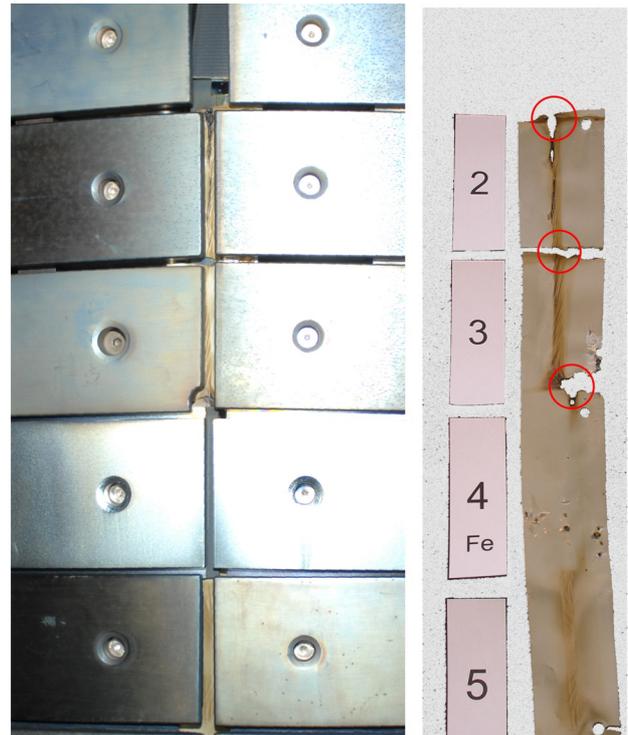
Traces of ECRH shine through on the PEEK strips of the HS (Figure 8) could be evaluated in February 2014. One of the polarisers of ECRH #8 had an angular offset, probably due to an error in the polariser rotation controller. A 5 sec pulse (#30227) with an estimated 30% O-Mode content generated visible arcing on the HS. The problem was identified in the subsequent discharges, where only short pulses of ECRH #8 were applied. On the next day, the AUG vessel was vented with air and the concerned PEEK was replaced. Figure 16 shows the strip that was taken out.

We made a calorimetric estimate of the millimetre wave power absorbed by the PEEK foil. The uncertainty is large, since neither the time scale on which the damage evolved, nor the dielectric properties of PEEK at 140 GHz are known precisely. Based on the delay between ECRH power and the arcing that was visible in the video observation, we assumed that the foil was heated from ambient temperature to its destruction limit (343 °C) within roughly 100 ms. The heat capacitance per area is calculated from the material properties (section 3) and amounts 0.0052 J K<sup>-1</sup> cm<sup>-2</sup>. Hence, we deduce the absorbed power per area of 17 W cm<sup>-2</sup>.

If we assume  $\epsilon' = 3$  and  $\tan \delta = 0.01$ , based on dielectric data at lower frequencies, then this foil absorbs 1.3 % of the millimetre wave power. Accordingly, the shine through was 1.3 kW cm<sup>-2</sup>. The unabsorbed Gaussian beam of ECRH #8 would have had a maximum beam intensity of 30 kW cm<sup>-2</sup> at this position.

**Figure 16.** Traces of absorbed ECRH power on PEEK, which was mounted behind the gap. The uncovered parts clearly changed colour. In rows 2 and 3, at intersections of vertical and horizontal gaps, it was completely burned through. According to the video analysis, this corresponds to where the ECRH shine through hit the tiles. Such traces do not exist in row 4, where the overlapping Fe tiles were mounted.

A pragmatic approach to protect the heat shield is the redesign of the tiles. Compared to the original design with open gaps, the situation improved, where the new overlapping tiles with an absorbing coating were installed. Presently, it is evaluated, whether the components can withstand the worst case scenario with an unabsorbed beam. These efforts include laboratory measurements of the shielding at 140 GHz by the labyrinth-like structure in the overlap.
