SURFACE COMPOSITION OF THE BE LIMITERS AND THE
STAINLESS-STEEL TORUS WALL AFTER OPERATION IN UNITOR

IPP 9/60

December 1986

MAX-PLANCK-INSTITUT FÜR PLASMAPHYSIK

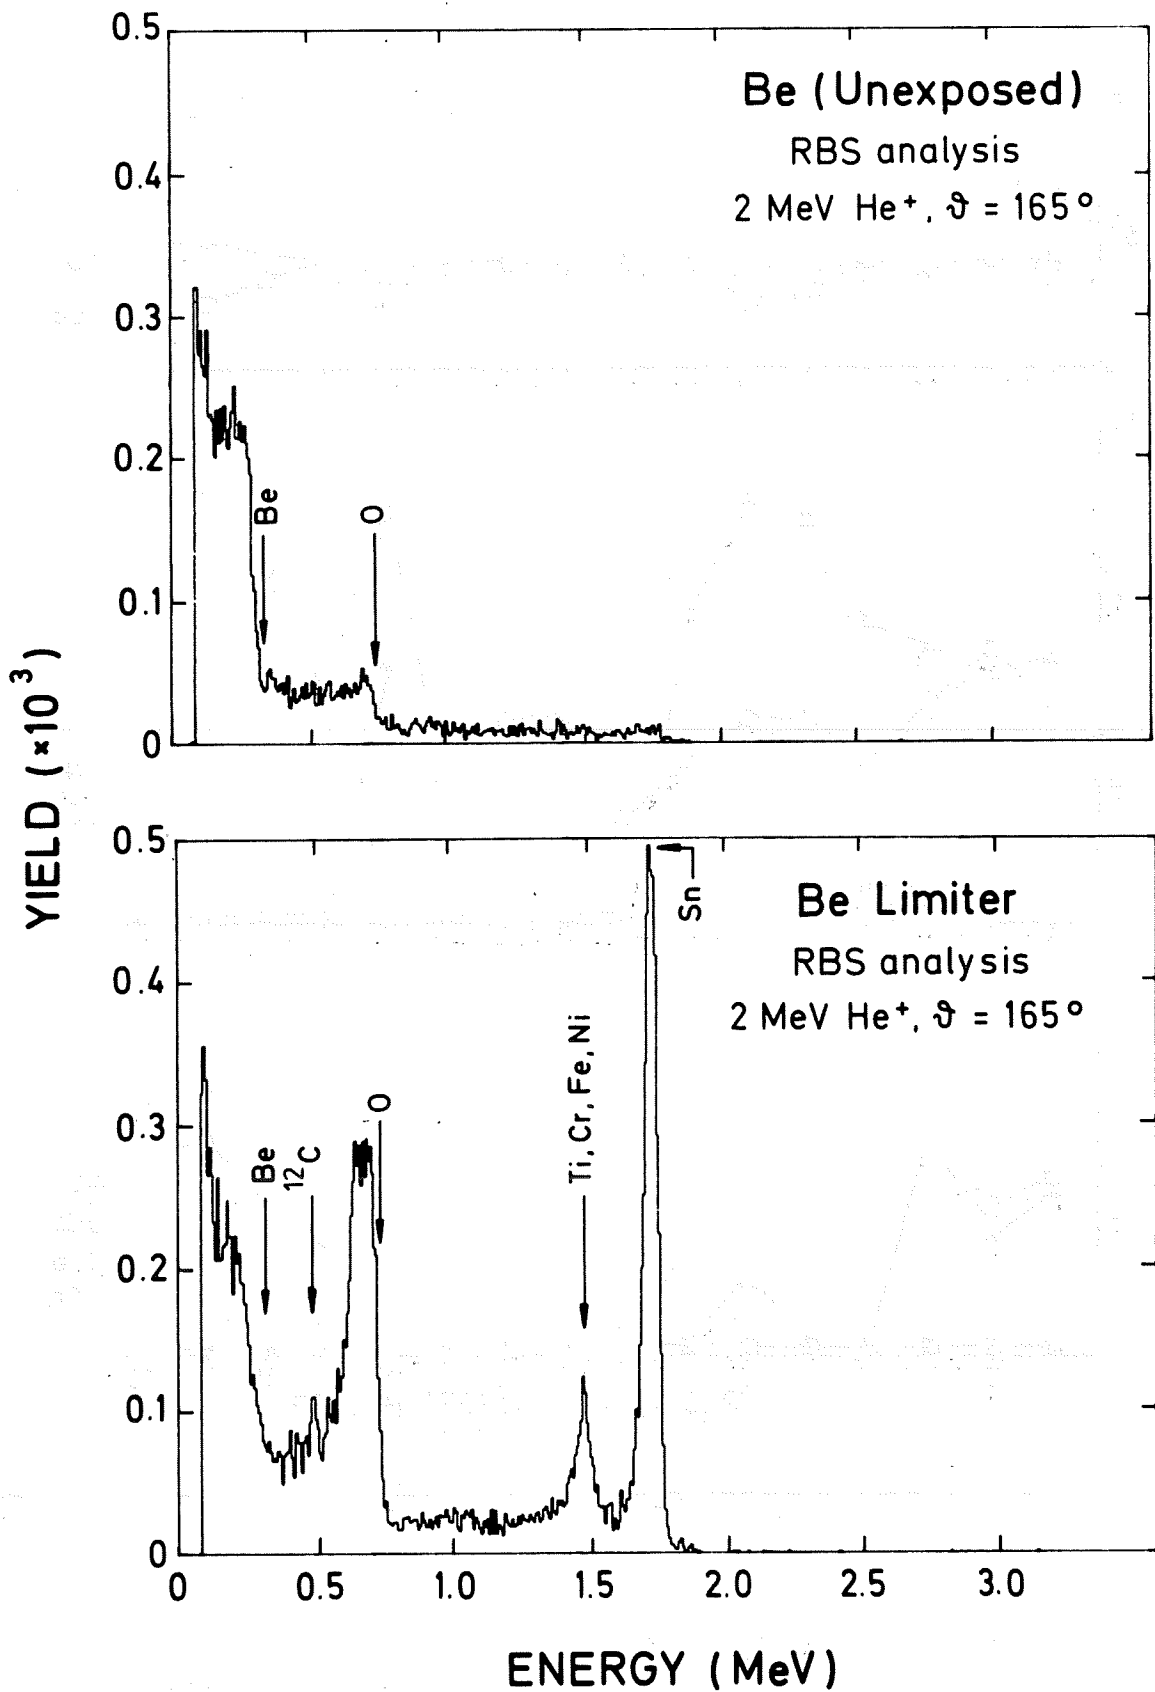
Fig. 4: RBS analysis of Be target 2D:
 The upper spectrum was taken for comparison from an unexposed target obtained by machining away a 0.05 mm thick layer.

In the RBS spectrum of the unexposed Be (fig. 4a) an average oxygen coverage of about 3×10^{16} atoms/cm² is found, which corresponds to a coverage of about 10 to 20 monolayers of BeO. In addition, a small concentration of heavy impurities is found in the Be, the masses of each of these being identified in the PIXE spectrum. The RBS spectrum of the exposed target (fig. 4b) shows considerably more oxygen corresponding to a one to two orders of magnitude larger coverage than in the unexposed target. Further peaks corresponding to a surface deposition of C, of Ti, Cr, Fe, Ni and of Sn are found.

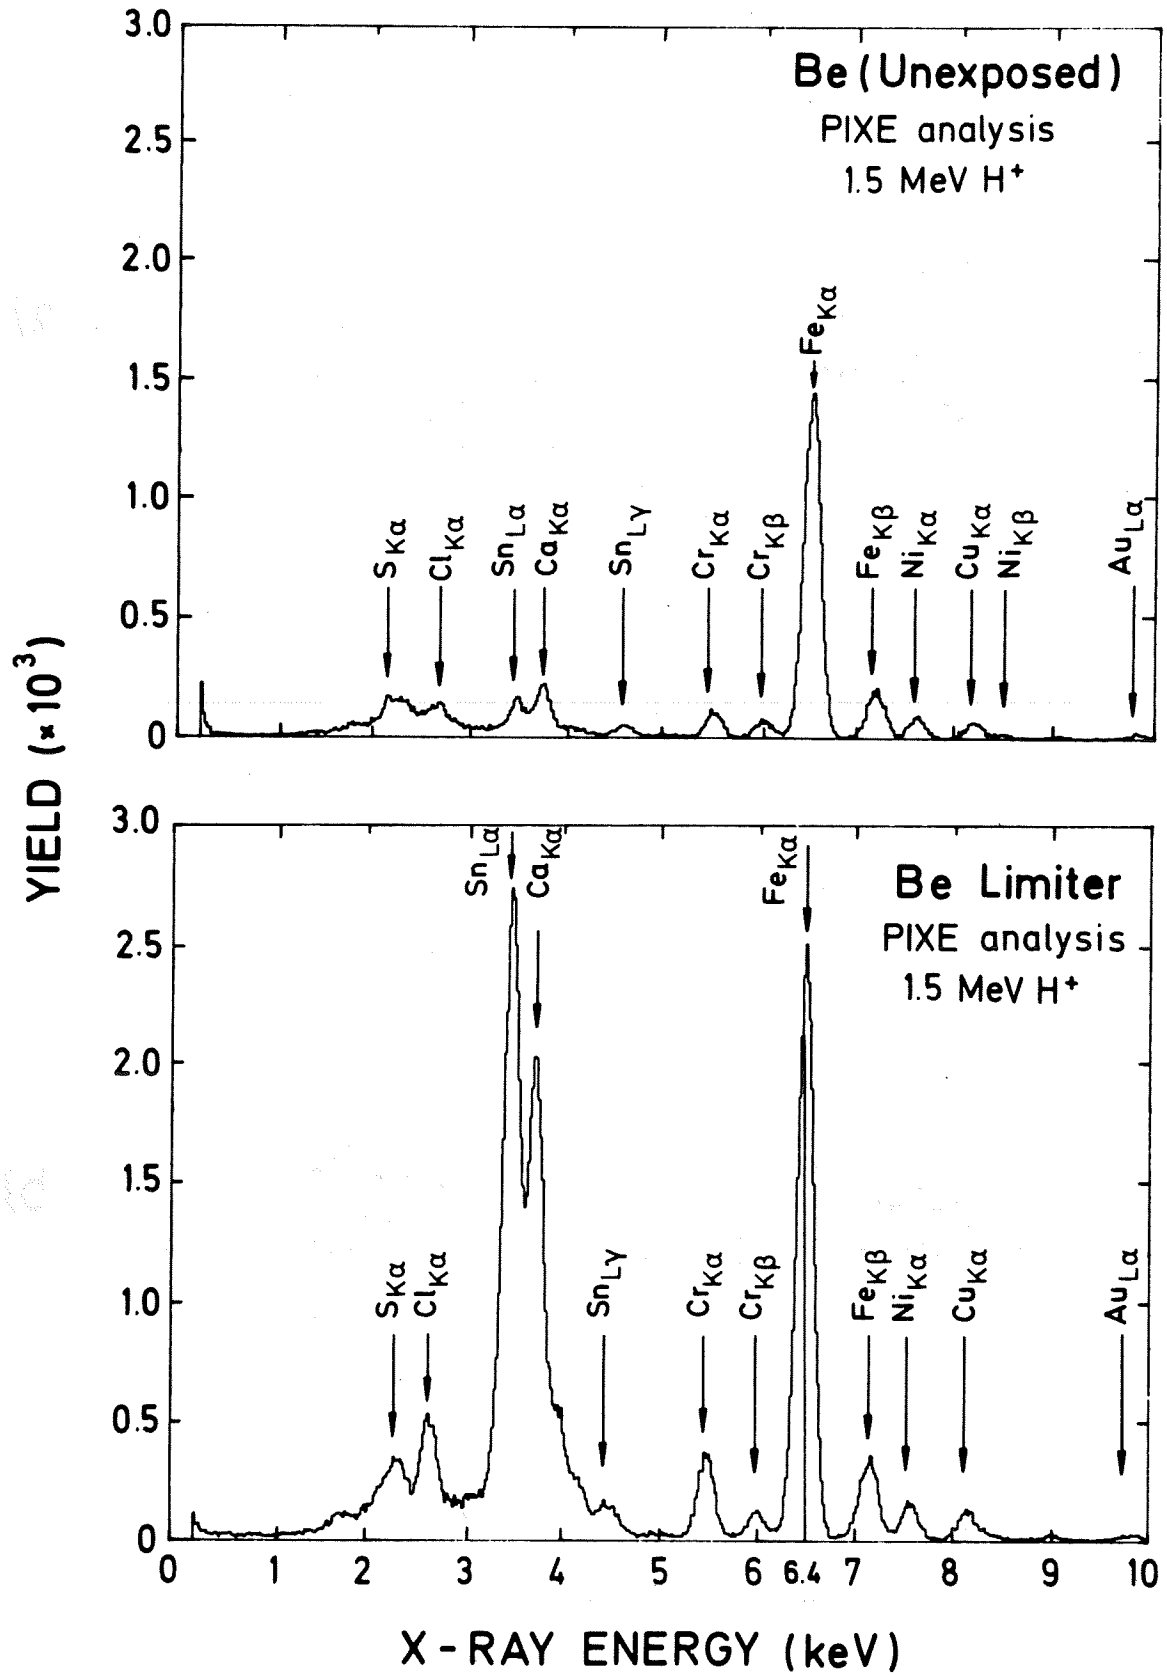
Fig. 5: PIXE analysis of the same part of the Be limiter shown in fig. 4.

The PIXE spectra measured at the same points as the RBS spectra are shown in figs. 5a and 5b. In the unexposed target the elements S, Cl, Sn, Ca, Cr, Fe, Ni, Cu, Au are found. At the plasma-exposed sample

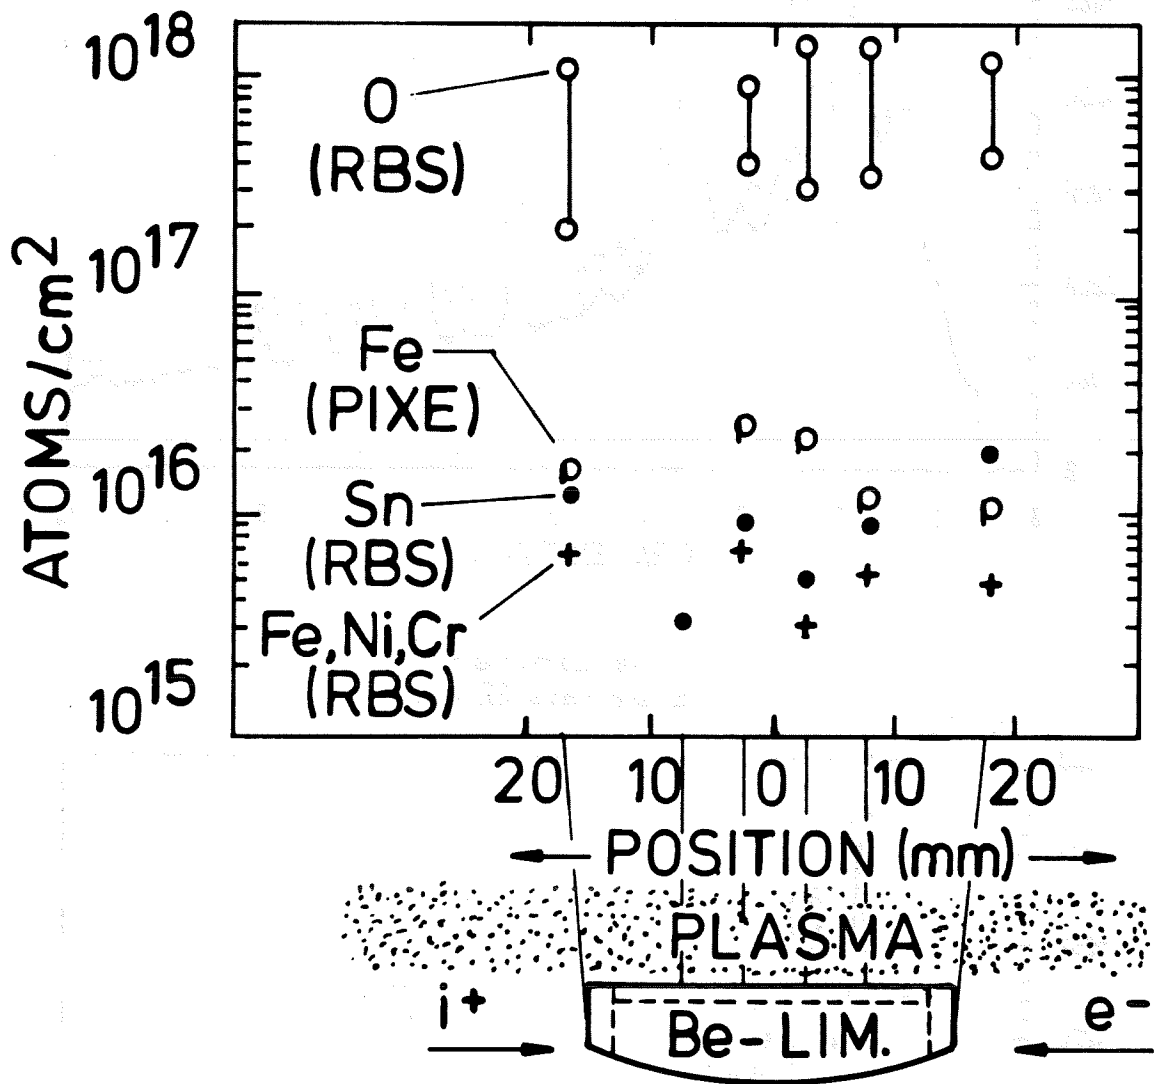
Fig. 6: Summary of RBS and PIXE results for the main contaminants found on the Be limiters (O, Fe, Sn):
 c) spatial distribution on the central part of limiter No. 2.

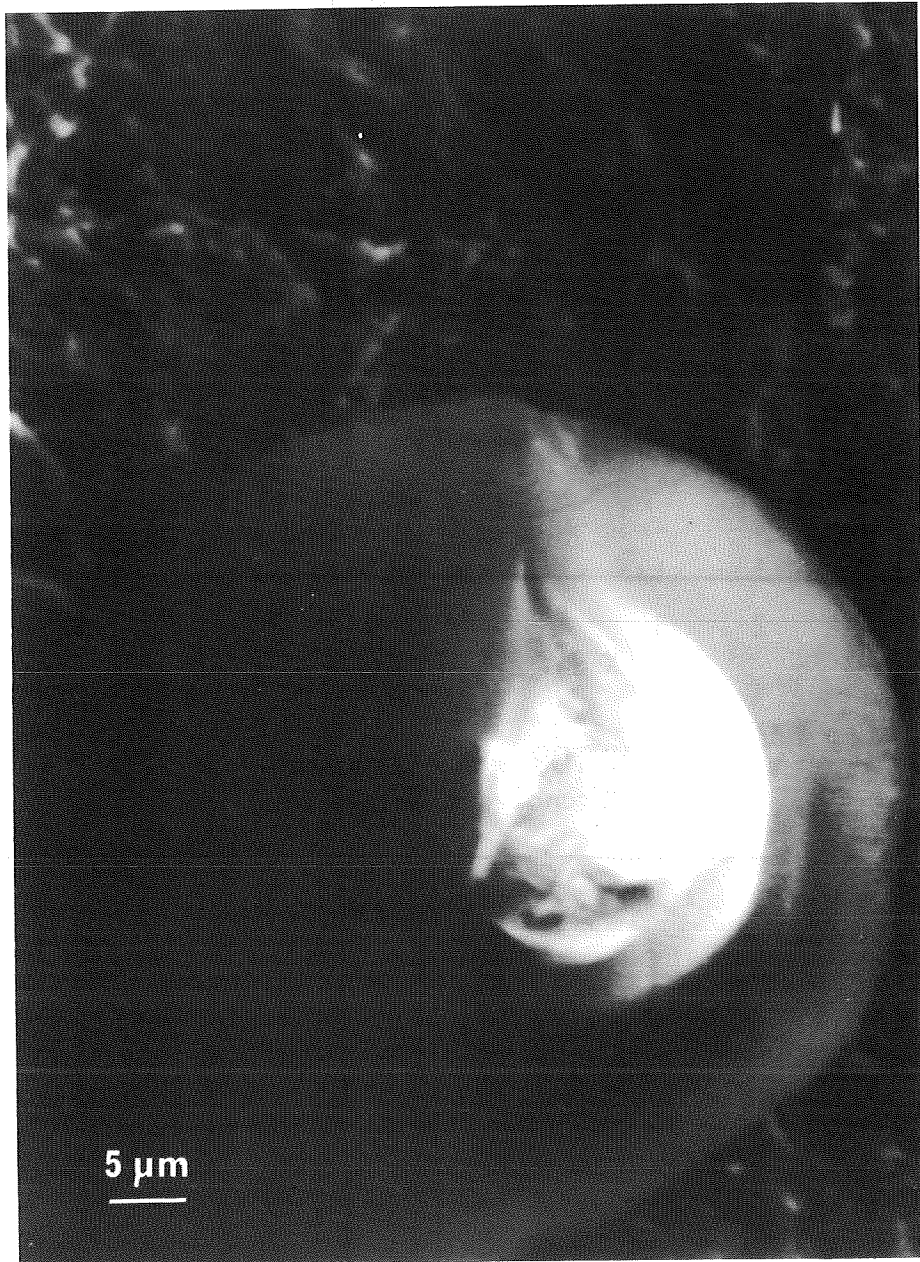
Fig. 11: A SEM picture of the area where the spectrum of fig. 10 was taken shows a spherical object with a diameter of about 50 μm.

sion of about 50 μm (see fig. 11). It is possible that this is a piece of molten limiter material eroded during a disruption. The presence of Cr, Fe and Ni lines in the EIXE spectrum indicates coverage by stainless-steel components deposited during later discharges. Additionally, SEM pictures show some droplets and splashes containing mainly stainless-steel components. An example is shown in fig. 12.

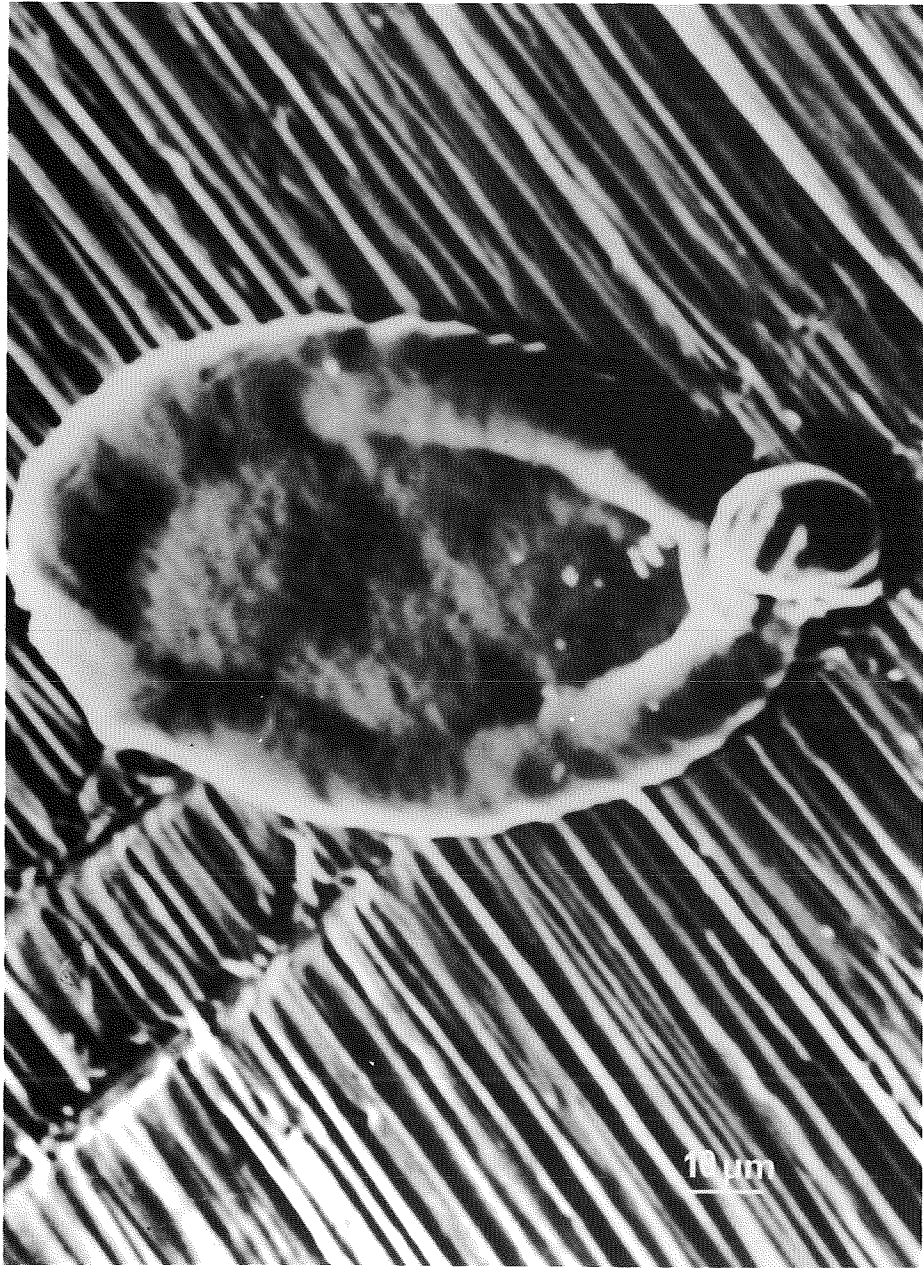
Fig. 12: Stainless-steel splash on the wall sample. Many of these splashes and droplets are found on the samples.
