Tungsten Coatings for the JET ITER-like Wall Project

H. Maier^a, R. Neu^a, H. Greuner^a, Ch. Hopf^a, G.F. Matthews^b, G. Piazza^c, T. Hirai^d, G. Counsell^b, X. Courtois^c, R. Mitteau^c, E. Gauthier^c, J. Likonen^f, G. Maddaluno^g, V. Philipps^d, B. Riccardi^g, C. Ruset^h, EFDA-JET Team

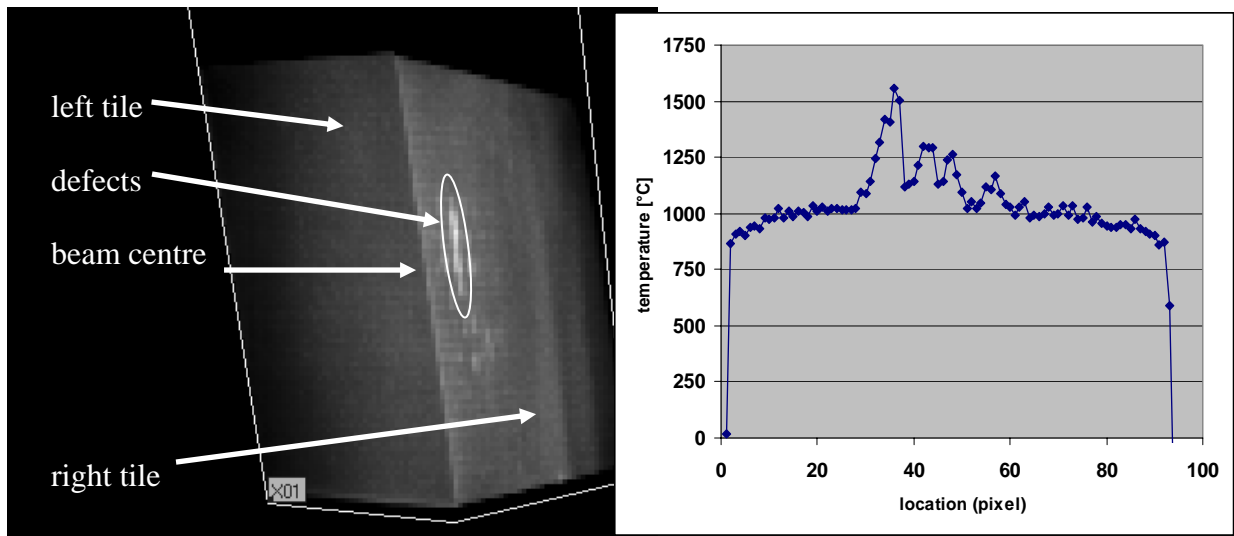
Figure 3: Lefthand: Infrared camera frame showing hot spots on a 200 micron VPS sample during cyclic loading at $t=2.0$ s, which indicates the beginning of delamination. Righthand: Vertical linescan through the hot spots. Data taken from a vertical pixel column and calibrated assuming an emissivity of 0.25.

For the thick coatings the cyclic loading program did not reveal any specific common fatigue phenomena. In some cases, however, mm- to cm-sized delaminations occurred. These areas are clearly observable at an early failure stage in the IR camera data during a pulse, because they overheat with respect to the surrounding surface. Melting occurs when the heat removal path becomes insufficient as compared to the power input. The lefthand side of Figure 3 shows an IR camera frame of such a failure which is developing during the cyclic loading program. The frame is taken early during the pulse at 2.0 s. To further illustrate the hot spots on the tile, the righthand side of the figure shows a linescan taken from the IR frame and calibrated to temperature assuming an emissivity of 0.25. The linescan is taken along the whole tile from top to bottom through the hot spots. For this sample, melting occurred 20 pulses after the first visible anomaly.
