Title: Quality assurance of aluminium weld seams and cast casings of the W7-X coils

Quality assurance of aluminium weld seams and cast casings of the W7-X coils

M. Schröder, J. Holluba, K. Heyn *

Max-Planck-Institut für Plasmaphysik, Euratom Association

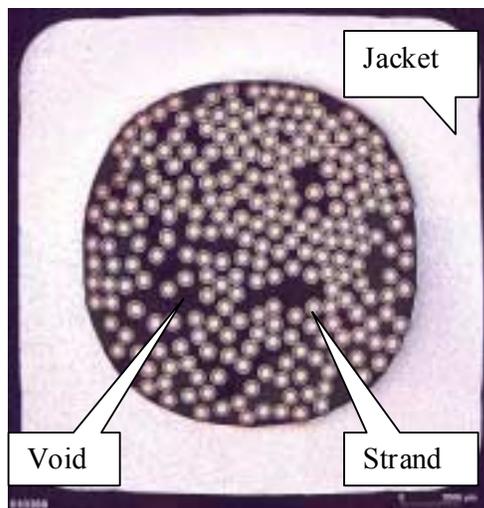
Fig. 1: W7-X superconductor cross section

The superconductor used in the coils and in the busbar system consists of 243 strands composed of NbTi filaments and copper stabilizer. The strands are wound to a cable and are co-extruded with an AlMgSi0,5 billet to form the aluminium jacket, which stabilizes the cable against the Lorentz forces. Liquid helium will flow through the voids between the strands and the jacket to cool the conductor to approx. 4K (see Fig.1). The non-planar and planar coils of W7-X consist of winding packages made from six and three winding layers. The connections of the winding layers inside a coil are made by the manufacturer. The interlayer joint housings are composed of aluminium and are welded to the conductor jacket. The qualification of these welds by the manufacturer has already shown that it is very difficult to get defect free welds. For the connection of the coils amongst each other and also for the connection of the bus system across the module separation planes welded joints are used with austenitic steel housings because of a possibly increased pressure level inside these joints during a quench. The con-

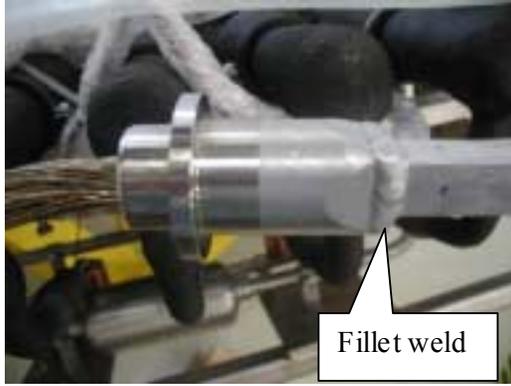
Fig. 2: Welded Al-St-transition piece

Although the weld seams are in principle simple fillet welds (see Fig. 2) their manufacture is not without risk due to a number of constraints and boundary conditions:

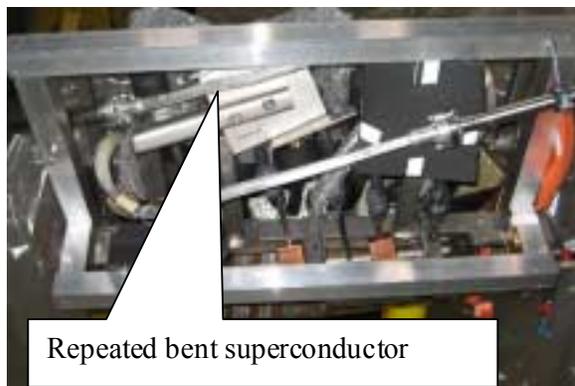
Fig. 3: condition of the superconductor after coil delivery

- **Geometrical deviation:** Because of the tolerances of the production, the dimension of the cable jacket cross section can vary from 15.85 mm to 16.05 mm. The superconductor of the coils is bent during coil production and tests. Since the dimensions of the transition piece are fixed, the welding gap varies accordingly (see Fig. 3).

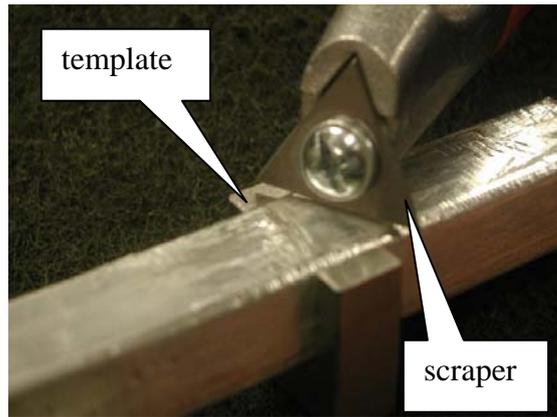
Fig. 4: Welding preparation

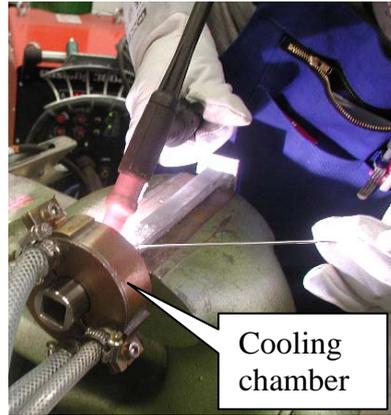
Fig. 5: Welding of a test sample

The non-destructive testing of the welds to find the typical imperfections is not possible. Since the actual weld can only be inspected visually and leak checked, the destructive inspection of the weld can only be carried out on proof samples. To consider all factors (condition of the superconductor, accessibility, ambient conditions, daily ability of the welder) a proof sample is produced before welding on the real coil. The welding of the proof sample is always done under the same conditions as at the coil. This sample is investigated within some hours by preparing four macros. If the macros fulfil the specification, the welding is released, if not, another sample must be prepared. Immediately before the welding at the component a manual skill sample is welded too in order to train all welding steps for the last time. If the samples are successfully manufactured and visually inspected, the welding on the component is released. The results of the tests are documented and the samples are stored.

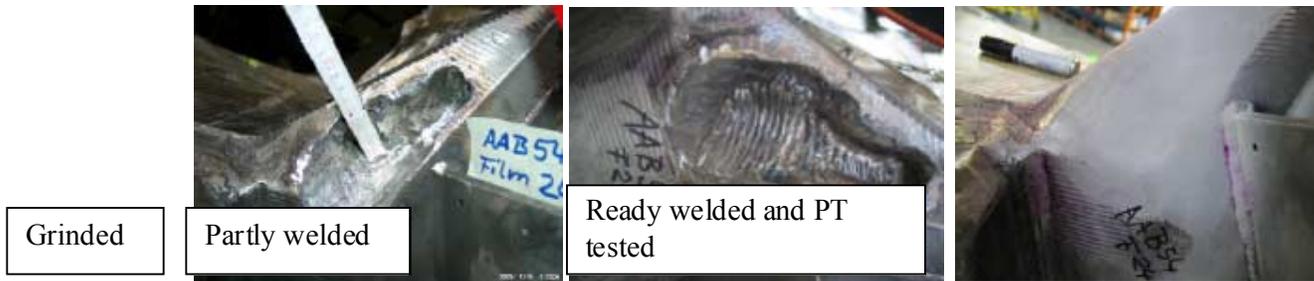
Fig. 9: Repair of a casing defect

- Only wall thicknesses up to approx. 70 mm could be tested, but there are some regions in the coil casing (see Fig. 9) where the thickness is up to 300 mm.
- The dendritic coarse grains (see Fig. 10) of the austenitic casting create (at low x-ray energies) microstructure indications on the x-ray film, which can cover real failures.

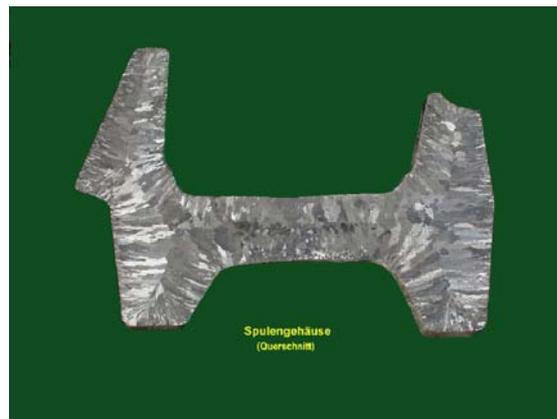
Fig. 10: Section of a half ring
