Paschen Problems in Large Coil Systems

Abstract— When a breakdown of the thermally insulating vacuum occurs in an energized high power coil system (e.g. a leakage of the He-cooling system or to the surrounding air) the coils warm up and have to be discharged fast to avoid destruction. Due to the coil inductance and the necessary discharge time, a high voltage is produced in the coil and the feeder system. Therefore an unspecified pressure coincides with the occurrence of a high voltage at the coil and feeder system.

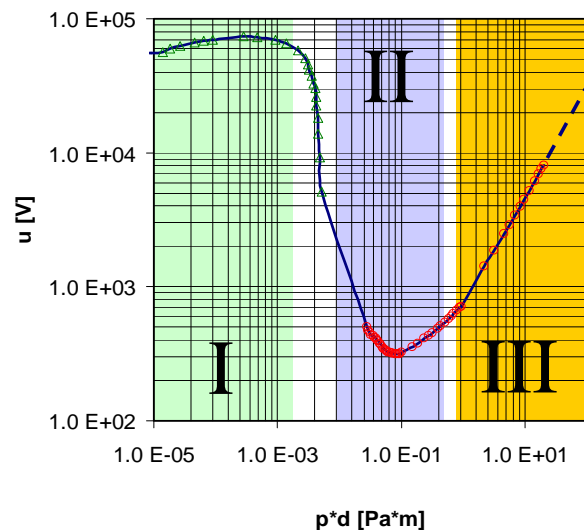
Fig. 1: Paschen curve for air

The Paschen curve shows the breakdown voltage as a function of $p \cdot d$ for a constant temperature.

For very low values of $p \cdot d$ (range I) the dielectric strength is constant and depends mainly on the surface conditions of the electrodes. At high values of $p \cdot d$ (range III) the breakdown voltage is relatively high and increases approximately linear with $p \cdot d$. In between (range II) the breakdown voltage has a distinct minimum with values down to 350 V at 0.73 Pa·m for air and 155 V at 5.3 Pa·m for He under worst case conditions [3]. This minimum is called Paschen minimum.

This dependence is known as the Paschen's Law. Fig. 1 shows a Paschen curve for air [1], [2].

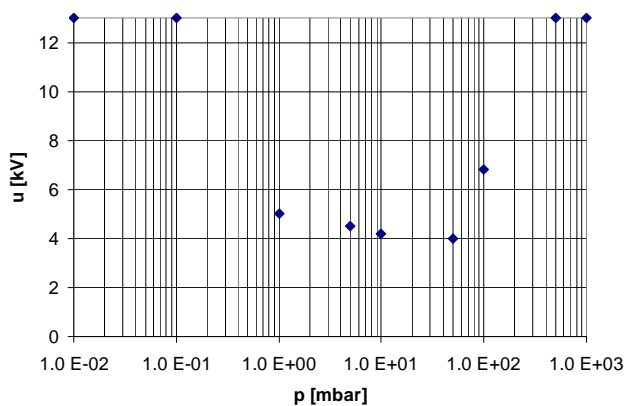
A 13 kV DC HV- test at ambient pressure and under good vacuum showed no failure. But for pressures between 100 Pa and $5 \cdot 10^3$ Pa a breakdown occurs on the experimental setup for voltages lower than 5 kV (Fig. 2)

Fig. 2: Measured isolating voltage (DC) of the complete setup

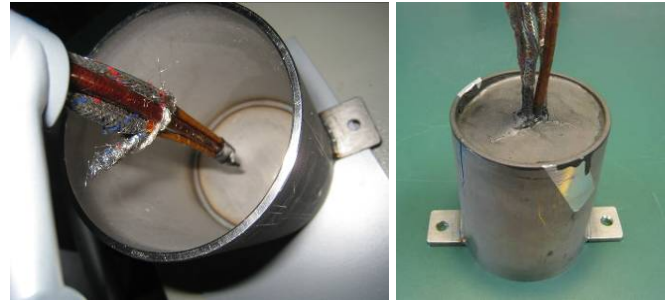
For the experimental setup the isolation failure was found with the last method. A casted measuring cable joint was not Paschen tight. (Fig. 3).

Fig. 3: Left side: Measuring cables and casting mold of the connecting piece before cast in. Right side: Not Paschen tight connecting piece after cast in, painted with conductive paint.

After identifying the failure the connection was fixed and the test could start.

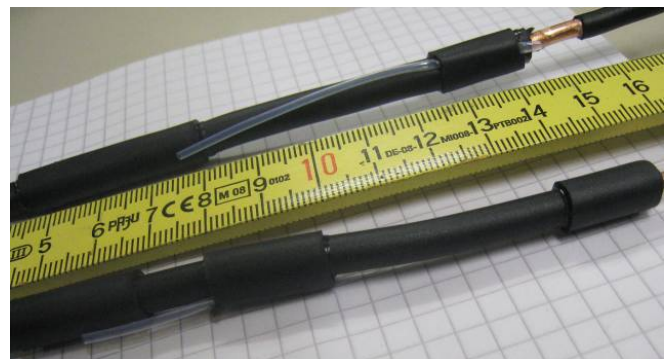
A copper wire (diameter 3.6 mm) was insulated by two layers of self-sealing heat shrinking tube (each 0.7 mm thick). A thin PVC tube (inner diameter 1.5 mm) was placed between the layers, that simulated a crack or gap in the insulation (like the not well glued connection of two glass reinforced plastic - pieces).

For the first and second test series the tube was 7.5 cm and 10 cm long, respectively. One end of the tube was located at the copper wire, the other end outside of the isolation. (Fig. 4 and Fig. 5).

Fig. 4: Bare copper wire (right side), inner layer of heat shrinking tube and PVC-Tube, still without the outer layer of heat shrinking tube

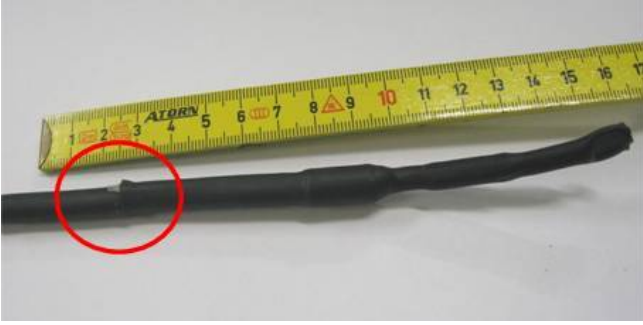
Fig. 5: Test object with outer layer of heat shrinking tube, outer end of the PVC-tube is free (on the left side)

This experimental setup was installed in a grounded vacuum vessel and the copper wire was connected to high voltage line. After the pressure was reduced to approx. 1 Pa, the pressure was raised in steps and at different pressure ratings the DC breakdown voltage from copper wire to ground was measured.

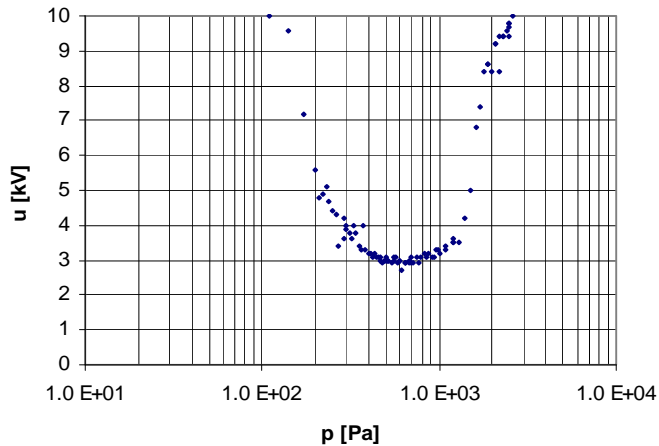
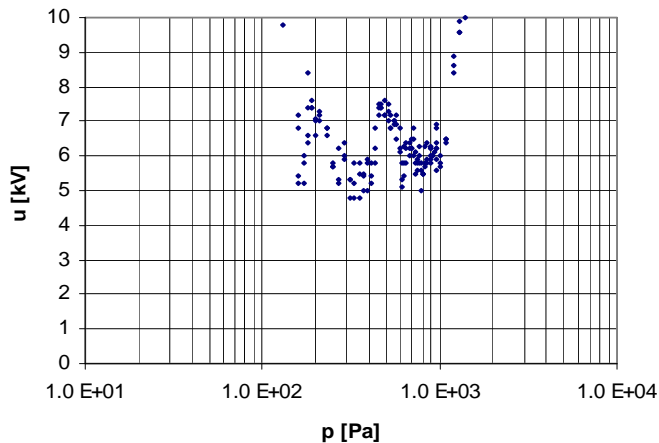
Fig. 6: The measured breakdown voltage (DC) of the simulated failure with the 7.5 cm PVC - tube without grounded shield as a function of gas pressure.

Fig. 7: The measured breakdown voltage (DC) of the simulated failure with the 10 cm PVC - tube without grounded shield as a function of gas pressure.

At pressures below 100 Pa and above 3000 Pa the setup is able to withstand at least 10 kV. For pressures between 100 Pa and 3000 Pa, sometimes breakdowns occurred at voltages down to 3 kV (Fig. 6 and Fig. 7).

it these high voltage tests. The arc starts at the inner end of the PVC-tube and flashes over from the outer end to a spot at the wall of the vacuum vessel. This spot moves and changes the length of the discharge, depending on the pressure of the gas. So the product of gas pressure times distance is constant for a wide range of pressures and the breakthrough voltage stays constantly low.

As expected no distinct Paschen minimum can be observed

Anyhow the Paschen minimum is far away from the ideal value, due to the not ideal electrodes, inhomogeneous electrical field and the possibility of a surface discharge.

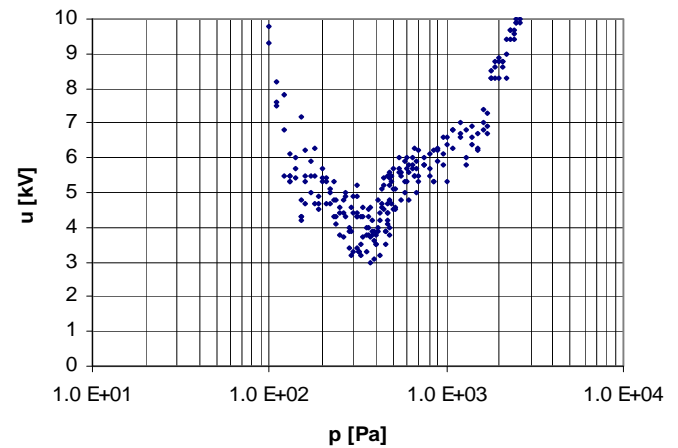
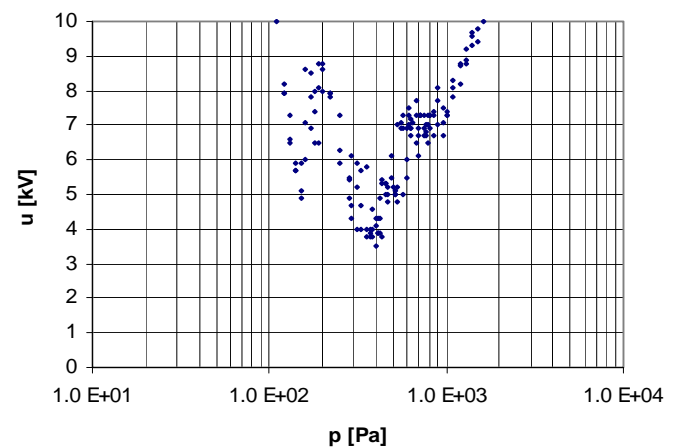
Fig. 8: The measured breakdown voltage (DC) of the simulated failure with the 7.5 cm PVC - tube with grounded aluminum tape.

Fig. 9: The measured breakdown voltage (DC) of the simulated failure with the 10 cm PVC - tube with grounded aluminum tape.

At this test the length of the breakthrough is limited through the length of the PVC - tube. Nevertheless there is no clear Paschen minimum but a smaller pressure range for the minimum voltage as in the previous test where the end of the PVC-tube was open (Fig. 8 and Fig. 9).

For an additional test the outer insulating heat shrinking tube was completely wrapped in aluminum tape to simulate a grounded coating. The end of the PVC-Tube was covered, too and the aluminum tape was grounded.

Again the Paschen minimum is far away from the ideal value.

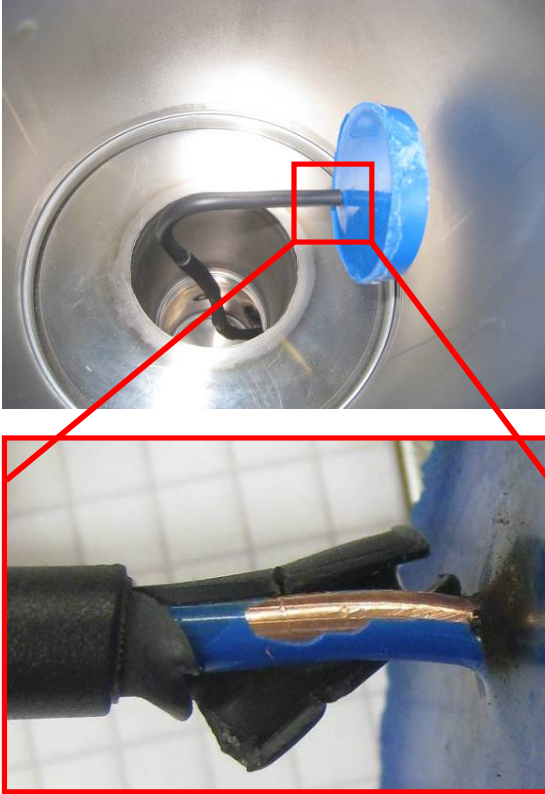
The end of a copper wire with a diameter of 3.6 mm was cast in a disk made of resin. The wire itself was insulated by a thin coat of cast resin and two additional layers of self-sealing heat shrinking tube ending at the disk. An intended failure was produced in the wire insulation at the transition to the disk by bending. This experimental setup was built into a grounded vacuum vessel and the copper wire was connected to high voltage (see Fig 10).

Fig. 10: Test object in vacuum vessel (top) and the failure at the test object (bottom) after test, the heat shrinking tube and parts of the resin were removed

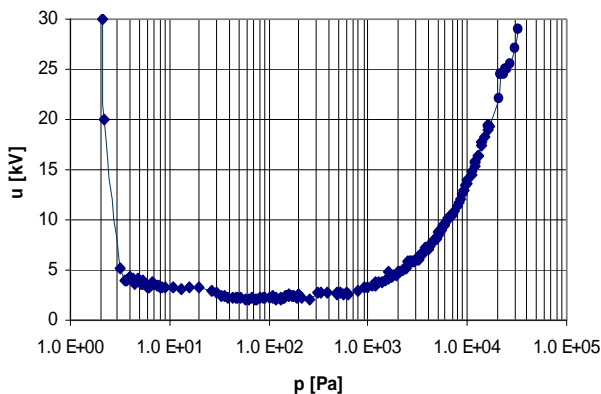
At a pressure lower than 2 Pa or higher than $4 \cdot 10^4$ Pa the isolation of the wire is able to withstand at least 30 kV. For a pressure between 40 Pa und 200 Pa a breakdown occurs at a test voltage of about 2 kV (Fig. 11).

Fig. 11: The measured breakdown voltage (DC) of the simulated failure II as a function of gas pressure.

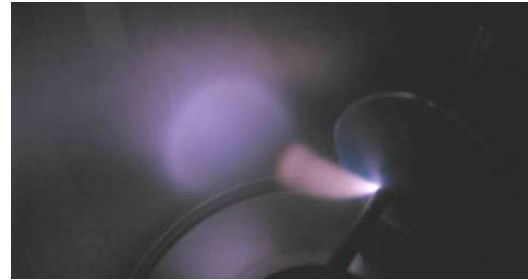
Like during the first test without outer grounded shield, the path of the electric arc is changed substantially, if pressure changes. The product of $p \cdot d$ remains constant for a wide range and the breakthrough voltage remains constantly low. The electric arc does not use every time the shortest path. For example at 60 Pa (Fig. 12) the discharge flashes over to the side wall of the vacuum vessel (long way) and at $1.8 \cdot 10^4$ Pa (Fig. 13) the discharge flashes over to the bottom (short way).

Fig. 12: The electric arc at 60 Pa

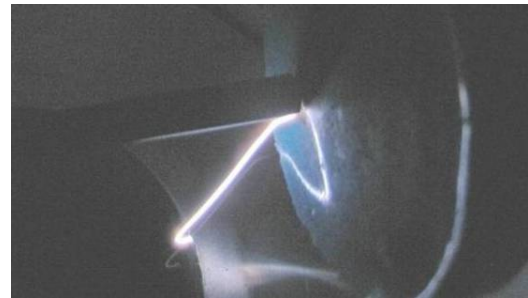
Fig. 13: The electric arc at $1.8 \cdot 10^4$ Pa
