Transmission Kikuchi Diffraction Mapping Induces Structural Damage in Atom Probe Specimens

Baptiste Gault^{1,2,*}, Heena Khanchandani¹, Thoudden Sukumar Prithiv¹, Stoichko Antonov^{1,3}, and T. Ben Britton⁴

Key words: atom probe tomography, damage, electron backscatter diffraction, transmission Kikuchi diffraction

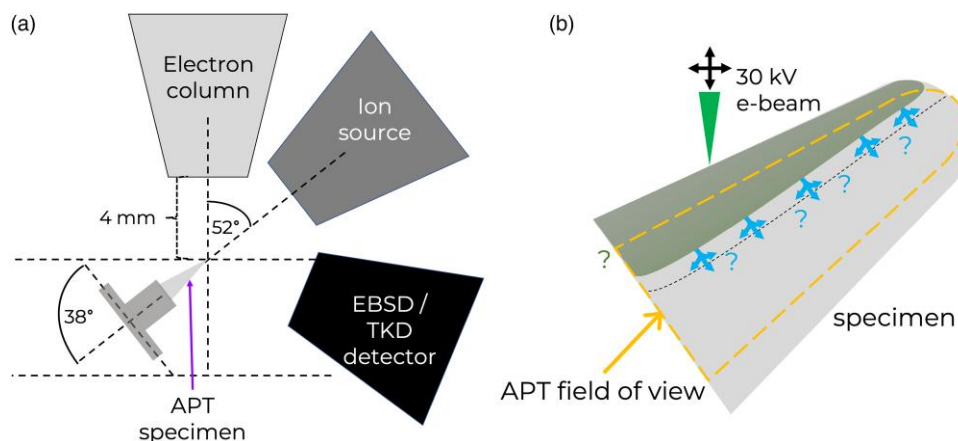
Fig. 1. (a) Schematic of the transmission Kikuchi diffraction setup; (b) detail.

An important aspect for the APT community is that the TKD samples used for analysis are needles, and hence of a very different geometry different to many of the TEM-like samples used in other studies. The needle is a curved surface that can be several hundred of nanometers in thickness, which represents a very small volume in comparison to a conventional specimen for SEM. The incoming electron beam is also at a high angle with respect to the normal to the surface, which can enhance the risk of structural damage (Egerton et al., 2004). Damage from the incoming electron beam could hence potentially be extending beyond just the surface and into the bulk of the specimen, as illustrated in Figure 1b.

Figure 2e displays a series of detector hit maps containing 4×10^6 detected ions, showing the evolution of the pattern as the specimen is being field evaporated. The pink arrows point to some of the anomalies in the point density that did not appear in the specimen's maps obtained for the specimen not exposed to TKD. On these projected hit maps, the planar feature appears as a series of high-density regions forming a curved linear is visible in (iii–iv) and keeps propagating down until (v–vi) in which a less obvious second feature is also visible. Even towards the start of the run, in the first hit maps, anomalies in the point density are visible, see those marked by a pink arrow in Figure 2e-ii for instance. The linear features appear to be moving progressively out of the field-of-view as the specimen gets blunter, which could indicate that it is parallel to the sides of the specimen, as suggested in Figure 1b.

To summarize, the observed elemental segregation that is likely correlated with TKD-induced electron beam-related damage is not at the top-most surface, but tens of nanometers below, in a region that appears to have a maximum of compositional changes, as illustrated in Figure 1b.

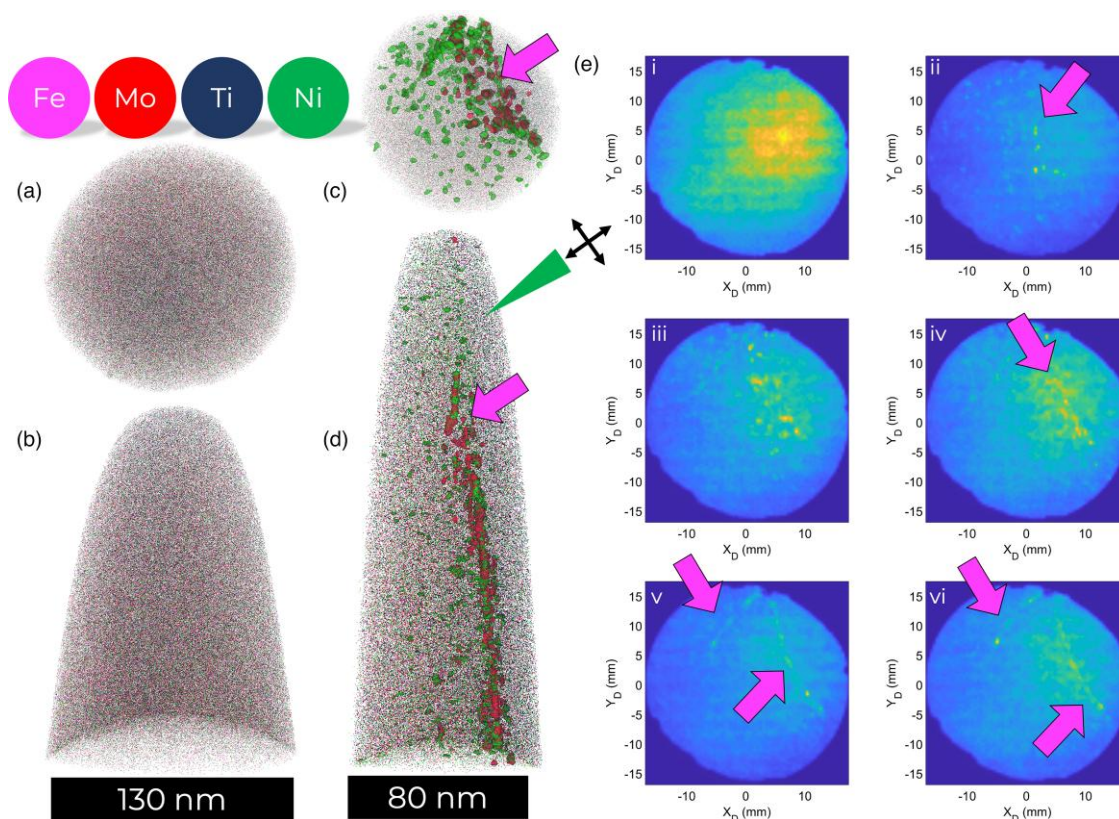
Fig. 2. Top (a) and side (b) view of the 3D APT reconstruction of a specimen not exposed to TKD. Top (c) and side (d) view of the 3D APT reconstruction of a specimen exposed to TKD (only a fraction of the atoms are shown for clarity). Sets of isosurfaces encompass regions containing more than 5 at.nm^{-3} Mo and more than 0.25 at.nm^{-3} of Ni, displayed in the color corresponding to each species. The triangle to the right of the elemental map indicates the direction of the incident electron beam. (e) Series of successive detector histograms containing each 2×10^6 hits. In between two histograms, 4×10^6 hits were skipped. The dark blue corresponds to a low point density and the yellow regions correspond to high point density. The arrows indicate typical regions of artificial variations in the point density associated to structural defects.

Figures 2a and b are the top and side view, respectively, of the tomographic reconstruction obtained from the APT analysis of a specimen of Ti-12Mo that was not exposed to TKD. Impurities, namely C and Ni atoms, are detected in the analysis and displayed. These impurities appear randomly distributed across the data set, as expected for a solid solution. A second specimen was prepared from the same lifted-out region, within the same crystallographic grain and did not contain any grain boundary or any other notable microstructural feature. It was subjected to TKD mapping prior to analysis, see Supplementary Figure S1. TKD mapping was carried out from the apex of the needle to its bottom, and mainly to show its effects on the material by APT, not to search for a particular feature of interest.

Figures 2c–d are top and side views for the APT reconstruction from the analysis of this second specimen. The pink arrows point to regions of anomalous compositional variations, and the electron illumination during TKD mapping

was coming from the right side of the reconstructed data. As highlighted by two sets of isosurfaces, Ni and Mo are heterogeneously distributed, and seem to be forming a planar feature. This plane is nearly parallel to the edge of the reconstructed data set along the z -direction, and appears to start only below a certain depth, even though towards the specimen's apex, regions of higher Ni concentration also appeared.

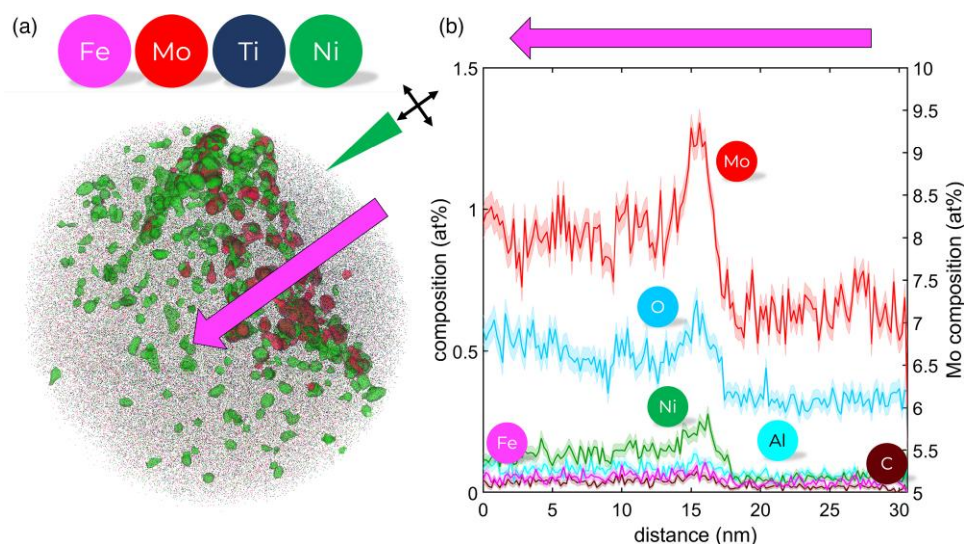
Fig. 3. (a) Top view of the 3D elemental maps with similar isosurfaces as in Figure 2 (c–d). The triangle to the right of the elemental map indicates the direction of the incident electron beam. (b) 1D composition profile across the region indicated by the pink arrow.

The composition across this planar feature, Figure 3a, is quantified by using a 1D composition profile calculated in a cuboidal region of interest positioned normally across over 120 nm of the length of the interface, and with a width of approx. 25 nm, in the direction indicated by the pink arrow. This profile showcases a substantial increase in the concentration of elements including C, Ni, and O, as well as Mo. In principle, this specimen is devoid of any microstructural feature that could explain the segregation. If Ni was reported to be a fast diffuser in Ti (Lutjering & Williams, 2003), diffusion of Mo at or near room temperature is most unexpected (Bian et al., 2019). The curvature, orientation, and inhomogeneous composition profile suggest that this is an artefact that is related to the TKD mapping. N is also found segregated but not plotted in this 3D rendering for clarity. Overall, the composition of carbon in the sample is almost twice as high in the sample post-TKD (0.11 at % vs. 0.06 at%), and that of N (0.06 at % vs. 0.04 at%) and H (14.9 at% vs. 13.4 at%) is also overall higher. It is anticipated that this high level of H is related to the ingress of H during the preparation of the specimens, but it is noteworthy that is found more highly concentrated in the region high in Mo, and segregated to the interface. There is also in this region a higher fraction of Al³⁺ and Ti³⁺, indicative of a higher electric field, which supports that the hydrogen is inside of the specimen and not from the chamber's residuals (Chang et al., 2018).

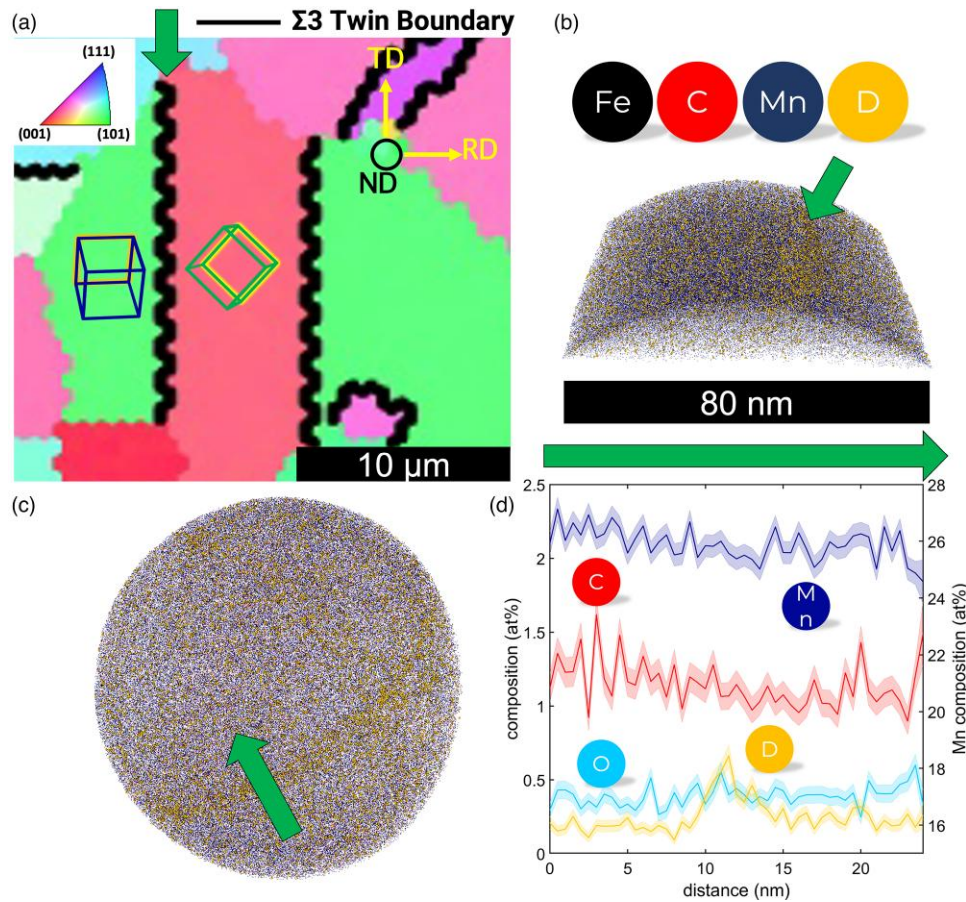
Fig. 4. (a) Electron backscatter diffraction-inverse pole figure (IPF) map, colored with respect to the normal direction, used to identify the coherent $\Sigma 3$ twin boundary which was selected for APT analysis; TD, transverse direction; ND, normal direction out of the plane; RD, rolling direction; side (b) and top (c) view of the 3D elemental map showing iron (Fe), manganese (Mn), carbon (C), and deuterium (D) atoms distribution (only a fraction of the atoms are shown for clarity); (d) 1D composition profile across the interface indicated by the arrow.

Two APT specimens were prepared from a region near a coherent $\Sigma 3$ twin boundary of the recrystallized TWIP steel sample which is indicated by the green arrow in the EBSD-inverse pole figure (IPF) map in Figure 4a. TKD was performed on one specimen and not performed on a second specimen. Both specimens were then exposed together to a deuterium gas atmosphere, under a pressure of 250 mbar in the gas charging chamber described in Khanchandani et al. (2021) at room temperature for 6 h. Room temperature was chosen for introducing deuterium into the APT specimens to avoid any changes in the stacking fault energy of the selected TWIP steel

Figures 4b–c are the results of the APT specimen following charging and on which TKD was not performed. The 3D elemental map in Figures 4b–c shows iron, manganese, carbon, and the detected deuterium atoms, and Figure 4c is the top view from the same distribution. The deuterium content obtained from the bulk composition analysis was 0.027 ion%, but the deuterium atoms appear segregated at an interface, which we assume to be the targeted grain boundary. This could not be ascertained due since TKD was not performed on this specimen. The slight decrease in C and Mn that we can observe supports this hypothesis, based on previous reports in a similar alloy of APT analysis of a coherent twin (Herbig et al., 2015). The peak D composition, quantified by a 1D composition profile obtained along a cuboidal region-of-interest positioned across the interface, is in the range of approx. 0.5 at%. By comparing the D/H ratio, using the reference data from Khanchandani et al. (2022) plotted in Supplementary Figure S2, we can confirm that the charging had been effective, and the observation of a signal at 2 Da is not only related to an artefact from the APT analysis.

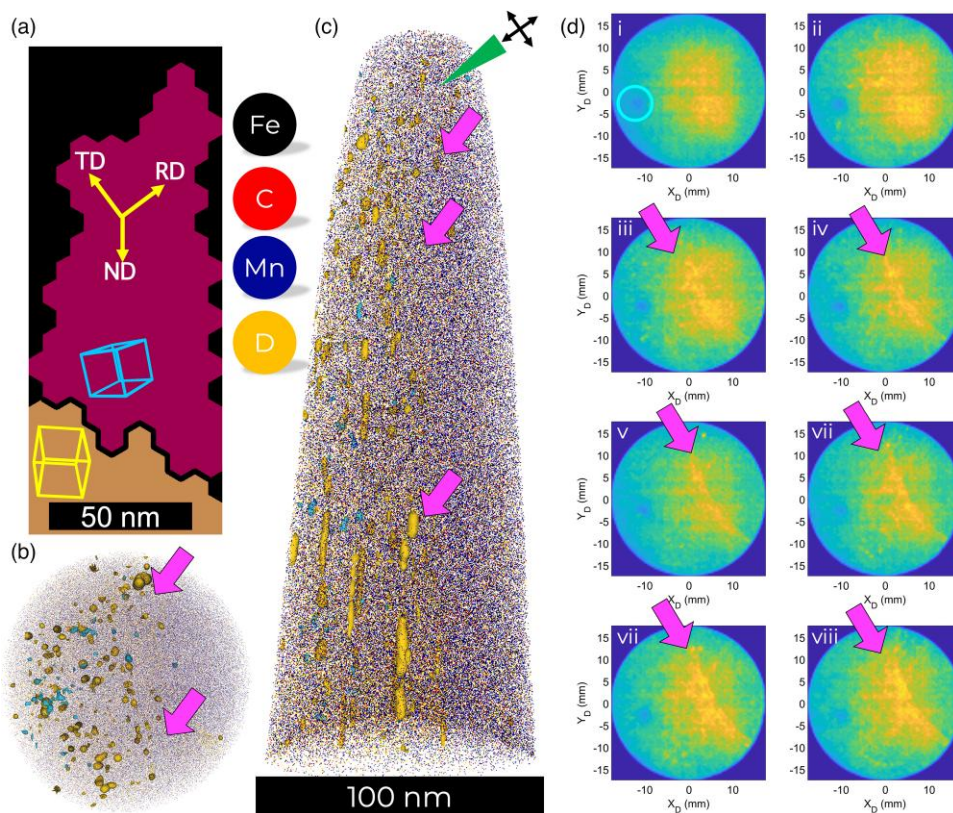
Fig. 5. (a) Transmission Kikuchi diffraction unique grain map of the APT specimen. ND, normal direction in the plane, TD, transverse direction, RD, rolling direction. (b) Top and (c) side view of the tomographic reconstruction from the APT analysis of the TKD-illuminated specimen. The blue isosurfaces encompass regions containing more than 1.4 at% O and the gold isosurfaces encompass regions containing more than 3 at% of D. The triangle on the side of the elemental map indicates the direction of the incident electron beam. (d) Series of detector histograms containing each 3×10^6 hits, and with 6×10^6 hits in between two histograms. The circle marks a crystallographic pole (200). The arrows indicate the location of the TKD-damaged region.

The second specimen was mapped by TKD, and the corresponding unique grain map is plotted in Figure 5a. This shows the presence of a boundary approximately 100 nm below the needle's apex. Figure 5b is the top view of the reconstructed APT analysis showing the distribution of iron, manganese, carbon, and deuterium atoms, whereas Figure 5c is a side view from the same distribution. Two sets of isosurfaces highlight regions of relatively high content in O and D. The left part of the reconstructed data appears enriched in deuterium, with a distribution that is not homogenous. In this case again, there appear to be a curved, planar feature containing a high density of D-rich regions, similar to the two regions observed in Figure 3.

Figure 5d is a series of detector hit maps, similar to those in Figure 2e. Unexpected point density fluctuations, pointed to by the pink arrows, are also imaged in the form of a curved linear feature propagating down as the specimen is analyzed, moving progressively out of the field-of-view. The blue circle in Figures 5d to 5i marks the position of a pole associated to the set of (002) atomic planes (Khanchandani et al., 2023).

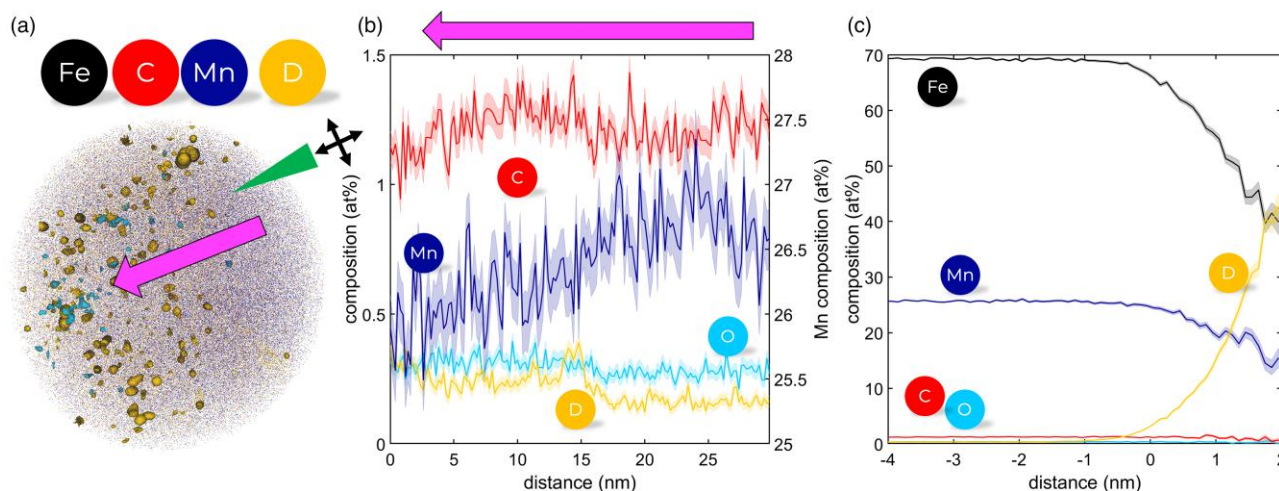
Fig. 6. (a) Top view of the 3D elemental maps with similar isosurfaces as in Figure 5 (c–d); (b) 1D composition profile across the interface indicated by the arrow in (a); Mn composition is reported on the right y-axis; (c) proximity histogram as a function of the distance to the D-isosurfaces.

The composition of the interfacial region, Figure 6a, is analyzed using a 1D composition profile calculated in a cuboidal region-of-interest positioned perpendicular to the interface, and includes an area of 100 nm by 25 nm, Figure 6b.

We calculated a single composition profile as a function of the distance to the D-isosurfaces, i.e., proximity histogram ([Hellman et al., 2000](#)), plotted in [Figure 6c](#). Because of the difference in size between the particles highlighted by a single set of isosurfaces, this proxigram should be considered as qualitative ([Martin et al., 2016](#)). The proxigram indicates a very high concentration of D in these regions, up to 50 at% or more, which we consider to be voids or bubbles filled with D formed by the agglomeration of vacancies generated by the incoming ions. Vacancies are also likely to be further stabilized by hydrogen or deuterium ([Hayward & Fu, 2013](#)). These D-filled bubbles are similar to those reported in [Khanchandani et al. \(2021\)](#). The presence of these defects in

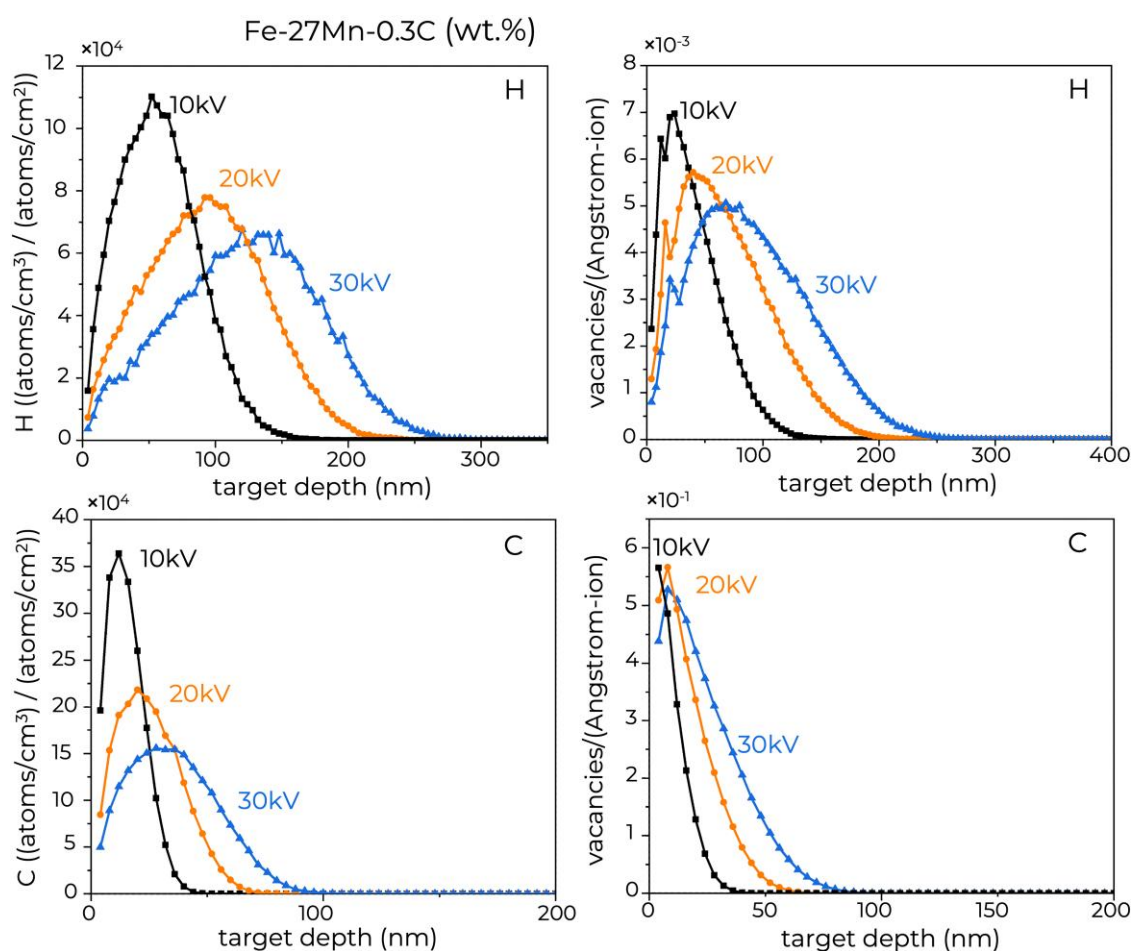
Fig. 7. SRIM-calculated implantation and vacancy depth profiles for H and C in a target with the composition of the TWIP steel analyzed herein.
