Title: DC Incubation Tests of W7-X Coils at CEA, Saclay

Abstract: The Wendelstein 7-X (W7-X) is an advanced optimized stellarator under construction at the Greifswald branch of the Max-Planck-Institut für Plasmaphysik. Its magnet system consists of 70 superconducting coils, i.e. five types of 10 non planar (NPC) and two types of 10 planar (PC) individuals each. In case of an emergency shut-down like in succession of a quench, the voltage across a NPC may raise up to 450 Volt according to the specification. Since all the 10 coils of a type are connected in series, the total voltage could thus reach 4.5 kV. Therefore, the coils had to be provided with a corresponding electrical insulation. Its test voltage levels were fixed at 10.4 kV and 7.2 kV, respectively, for the NPCs and PCs.

## DC Insulation Tests of W7-X coils at CEA, Saclay

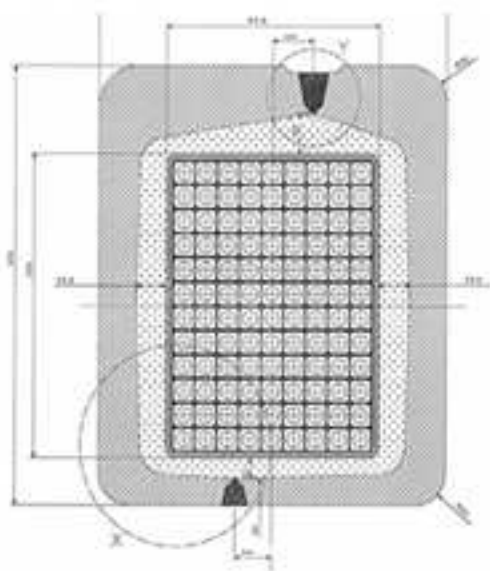
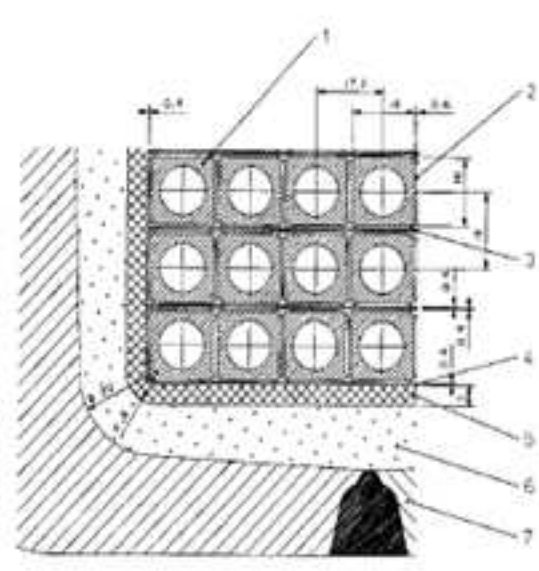
Figure1

The picture below shows the cross section of a NPC with a detailed zoom of the general insulation between the winding pack and the coil casing [2].

**Figure 1: Cross section of a NPC and its detail of the Embedding insulation.**

1. AL - Jacket
2. Superconductor Insulation
3. Inter turn Insulation
4. Inter turn Insulation
5. Ground Insulation
6. Embedding
7. Coil Casing

As it was shown in figure 1 the hollow space between the coil casing and winding pack is filled with epoxy and has to prevent any movement of the winding pack into the casing.

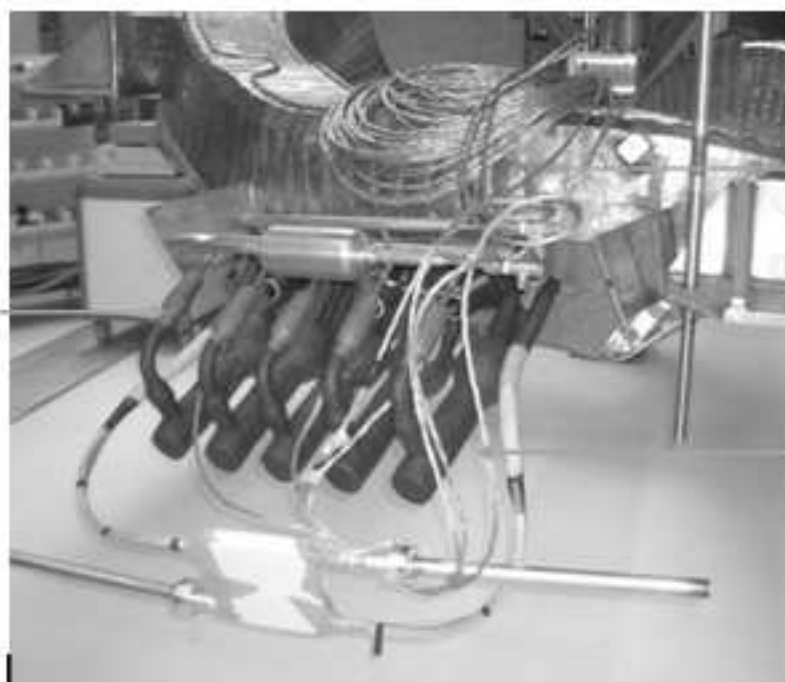
Figure2

**Figure 2: Header area of a type 4 NPC.**

Potential  
Breaker

QD  
Wires

Interlayer  
Joint

Two adjacent layers of the winding pack are connected by the interlayer-joints; the insulation with respect to the outer part is achieved by epoxy impregnated fibreglass.

A potential breaker can be responsible of an insulation failure as well as a Helium leak. There is 1 potential breaker for each interlayer joint.

These wires bring the interlayer voltages to the external data acquisition system. Their insulation is made of Kapton and they are externally ground shielded.

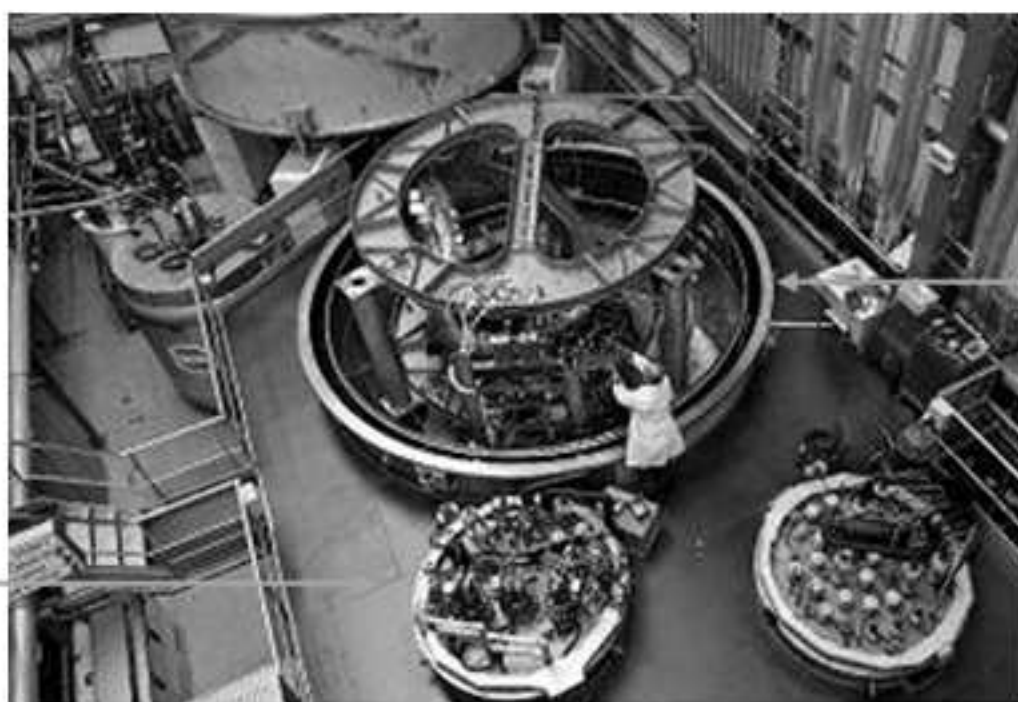
Figure3

In the picture below a top view of cryostat 2 with its relative valve box is shown.

**Figure 3: A top view of cryostat 2 and its valve box.**

Valve  
box

Cryostat

The currents leads are contained in a so called “valve box”. The outer part of the cryostat and of the valve box system is connected to ground, whereas the 3 current leads are energized with the high voltage (+ pole).

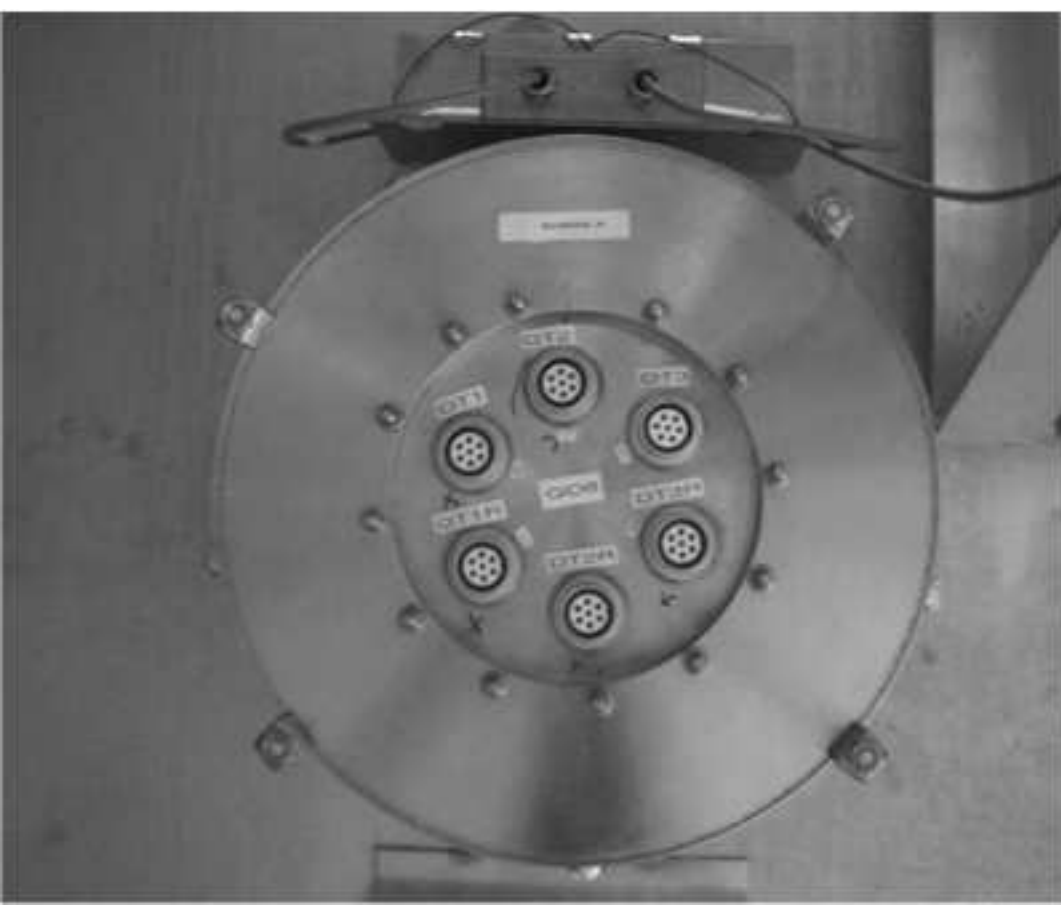
Figure 4

These elements are screwed on the cryostat wall from the inner side and are necessary to allow a connection outside to the data acquisition system. One QD-bucket contains 6 plugs which are all energized since they are connected to the QD-Wires.

**Figure 4: A QD bucket screwed on the lower part of the cryostat wall.**

Nowadays the ground insulation of the QD-buckets is much improved by means of additional insulation rings which are screwed between the cryostat wall and the QD-bucket flange. Thus a failure in a plug cannot any longer induce a current leak.

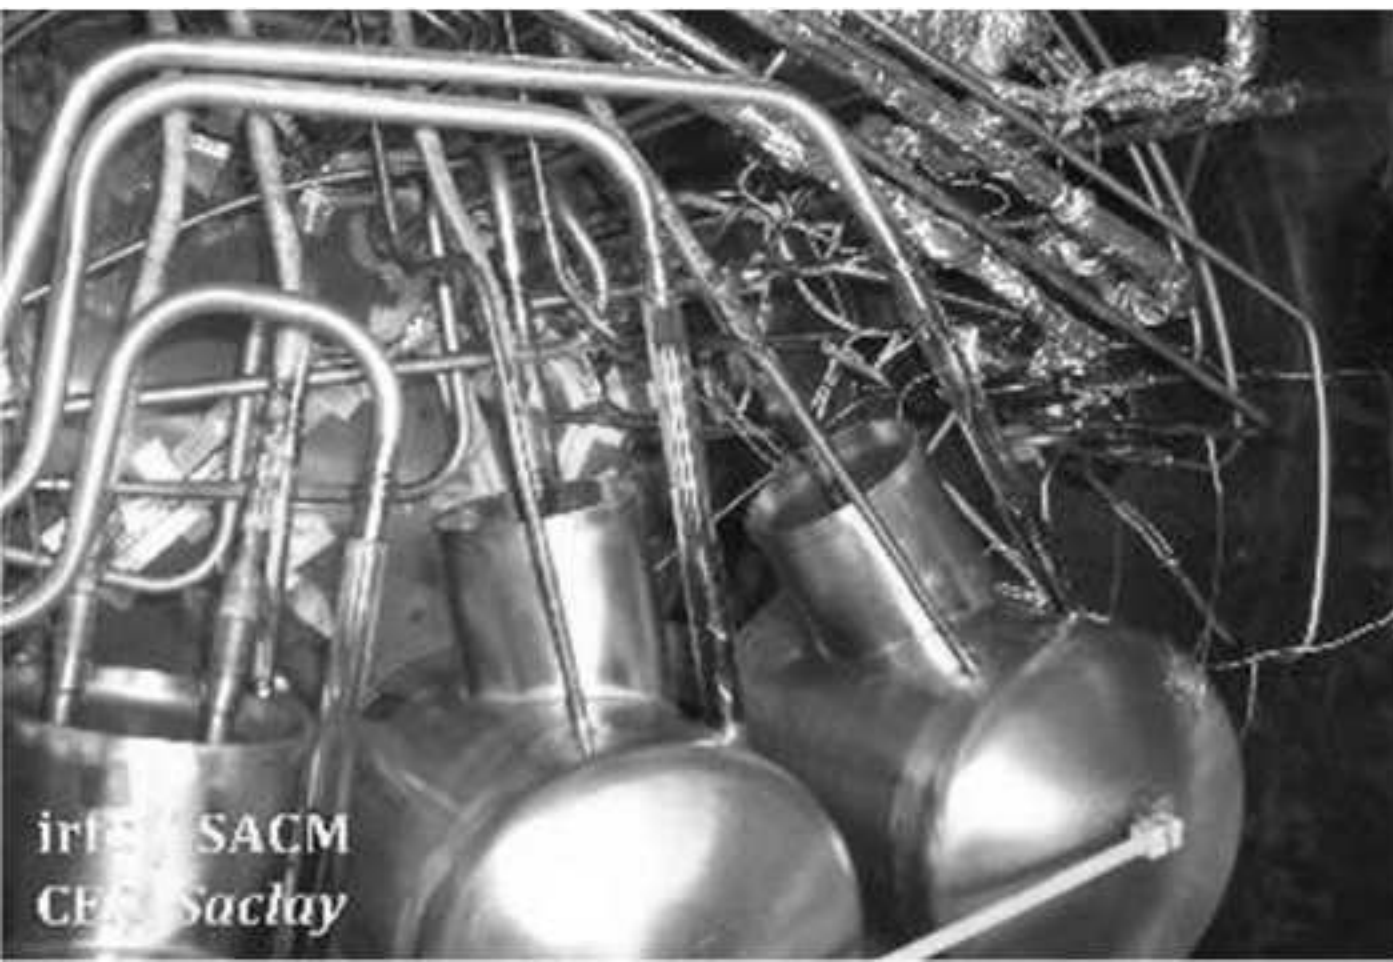
Figure5

The inner part of a valve box is kept under vacuum and each of the lowest parts of the 3 current leads is submitted to a Helium bath.

Helium vaporization as well as a vacuum reduction may induce a voltage breakthrough by Paschen effect [6].

**Figure 5: 3 tanks for Helium bath of the currents leads feet in the valve box volume.**

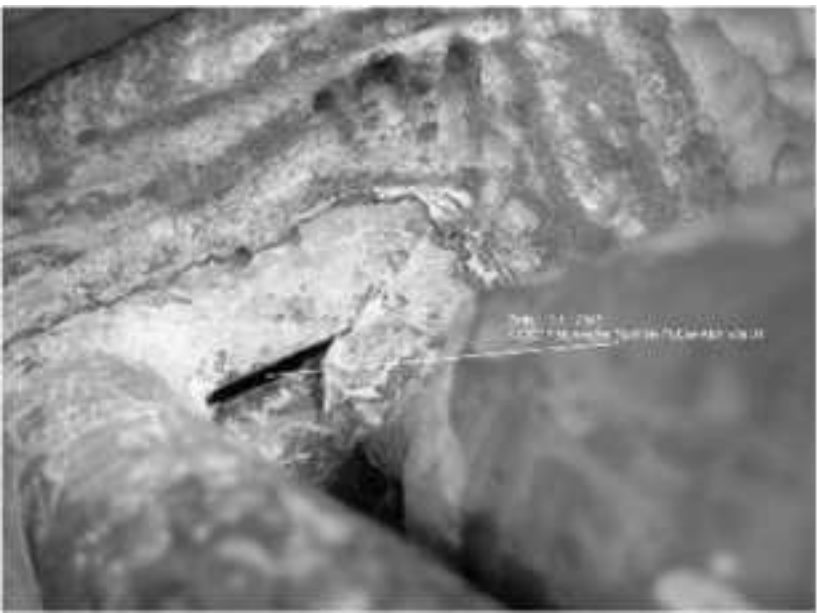
Figure6

During the last 5 years some defects on the coils came out by DHVTs. For instance, on a type 5 coil in 2005 a void was revealed after several failures by DC test (picture on the left).

By inserting a camera into the cryostat it was possible to observe some flashes coming from the QD wire outlet on the header area of another coil type 2. These coils were reworked by the manufacturer.

**Figure 6: On the left a void in the connection area of AAB25; on the right a sparkling QD cable On AAB59.**

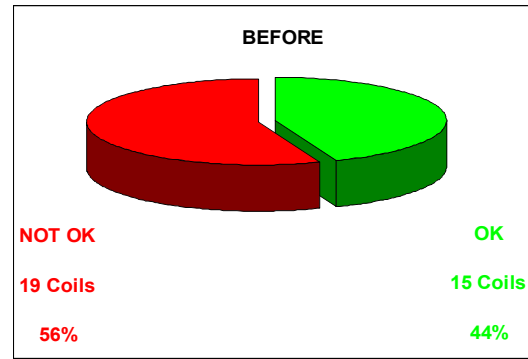
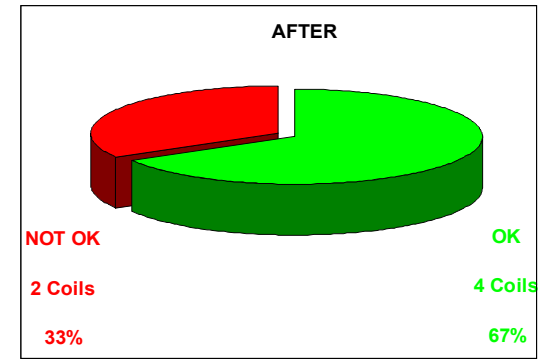
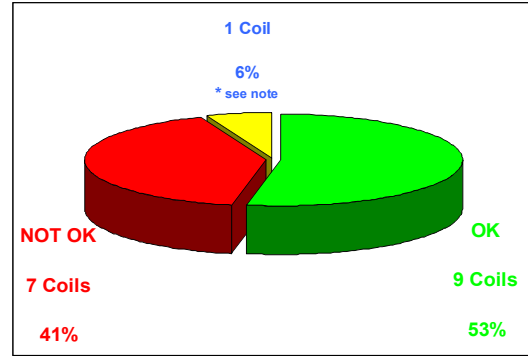
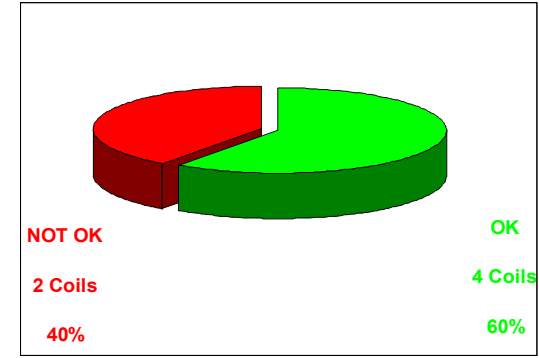
**Table 2: Summary of all the DHVT at cryogenic temperature only. The reported numbers represent the number of tested coils.** The improvement taken by the installation of the QD-rings can be observed by the graph below, the last update was done on 30/07/08.

Graph 1: For NPCs the successful DC tests increased from 44% to 67%; similarly for PCs the success rate passed from 53% to 60%.  
\*=one only planar coil at cold condition gave failed unlike at warm condition.
