Cracks avoidance with a modified solid tungsten divertor in ASDEX Upgrade

To clarify the suitability of solid tungsten as plasma facing material, a new divertor, DIV-III, entered in operation in ASDEX Upgrade (AUG) in 2014. Since the first experimental campaign, AUG divertor tiles faced crack issues. Trying to identify the reasoning, a new set of tiles was installed in 2016: many precautions were taken to reduce the stresses possibly causing the cracks. The AUG campaign 2017 started in March and the first results were collected during the short summer opening in 2017. This paper reports on the modification of the tile setup, based on Finite Element Modelling, and on the progress achieved in the first operation phase.

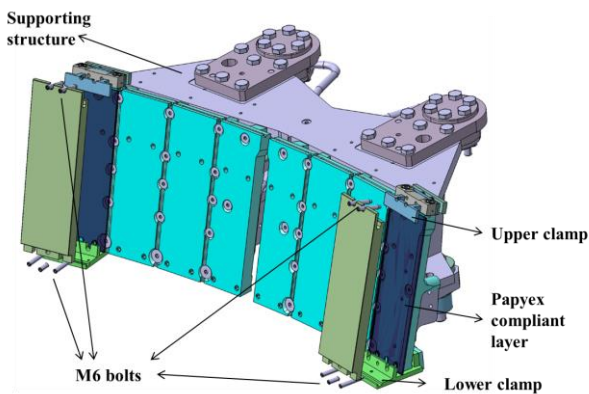
Fig. 1. Overview of one sector of the DIV-III: only the tiles in the outermost position are illustrated.

According to the ‘EFDA roadmap for the realization of fusion energy’ the material portfolio for DEMO will consist of consolidated developments of EUROFER as a structural material and tungsten as plasma facing material. Bearing that in mind, AUG is presently equipped with ferromagnetic tiles in the inner column [1] and massive tungsten tiles in the strike line region of the lower outer divertor [2]. The remaining wall elements are made of tungsten coated graphite. The divertor III (DIV-III) is an adiabatically loaded component and each sector consists of a water cooled stainless steel support structure on which 8 massive tungsten tiles (220x75x15 mm³) are clamped (Fig. 1).

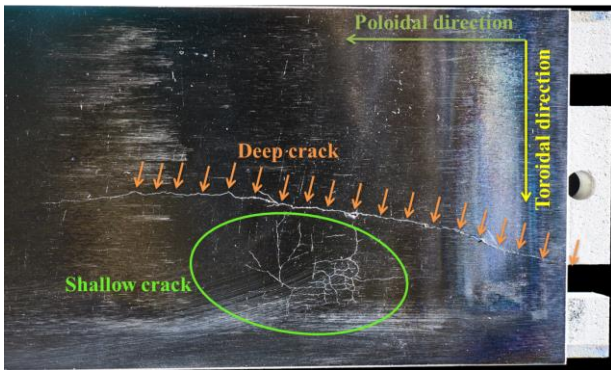
Fig. 2. Typical crack pattern in a tungsten tile: shallow cracks are identified by a dense superficial network, while the deep crack runs on poloidal direction from the lower part (right side) of the tile to the central one extending through the entire tile thickness.

The tungsten evolution of AUG over the years and an extensive overview of the results collected during the first campaigns with a solid tungsten divertor in AUG are given in [2]. The first campaigns revealed two main findings, which can be summarized as follows: 1) shallow cracks in the strike line region of the tiles and 2) deep cracks going through the tile thickness and in line with the longer (poloidal) direction of the tile. In Fig. 2 the typical crack patterns are illustrated: deep crack goes along the tile length, connecting the clamp region with the middle one, and it runs through the entire tile thickness (15 mm). Conversely the shallow crack consists of a network of small and superficial cracks, with a depth of the order of hundred μm . At first glance, the thermo-mechanical stress seems to be responsible for the deep cracks: during the plasma operation, a compressive plastic deformation is generated in the strike line region. In the cooling phase of the tile, large residual tensile stresses are induced by plastic deformation acting as the driving force of the opening of the deep cracks. The initiation of the cracks can be attributed to plastic fatigue or to the repeated and concentrated load derived by the edge localized modes (ELMs). On the other hand, the tiles tested in GLADIS

Actually during the plasma operation, disruption events stress the tungsten tile, and they could be particularly damaging in an early operational phase, when the material is still cold. The disruption event induces eddy currents in the bulk material that, interacting with the static toroidal field, is responsible of moments acting into the components. Complex induced current paths between the stainless steel support and the tungsten tiles are also responsible for additional forces acting on the tungsten tiles. This ‘bypassing current’ is due to the low electrical resistivity of the tungsten with respect to the stainless steel of the supporting structure. The temporal variation of the radial magnetic field of 250 T/s and the static magnetic field of 2.5 T, typical values for AUG disruptions, cause a force of about 6.4 kN for the outermost tiles. Such electromagnetic loads end up in a high stress concentration in the clamped regions of the tile.

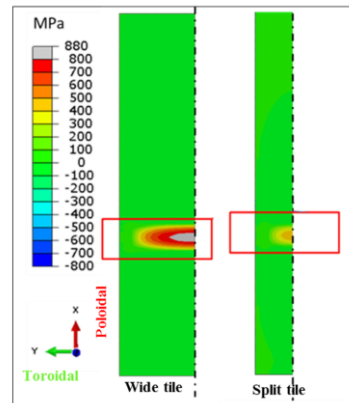
The residual stress component, which is normal to the plane of the crack, of a wide and a split tile are compared in Fig. 3.

Fig. 3. Residual stresses in toroidal direction after cooling down: comparison between the wide and split tile. The dashed lines on the right side indicate symmetry axis used in the FEM analyses.

The FEM analyses refer to a heat load of 15 MW/m² for 2.5 s for both cases. A strong reduction of plastic deformation and, consequently, of the residual stress along the toroidal direction after cooling down is observed in split tile compared to wide tile. The maximal tensile stress after cooling down at the surface is 880 MPa and 482 MPa, for the wide and split tile, respectively. A stress reduction is calculated also in case of a double poloidal groove or castellation on top of the tile surface, but a minimum depth of the castellation is required to avoid stress concentration in the castellation tip. For a moderate castellation depth, the stress increases, but from a depth of 6 mm on a reversal of the trend is found as shown in Fig. 4. The tile with double castellations, with 10.5 mm of castellation depth, has a residual stress of 866 MPa after the cooling down, which is further reduced to 700 MPa with the edge smoothing of the grooves. A dedicated paper on the thermo-mechanical analysis will be published elsewhere [10].

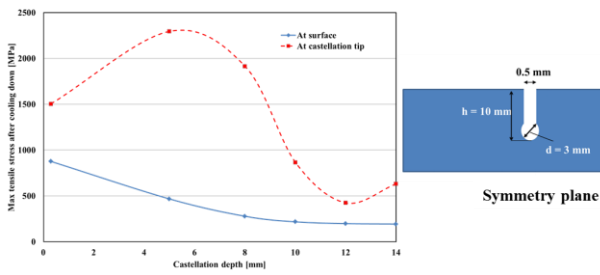
Fig. 4 On the left hand side: maximum residual stresses in toroidal direction after cooling down for the wide tile with double castellation. The solid line indicates the residual stress on the tile surface; the dashed line indicates the residual stress at the castellation tip. On the right hand side the castellation dimension of built tiles are reported.

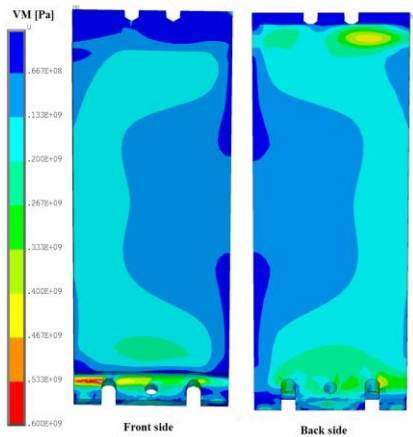
Fig. 5. Von Mises stress [Pa] distribution in the tungsten tile with titanium clamp during a disruption.

In Fig. 5 the stress distribution for the titanium clamp is illustrated. With similar forces acting on the tile, a stress relaxation of about 10% is expected moving the peak stress from 875 MPa to 760 MPa using a titanium clamp. For the eddy current calculations a dB/dt of 250 T/s and a static toroidal field of 2.5 T are considered. In addition, the higher electrical resistivity of titanium with respect to the austenitic steel reduces the current bypassing through the tungsten tiles, with a corresponding reduction of 25% of the load acting on the tile. Therefore, the tiles installed with titanium clamps will benefit from a double effect: reduction of electromagnetic load and some more flexibility.

Based on these evidences, the crack could be affected by the rigid constraint of the stainless steel clamps that, at least in the lower part and in combination with the loads arising during a disruption, could end up in a sudden and peaked stress distribution into the tile. To relax this contact stress, the steel clamp is replaced by a more elastic titanium alloy, so that the tile can have some freedom in its movements.

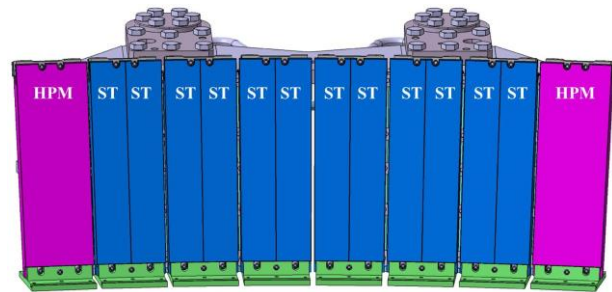
Fig. 6. CAD model the standard module installed in AUG. The outermost pink tiles are made of HPM and the remaining are the split tungsten tiles.

Following the optimization of the thermally induced stress, while keeping the manufacturing process as simple as possible, the solution of the split tile is selected as the favorite. As drawback, mounting the split tiles inside the vessel is more complicated than for the wide tile. At 6 out of 8 positions in 13 out of 16 divertor modules tungsten split tiles were installed with stainless steel clamps. The remaining two outermost positions were used to install more ductile tungsten heavy alloy, since in this position the highest bypass currents are expected. In Fig. 6 a CAD model of the standard sector setup is shown.

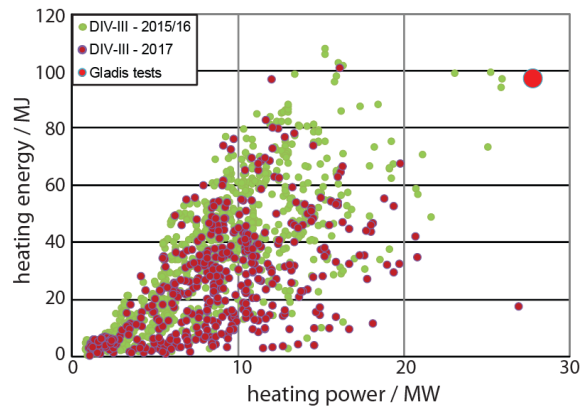
Fig. 8. Operation range for the last two experimental campaigns. At the end of 2015/16 campaign nearly all the tiles suffered from deep cracks. After 2017 campaign no deep cracks were built up. For comparison, the plasma heating power and energy equivalent to the GLADIS test is shown.

The AUG operation started in March 2017 and a short summer opening allowed the inspection of the newly installed tiles. The DIV-III stands about 760 shots, most of them in lower single null configuration and about half of them end up in a disruption. The operation ranged over the first part of the experimental campaign is reported in Fig. 8. Unfortunately, the operation of AUG suffered during last campaign from cracks in the above mentioned tiles embedding Langmuir probes, namely in sector 8 and sector 13. One of the two tiles built up a deep crack that running all along the toroidal width, split the tile in 2 half (see Fig. 9). Thus, the cooling rate temperature of the tile was drastically reduced, causing a prolongation of the dwell time between shots.

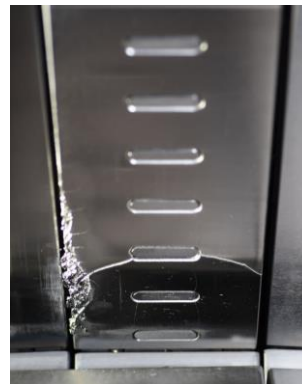
Fig. 9. Picture of a broken tile embedding Langmuir probes in AUG with strongly damaged leading edge (sector 8).

from the melting at the leading edge nearby (see Fig. 9). The tiles were carefully analyzed with optical microscopy: the damaged tile reveals superficial cracks disconnected from the clamping region. The cracks belonging to this network seem to be independent from each other; that would be compatible with hypothesis that the shallow cracks are induced by different shots with different strike regions. Thus, it is reasonable to think that these cracks had a thermo-mechanical origin. In Fig. 12 views of the microscopic analyses are shown. A crack width of 50 μm and a crack depth of at least 100 μm were determined.

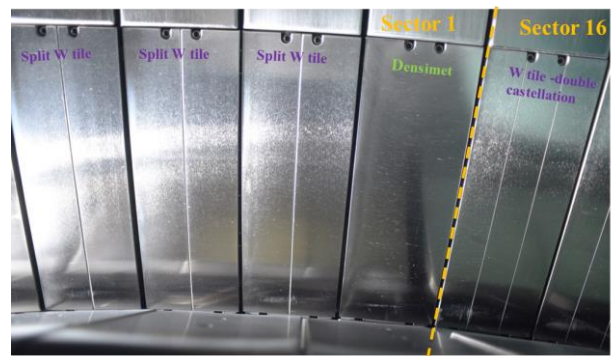
The replacement of the broken tiles gave the possibility to inspect the whole DIV-III. For the first time, since AUG moved to bulk tungsten as plasma facing component, no deep cracks were found in all sectors of the new installed tiles. Fig. 10 illustrates that both the split tiles and the castellated tiles are free of cracks.

Fig. 10. Picture of half sector with standard configuration (Sector 1). On the right side, a tungsten tile with double castellations is visible (Sector 16).

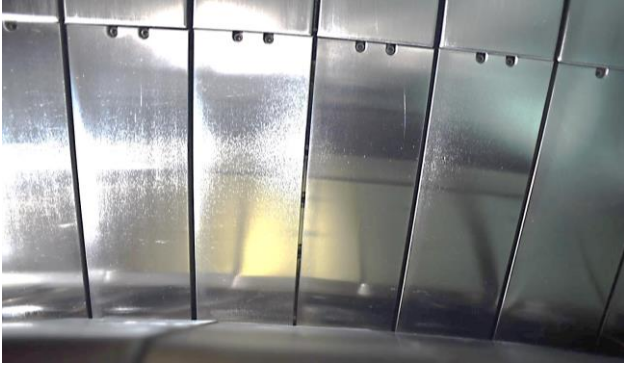
The wide tiles with titanium clamps even do not generate deep cracks, neither the wide tiles (Fig. 11) nor the split tiles.

Fig. 11. Picture from AUG vacuum vessel: wide tungsten tiles with titanium clamps (Sector 7).

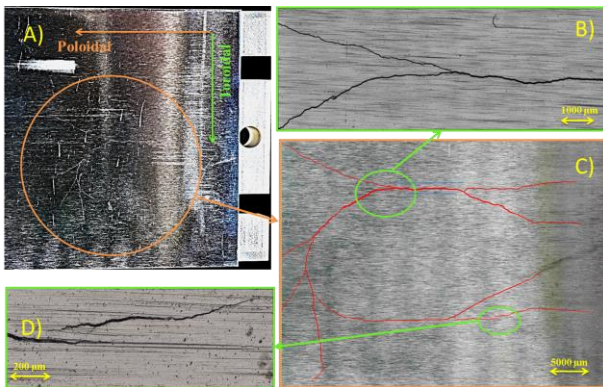
Just one of the wide tiles with titanium clamp has shallow cracks in the strike line region, but, as mentioned, they are not through the tile thickness. This damaged tile, together with another wide tile were taken out from the vessel for further analyses. Both tiles have on top of the surface many tungsten droplets originating

Fig. 12. On the top left: A) picture from the wide tungsten tile with titanium clamp. C) Microscopic analyses of crack path with detailed views in B) and D).

On the other side, also in the sector with more flexible titanium clamps no deep cracking was observed, yet. For the first time, no deep cracks were induced in wide tiles. But the solely tile (excluding the divertor manipulator) with shallow crack belongs to this sector. From the microscopic analysis, these cracks have the characteristics of the shallow cracks: they are running superficially (few μm depth) and they appear disconnected from each other. Since they are far away from the clamping region, their origin is certainly thermo-mechanical. It is interesting to see how these cracks will evolve for a longer exposition time, if they can be considered the first stage of a deep crack or they will remain in this superficial stage. As next step, the installation of the wide tile with shallow cracks on the AUG divertor manipulator is envisaged, taking advantage of a video inspection in between shots. In this way, it would be possible to check the propagation of the cracks. The results of the intermediate inspection are overall positive: no differences between the 2 tungsten suppliers are remarkable and all the precautions definitively improve the tungsten tile behavior. The synergetic effect between thermal and mechanical loads seems to be responsible for the formation of deep cracks. The combination of the two loads accelerates the crack initiation and propagation. This statement should be confirmed by a longer exposure of the tiles in AUG, making a strict comparison between the double castellated tiles and the wide tiles with the titanium clamps. Also the performance of the HPM tiles was remarkable, especially considering that they were facing the higher induced currents and the higher thermal load due to sector misalignments.
