Tungsten coatings under high thermal loads in JET and Magnum-PSI

C Ruset¹, H Maier², E Grigore^a, G F Matthews³, G De Temmerman⁴, A Widdowson³
and JET-EFDA contributors⁵

Abstract

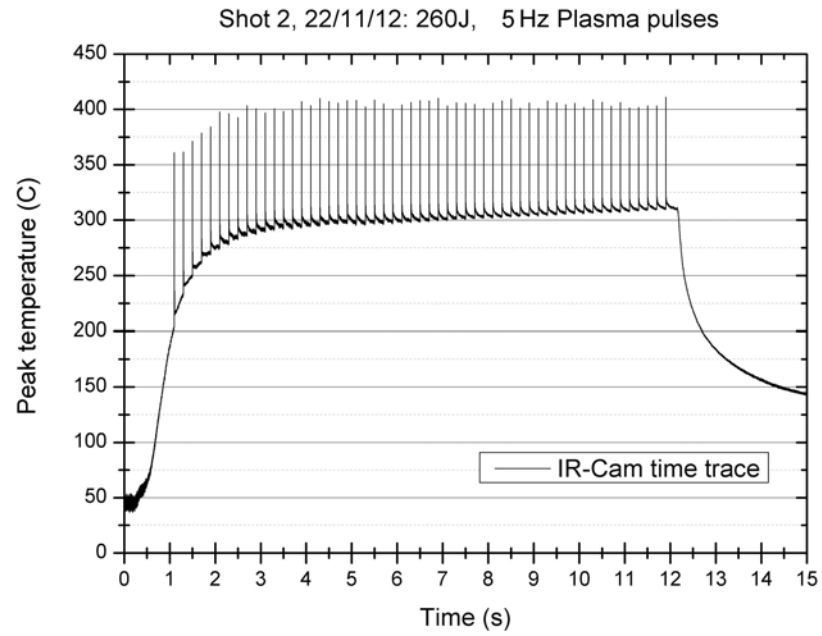
The plasma beam with a diameter of about 30 mm was centered on the area 80x70 mm of the sample. The temperature was measured with an IR camera at a frequency of 4 kHz on the wavelength of 4 μm . Under these conditions the base temperature due to the steady state plasma started at ~ 40 °C and reached after 12 s a temperature of ~ 315 °C. The base temperature at which thermo-shocks were applied was $\sim 200 - 315$ °C. The increase of surface temperature due to short pulses was about 100-120 °C. The time dependence of the W coating temperature is shown in Fig.2.

Fig.2 Typical temperature time trace of applied thermal shock loads at 5 Hz in Magnum PSI, super positioned with a steady state heat load of 10 MW/m^2
