Investigation of Tungsten Coatings on Graphite and CFC

JET ,ITER-like Wall' project:

Test of ITER material mix of PFCs: Be/W/(CFC)

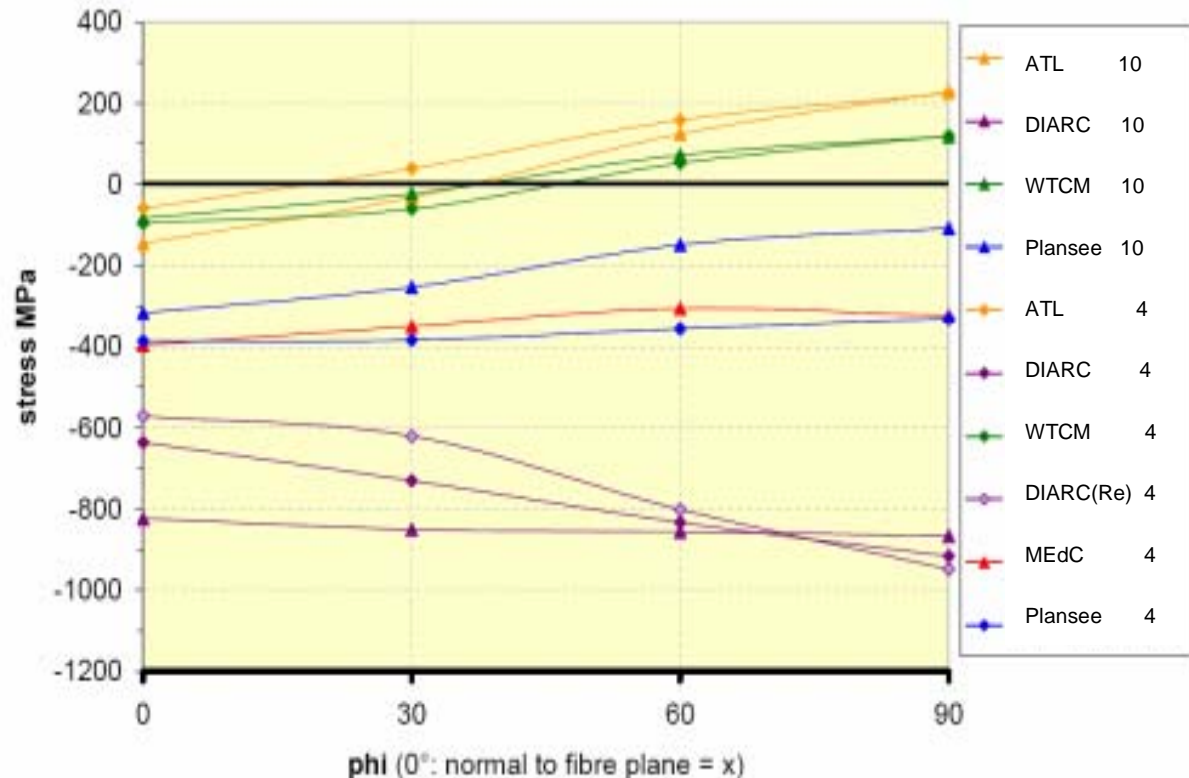
- CVD coatings almost stress free
- rest of coatings show compressive stress
- stresses in coating provided by MEdC (CMSII) rather low
- surface of VPS coatings show only low orientation independent stresses

stress states of thin coatings @ r.t. by X-ray diffraction

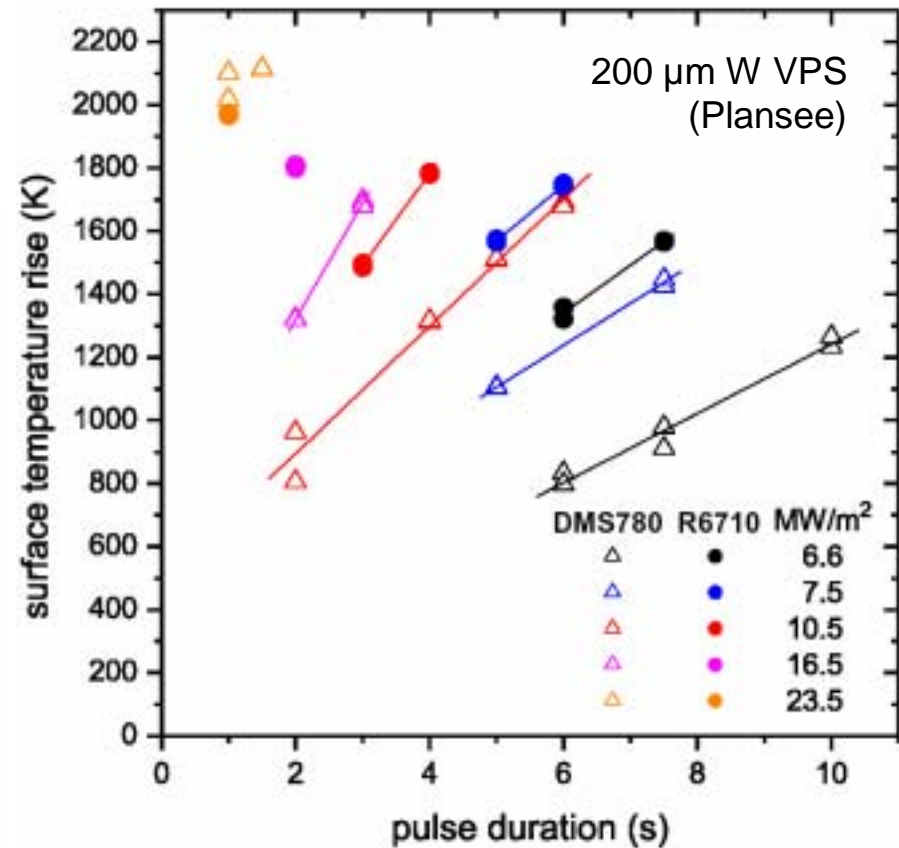
thermal response of VPS coated CFC and graphite

Thermal Screening:

- surface temperatures $> 2000^{\circ}\text{C}$
- Higher T_{surf} of graphite samples consistent with lower therm. cond.
- **most of the coatings survived** (or failed only at 23.5 MW/m^2)

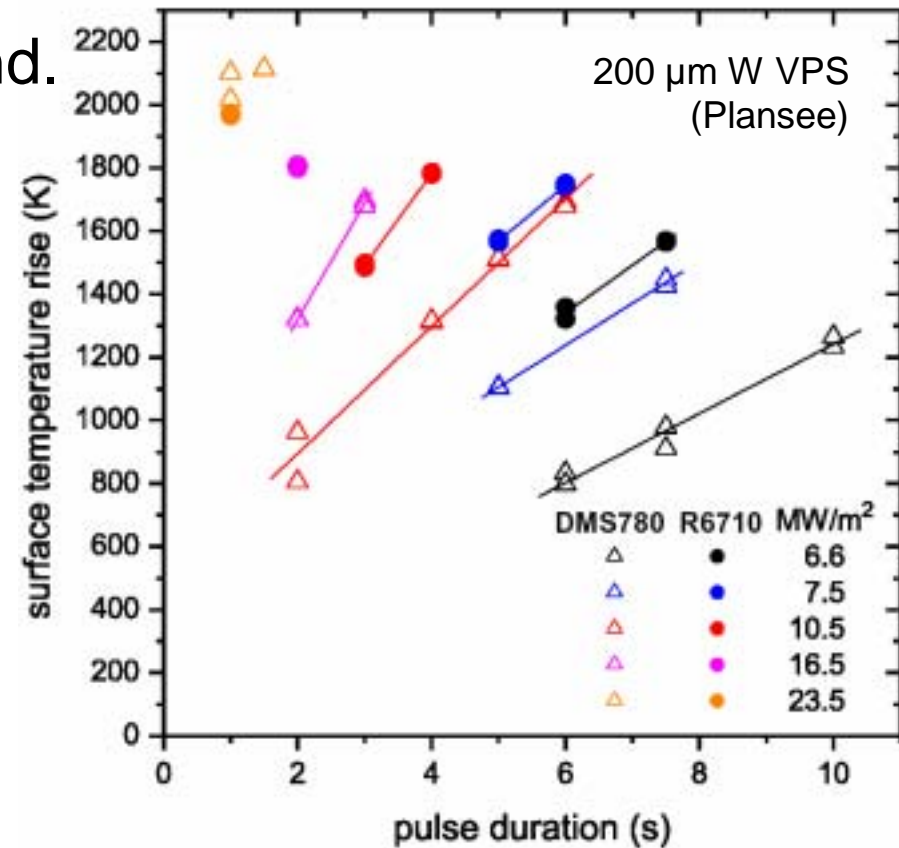
thermal response of VPS coated CFC and graphite

Thermal Screening:

- surface temperatures $> 2000^{\circ}\text{C}$
- Higher T_{surf} of graphite samples consistent with lower therm. cond.
- **most of the coatings survived** (or failed only at 23.5 MW/m^2)
- **failure** of samples with **fibre planes || to surface** ('layout II') already at 16.5 MW/m^2

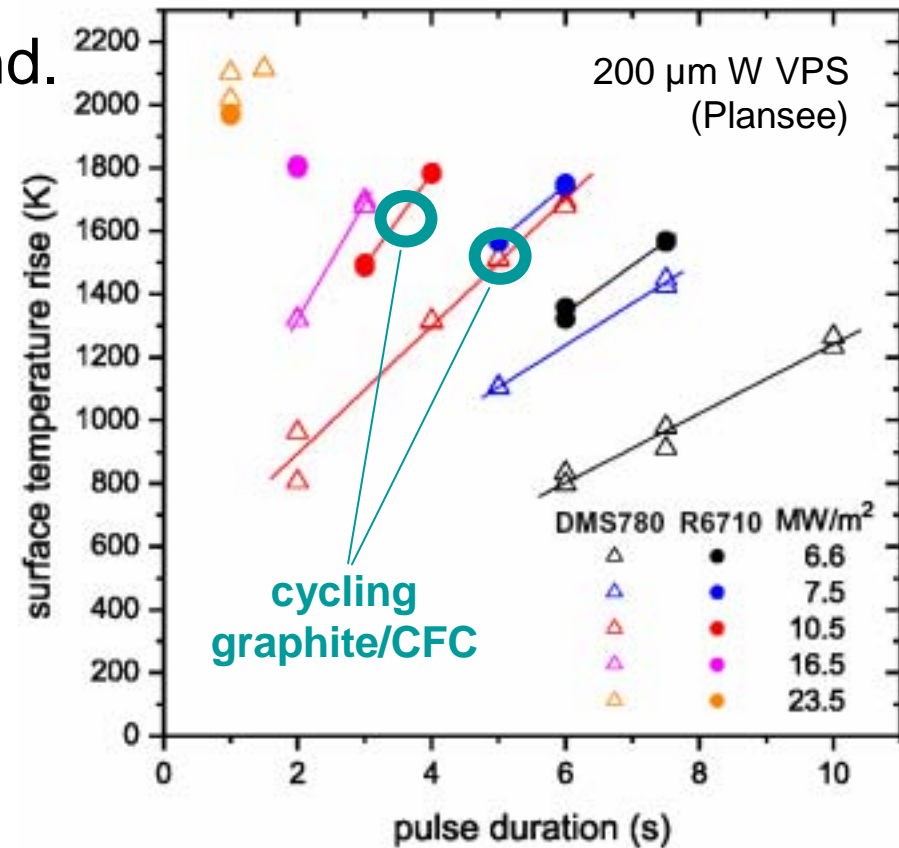
- surface temperatures $> 2000^{\circ}\text{C}$
- Higher T_{surf} of graphite samples consistent with lower therm. cond.
- **most of the coatings survived** (or failed only at 23.5 MW/m^2)
- **failure** of samples with **fibre planes || to surface** ('layout II') already at 16.5 MW/m^2
- defects not detectable in pre-NDT

thermal response of VPS coated CFC and graphite

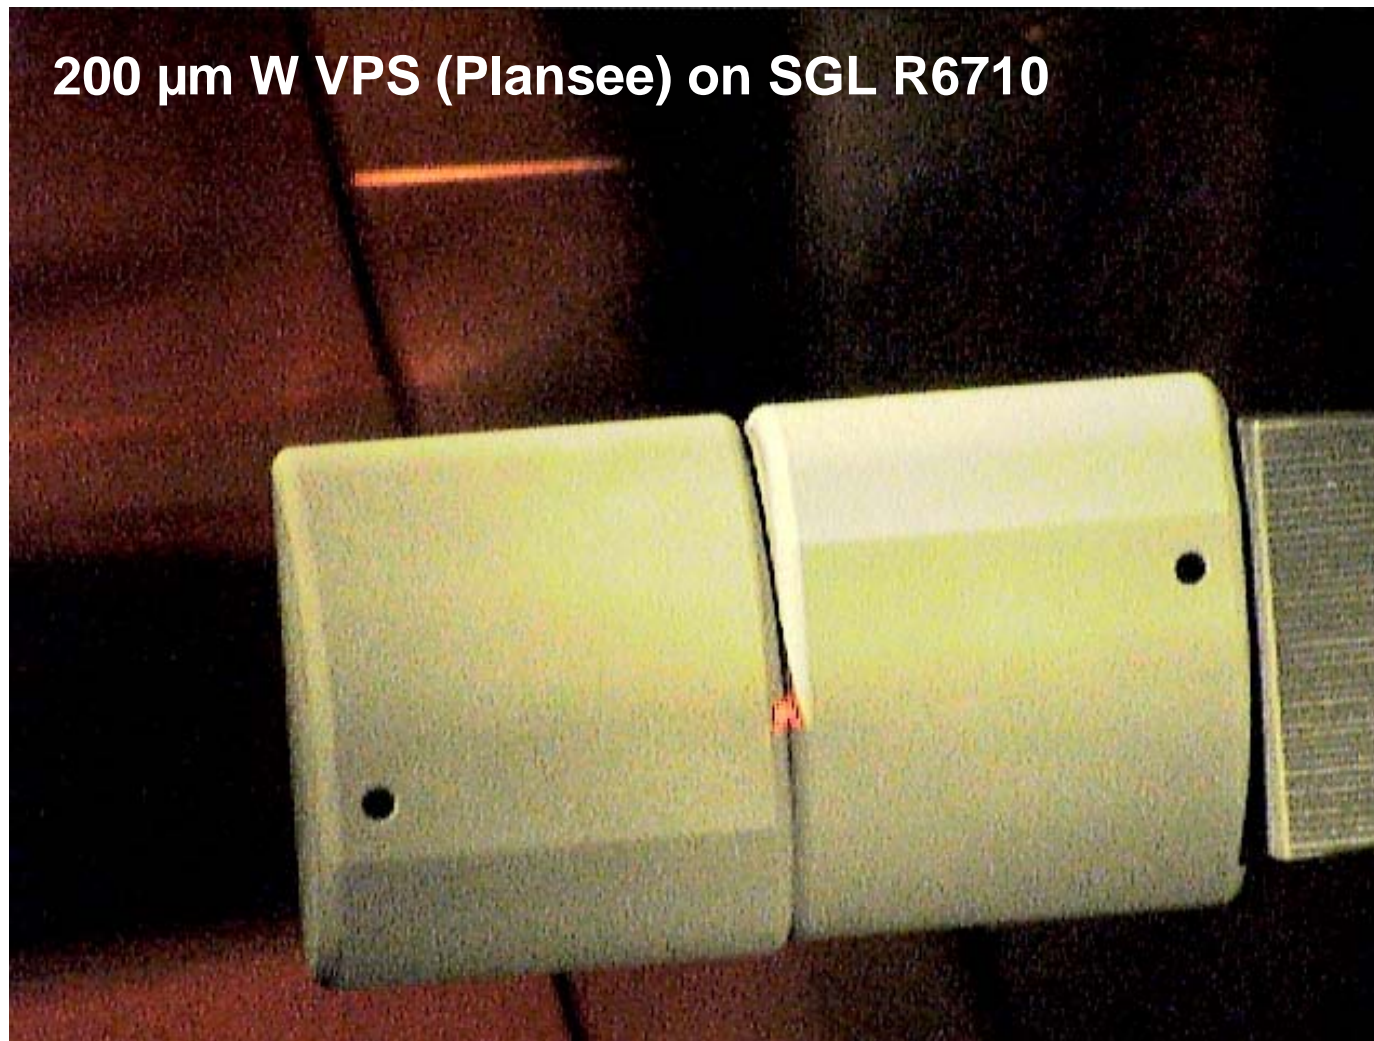
200 μm W VPS (Plansee) on SGL R6710

Mounted graphites samples in GLADIS

Cyclic Loading:

- 200 pulses @
- 10.5 MW/m²
- 5.0 s (DMS780)
- 3.5 s (R6710)

$T_{\text{surf}} > 1600^{\circ}\text{C}$

thermal fatigue
expected for
CFC samples
due to strong
mismatch in α

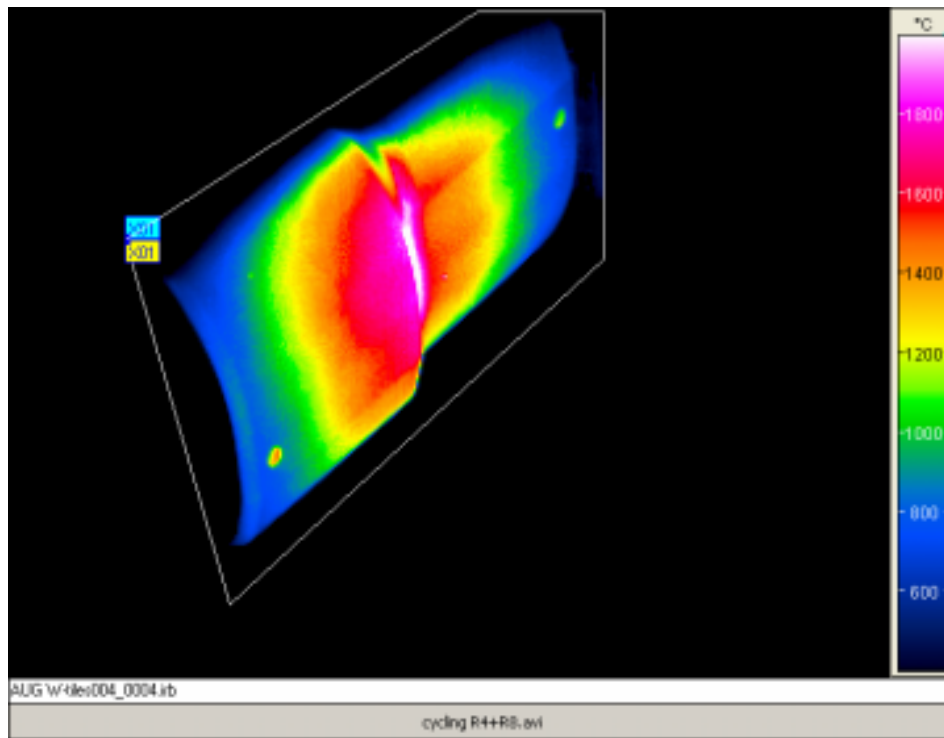
Sequence of thermographic pictures from 200 pulses

Cyclic Loading:

- 200 pulses @
- 10.5 MW/m²
- 5.0 s (DMS780)
- 3.5 s (R6710)

$T_{\text{surf}} > 1600^{\circ}\text{C}$

thermal fatigue
expected for
CFC samples
due to strong
mismatch in α

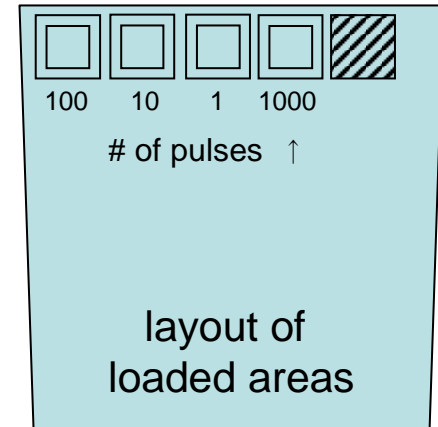
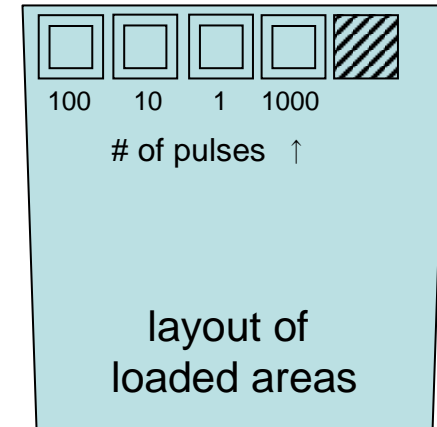
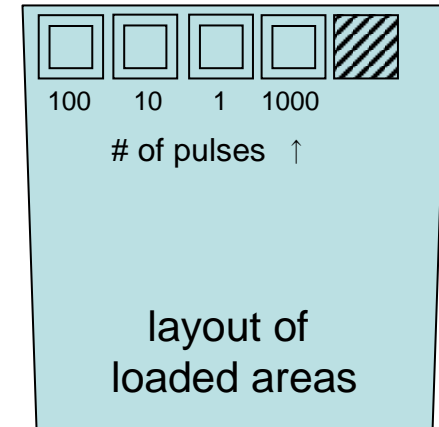
Three most successful coatings on CFC
 (VPS: Plansee, St. Gobain, PVD: MEdC)
 were exposed to **thermal shocks** in the electron
 beam test facility JUDITH **to simulate ELMS**

0.35 GW/m², 1 ms, 1000 pulses (~0.3 Hz), 8 x 8 mm²

Results:

- failure mode 2 and 3 for **PVD coating**
 ⇒ **delamination and local melting**

- failure mode 2 and 3 for **PVD coating**
⇒ **delamination and local melting**
- **no visible defect on VPS surfaces**
- however, metallographic cross section reveal **start of delamination** at areas with fibres parallel to surface
