Implementation of ferritic steel as in vessel wall:

Lessons learnt and follow up

I. Zammuto^a, L. Giannone^a, A. Herrmann^a, A. Houben^b, A. Kallenbach^a, K.H. Schuhbeck^a, B. Sieglin^a, S. Vorbrugg^a and the ASDEX Upgrade Team

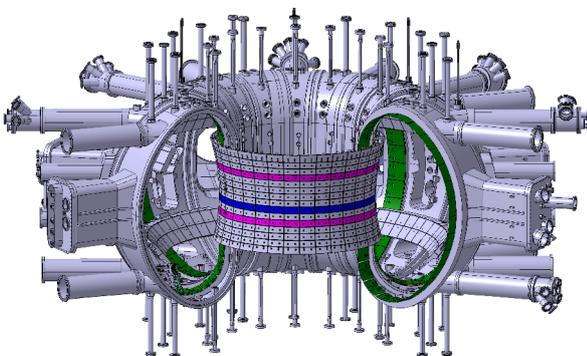
Figure 1 AUG overview of the inner vessel setup: the ferromagnetic tiles installed first are highlighted in pink. In blue is the middle steel row placed in 2015.

During the 2015 VV opening, with the utmost caution, just one additional steel row is installed (see blue row in Figure 1). The third row is equipped with alternately P92 and Eurofer. Prior to installation, their magnetic properties were measured to make sure that the two are almost identical from the magnetic point of view (see Figure 6). As expected, during the operation of AUG, no difference between the two materials is remarkable. To measure the induced current flowing between adjacent HS, a Rogowski coil is installed in the lower toroidal support of one HS structure.

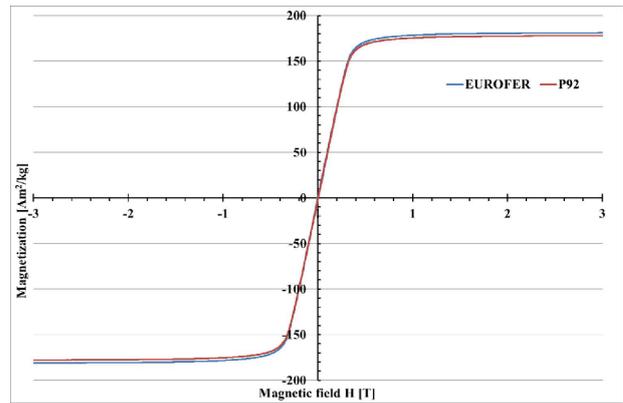
Figure 6 Magnetization curve for Eurofer and P92 in blue and red respectively.
