Measures to overcome deep cracks of tungsten tiles in the ASDEX Upgrade divertor

I. Zammuto^a, A. Herrmann^a, N. Jaksic^a, M. Li^a, M. Balden^a, V. Rohde^a, S. Vorbrugg^a, H. Greuner^a, R. Neu^{a,b}, A. Kallenbach^a, the ASDEX Upgrade Team^a

^aMax-Planck-Institut für Plasmaphysik, D-85748, Garching, Germany

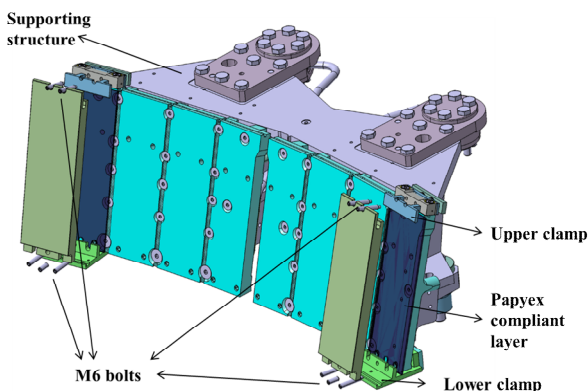
The main components of the outer divertor are illustrated in Fig. 1. Briefly, the AUG outer divertor consists of a water cooled stainless steel structure on which 8 tiles are fixed with stainless steel clamps.

Fig. 1. Overview of one sector of the DIV-III: only the tiles in the outermost position are illustrated.
