# A hot steam leak during baking of ASDEX Upgrade – consequences and lessons learned

A. Herrmann, V. Rohde, G. Schall, M. Balden, D. Bösser, K. Hegele, K. Hunger, J. Stober, T. Vierle, S. Vorbrugg,  
and the ASDEX Upgrade team

*Max-Planck-Institut für Plasmaphysik, D-85748 Garching, Germany*

Keywords: ASDEX Upgrade, steam event, vessel baking, safety

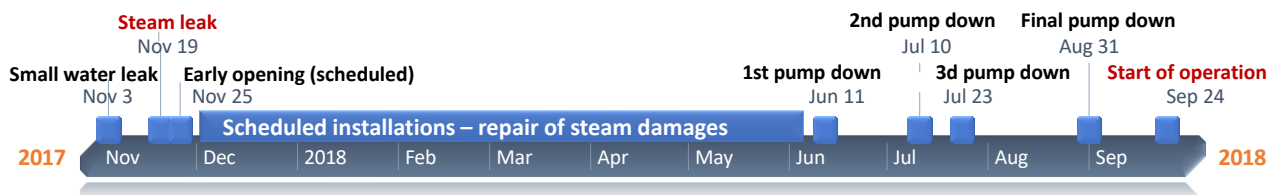
Fig. 1 Chronology of the steam event, the shutdown and restart.

The steam event happens about two months before a scheduled opening so that the damage repair and the scheduled work could be done in parallel, as indicated in Fig. 1.

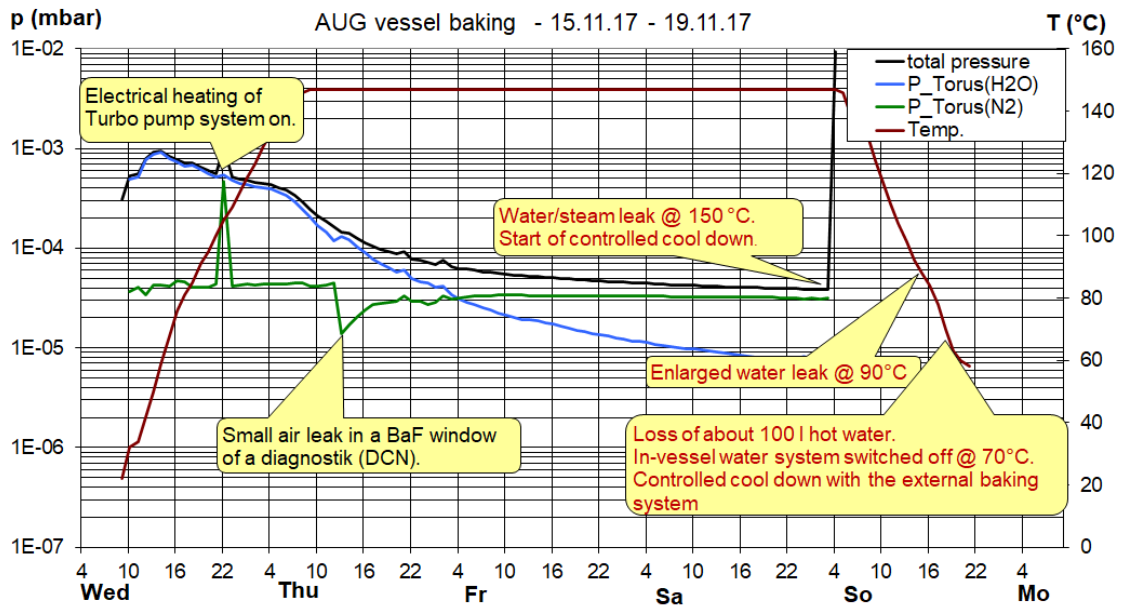
Unfortunately, during the cool down at about 90°C, the water leak was enlarged. After detecting a significant loss of water from the reservoir, the in-vessel water baking system was switched off at about 65°C. The amount of water escaped into the vessel was estimated from the loss of water from the water reservoir to about 100 l.

81 Fig. 2 Chronology of the steam event.
