Impact of H-mode plasma operation on pre-damaged tungsten divertor tiles in ASDEX Upgrade

The effect of continued plasma exposure on two divertor target tiles intentionally damaged before installation was studied for ASDEX Upgrade H-mode discharge conditions. On one tile, made of molybdenum alloy (TZM), superficial melt damage was created in the GLADIS high heat flux test facility. To measure the influence of the resulting surface corrugations on erosion, the tile surface was subsequently covered with a 20 nm tungsten marker layer. A second tile, made of tungsten, was pre-damaged by exposure to 2×10^5 consecutive ELM-like heat pulses in the electron beam test facility JUDITH, which resulted in formation of an extended crack network. Both tiles were placed at the outer divertor target of ASDEX Upgrade using the DIM-II divertor manipulator and exposed to a series of 15 identical H-mode discharges. The surface state of both tiles was documented pre- and post-exposure using electron scanning microscopy.

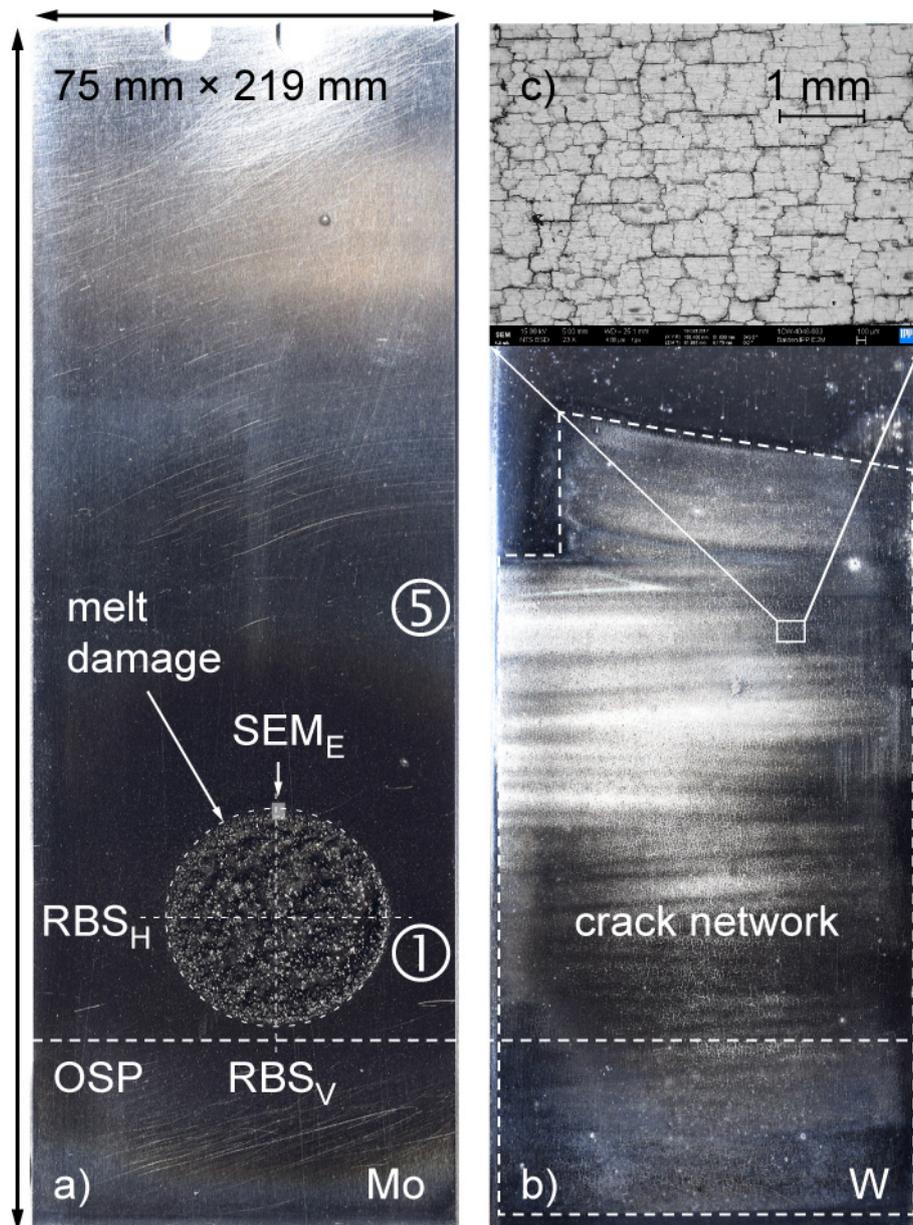
Figure 1: a) Mo tile with melt damage area and 20 nm W marker layer. Labels ① and ⑤ denote positions of corresponding spectroscopic viewing chords. Labels SEM_E , RBS_H and RBS_V indicate locations of microscopic and ion beam analysis as discussed in the text. b) Tungsten tile with crack network area indicated by dashed contour line. c) Magnified view of crack network surface. The horizontal dashed line represents the position of the outer strike point (OSP) during plasma flat-top.

$P = 22 \text{ MW / m}^2$, and exposure time, $\Delta t = 3.51 \text{ s}$, were tailored to create a shallow melt pool for a sufficiently short time to avoid significant melt motion by gravity at the vertically oriented surface (see Figure 1a). To measure the influence of the resulting surface corrugations on erosion, a tungsten marker layer with a thickness of 20 nm was subsequently deposited on the tile surface by magnetron sputtering.

A second tile, made of tungsten, was pre-damaged in the electron beam test facility JUDITH-2 [10] by exposure to 2×10^5 consecutive ELM-like heat pulses with a characteristic pulse width of $\approx 0.5 \text{ ms}$ and a peak power load of 0.55 GW/m^2 similar to what is expected for unmitigated type-I ELMs in ITER [6]. This procedure created an extended crack network within a depth range of $266 \pm 115 \mu\text{m}$ from the surface as shown in Figure 1b) and Figure 1c).

400.9 nm over discharges 3-15 of the experiment. The line emission was measured at spectroscopic line of sight ⑤, which views the tile close to the right edge at ≈ 66 mm above the outer strike point (see Figure 1a). The measurement shows that W erosion is strongly correlated to ELMs with a steady decrease of the average level over the entire series of discharges. At the other viewing chords the spectrometer was set to detect the molybdenum Mo I spectral line at 550.6 nm. In contrast to the tungsten signal this line appeared above detection limit in the fourth discharge and its average intensity increased linearly until the end of the experiment. An example is shown in Figure 3b) for the line of sight ① viewing at ≈ 16 mm above the OSP (see Figure 1a). From the opposite long term time evolution of the W and Mo spectral intensities one can infer that the initially uniform W layer is inhomogeneously eroded so that increasing fractions of the Mo bulk material underneath the W marker became exposed to the plasma. This conclusion could be confirmed by the post-exposure surface analysis, which will be discussed in section 3.

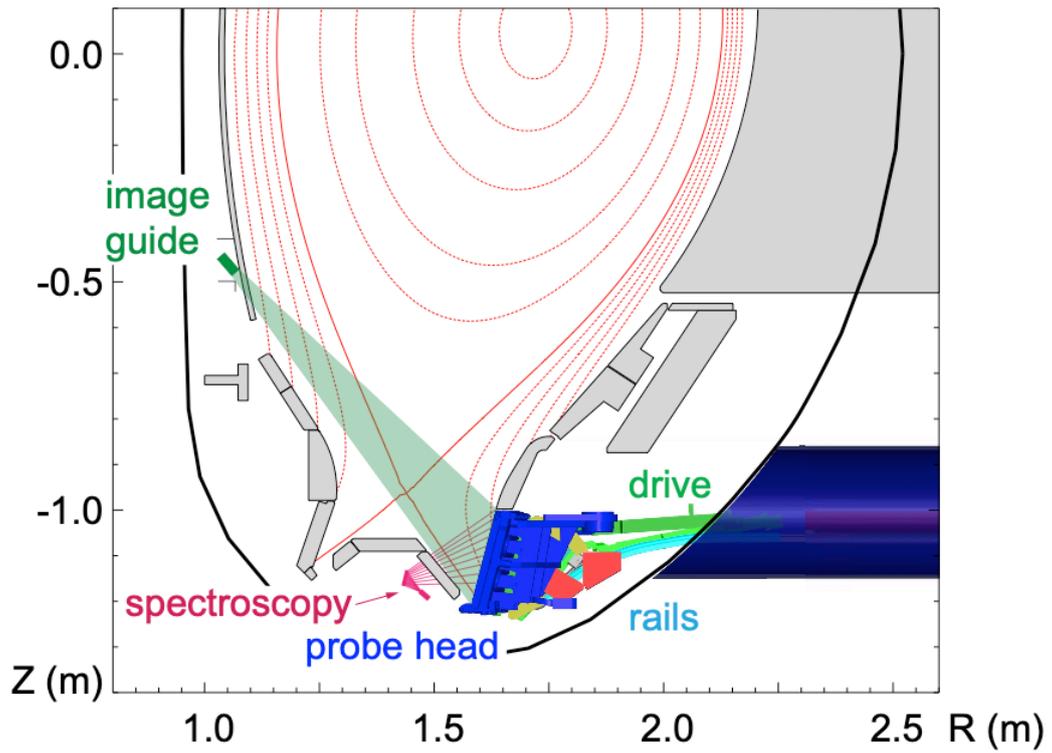
Figure 2: Cross-section of the ASDEX Upgrade vessel with the probe head of the divertor manipulator in exposure position at the outer divertor target. Also shown are the observation geometries of the local visible range spectroscopy and of the image guide optics of the near-infra-red camera. Flux surfaces are plotted for the flat-top phase of discharge 34892 at $t = 4.0$ s.

Both tiles were placed at the outer divertor target of ASDEX Upgrade using the DIM-II divertor manipulator [11] and exposed to a series of 15 identical H-mode discharges (discharge numbers 34889-901, 34904-5). Both the exposure geometry and the plasma magnetic configuration are illustrated by Figure 2, which shows a poloidal cross-section of the ASDEX Upgrade vessel in the centre of vessel sector 2 where the divertor manipulator system is installed. Basic discharge parameters were toroidal field $B_t = -2.5 \text{ T}$, plasma current $I_p = 0.8 \text{ MA}$ and average electron density of $6 \times 10^{19} \text{ m}^{-3}$. The plasma total heating power was 8 MW with 0.5 MW Ohmic heating, 5 MW delivered by neutral beam injection and 2.5 MW by electron cyclotron resonance heating. The ELM frequency in these discharges was 35 Hz with an average power loss per ELM of 50 kJ. With a total time of 90 s divertor exposure the target tiles were thus exposed to ≈ 3200 ELM transients. The outer strike point position was set to the lower edge of the melt area so that the maximum power flux would be delivered to the pre-damaged surface.

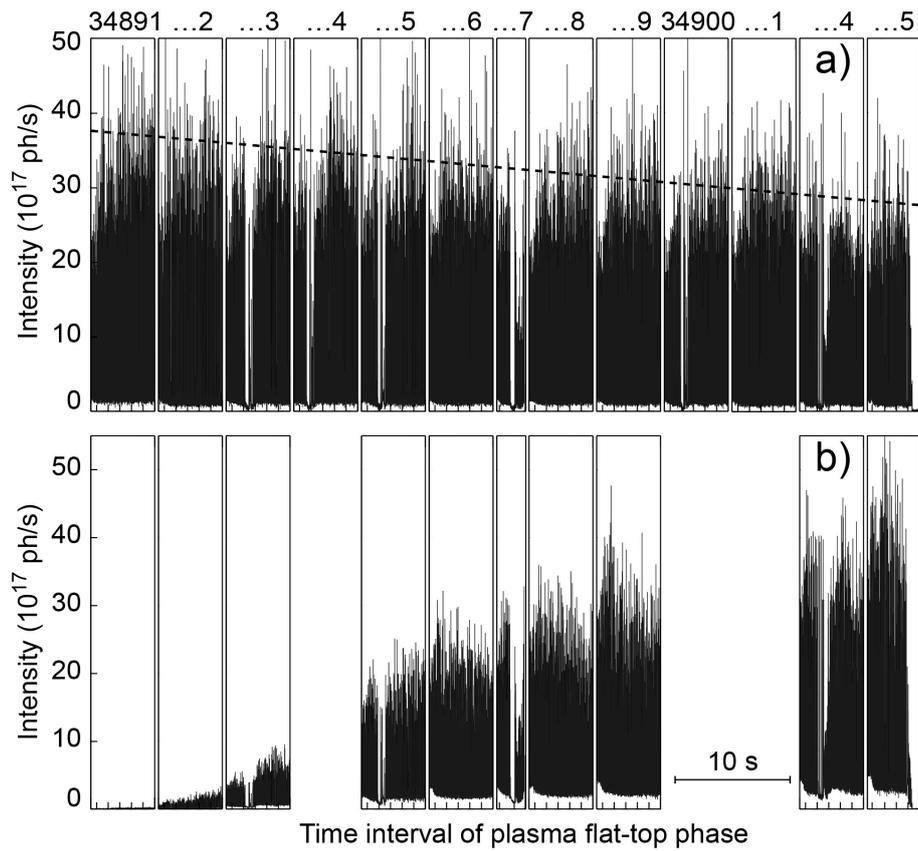
Figure 3: Time evolution of the spectral intensity of the tungsten W I emission line at 400.9 nm on the tungsten marker coating 66 mm above the outer strike point (a) and spectral intensity of the molybdenum Mo I emission line at 550.6 nm 16 mm above the outer strike point (b).

In addition to the thermal imaging, the gross erosion flux of molybdenum and tungsten at the Mo tile with tungsten marker layer was measured by spectroscopy in the visible light range. Figure 3a shows the evolution of the spectral intensity of the tungsten W I line at

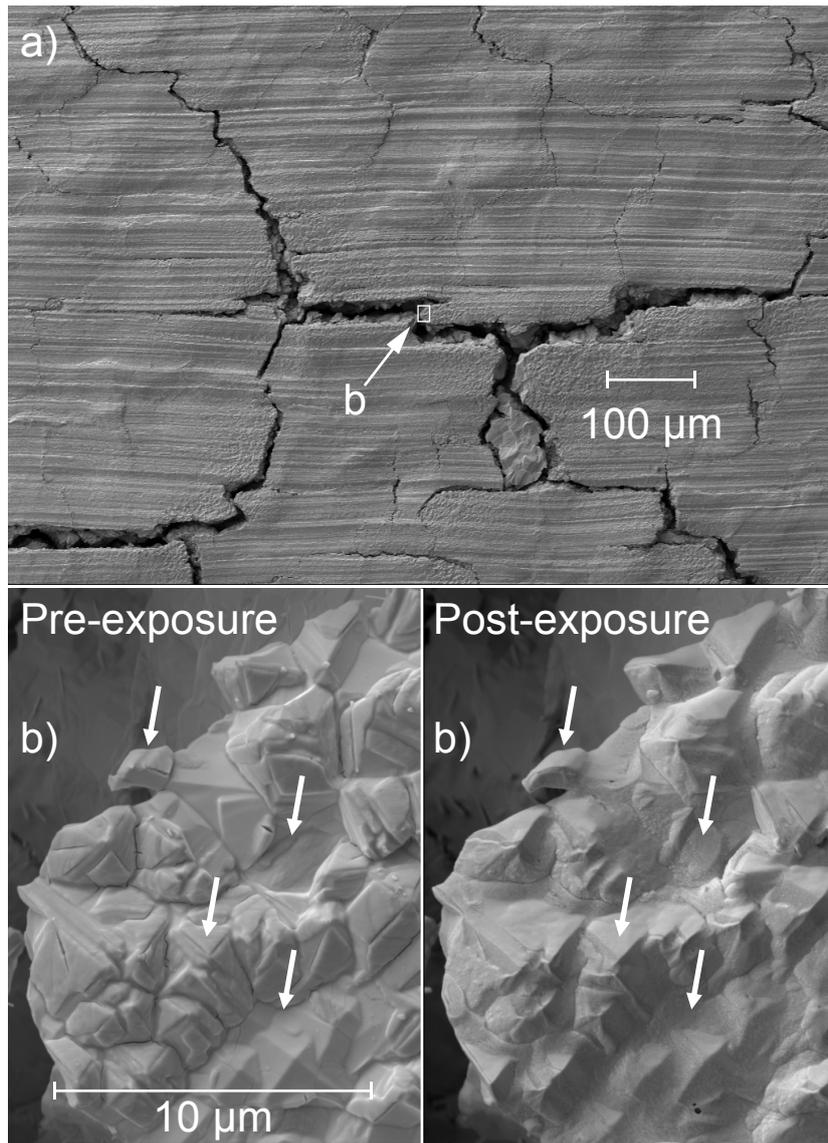
Figure 4: a) SEM image of a typical crack pattern at the tungsten tile with e-beam ELM-like loading. b) Magnified area at the edge of a crack before and after plasma exposure. The arrows in the post-exposure image denote typical erosion and deposition patterns.

SEM analysis of the crack network on the tungsten tile after the experiment did not show signs of melt damage created by the plasma exposure. There are, however, detectable modifications of the surface structure due to erosion by plasma impact and deposition of foreign material inside shadowed areas. A representative area at the edge of a surface crack (see Figure 4a) is shown in Figure 4b before and after exposure. The arrows in Figure 4b indicate surface structures where erosion and deposition respectively are clearly visible after plasma exposure although only on a microscopic scale. EDX analysis of the deposits revealed a mix of predominantly low-Z elements (boron, carbon, oxygen), which is to be expected because the throughput of migrating material is dominated by these elements, even with full

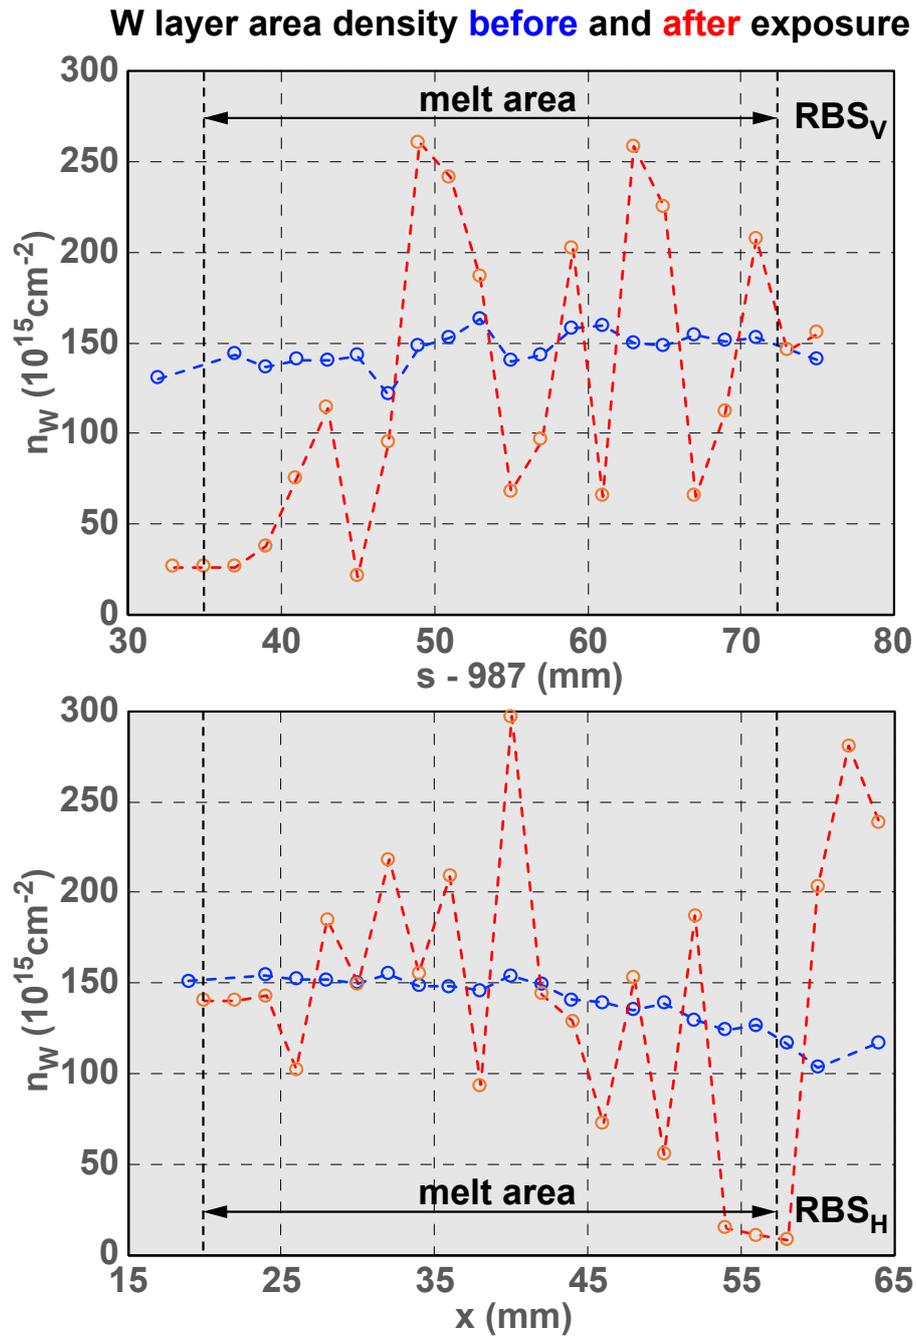
Figure 5: Thickness of W marker layer across melt zone at Mo tile measured by RBS along a line in poloidal (vertical on tile) direction (RBS_V) and a line in toroidal (horizontal on tile) direction (RBS_H).

The direct correlation of the the lateral distribution of tungsten erosion and deposition from RBS analysis with surface topography is hampered by the low spatial resolution of only ≈ 1.8 mm, given by the diameter of the 4He analysis beam spot. The observed laterally alternating net erosion and deposition zones in Figure 5 represent merely an average over variations on the smaller length scale of the surface corrugation. To overcome this limitation, the W marker on the Mo tile surface was additionally examined at these smaller length scales by EDX microscopic analysis. A typical example is shown in Figure 6, which covers an area of 3.6×5 mm^2 just at the edge of the corrugated melt pool. The location of the analysed area on the tile is shown in Figure 1a labelled as SEM_E . As the tile was installed rotated by 90° in the SEM, the vertical tile coordinate is along the horizontal axis of the images in Figure 6 and the direction of the incident plasma flux is from top to bottom, indicated by the arrow in image E1. An SEM image of the topography of the analysed area is shown in Figure 6 E1. For even more details two typical areas inside (Figure 6, M1) and outside (Figure 6, D1) the

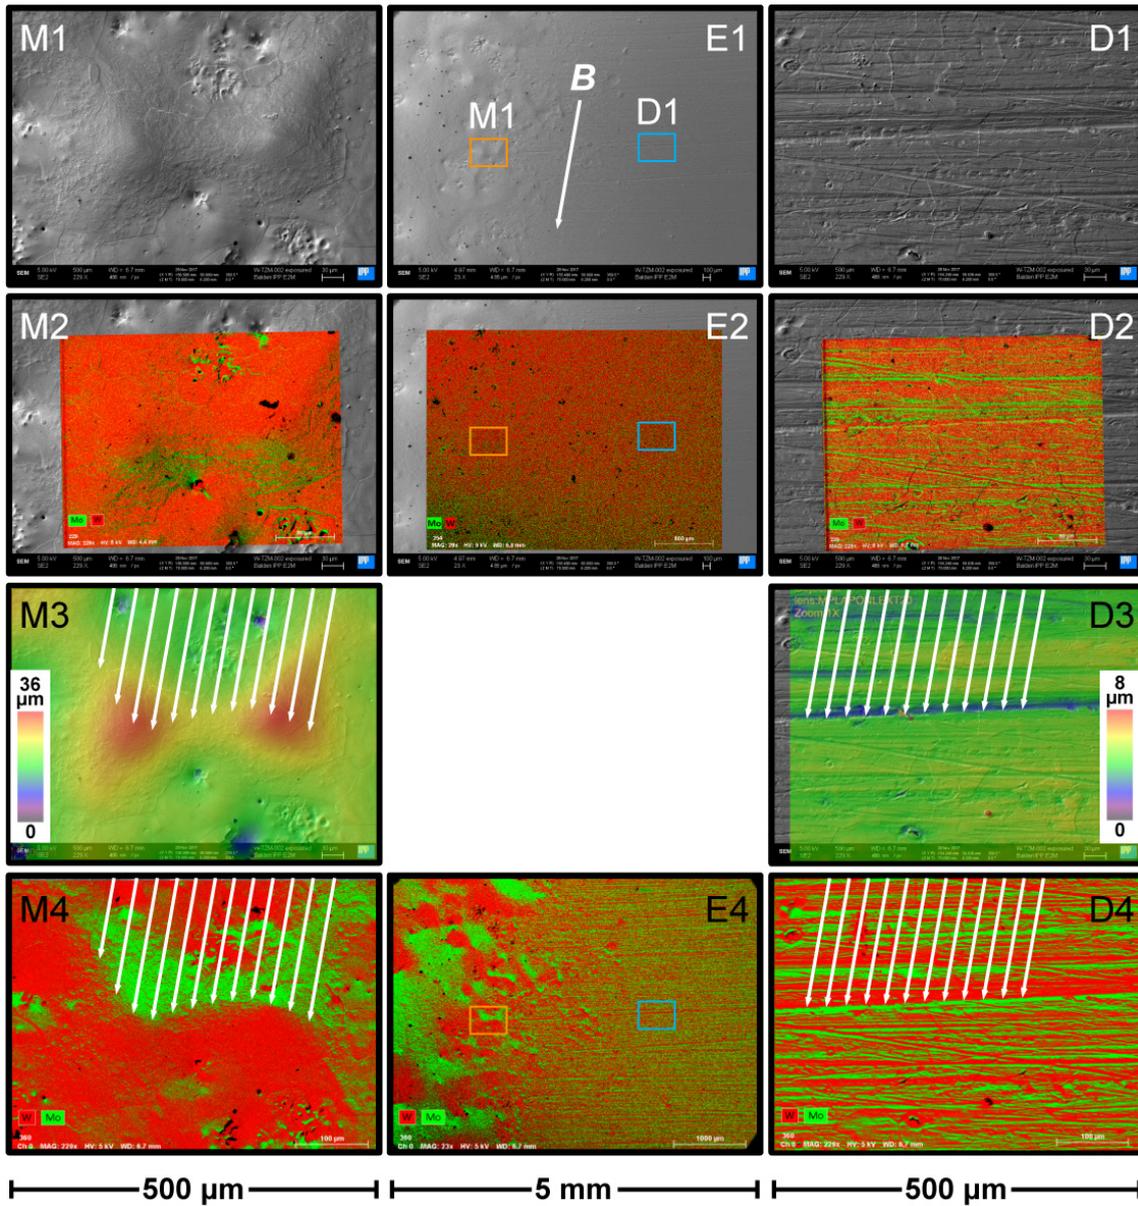
Figure 6: Surface analysis of the melt area on the Mo tile. For analysis the tile was installed in the SEM rotated by 90° to its orientation in the divertor. SEM image E1 shows a magnified view of the region with label SEM_E in Figure 1. Detailed views at ten-fold increased magnification are shown for a typical area inside the melt zone (M1) and at the default tile surface (D1). The white arrow indicates the direction of the orientation of the magnetic field and the direction of the incident plasma flux. Images E2, M2 and D2 show results of EDX analysis before exposure with pixel colours showing the respective strongest elemental concentration (red for tungsten and green for molybdenum). Images E4, M4 and D4 show corresponding results after exposure and images M3 and D3 show height maps of the respective surface areas obtained by CLSM.

The surface topography of the corrugated melt pool area created on the Mo tile in GLADIS was also studied by SEM imaging before and after exposure. As in the case of the crack network in the pre-damaged tungsten tile, comparison of the pre- and post-exposure surface did not reveal any signs of changes such as melt traces by plasma exposure. RBS analysis of the tungsten marker layer thickness showed, however, strong lateral variations with zones of both net-erosion and net-deposition of tungsten as shown in Figure 5 for a horizontal (RBS_H) and vertical (RBS_V) line across the corrugated surface. This observation suggested already a correlation of the erosion-deposition pattern with surface topography. The maximum values of both net-erosion and deposition were $\approx 10^{17}$ W at / cm^2 . Relating this value to an inter-ELM ion fluence of $\approx 10^{20}$ D^+ / cm^2 derived from Langmuir probe data, one obtains an erosion/deposition fraction of 10^{-3} . This value sets, however, only an upper limit because intra-ELM measurements of ion saturation current are not reliable due to the insufficient battery voltage of the Langmuir probe diagnostic for high T_e during ELMs. Still, the estimate is comparable to previous measurements of tungsten erosion for H-mode conditions [13, 14], with tungsten sputtering dominated by low-Z (B, C, O) impurity ions at typical plasma concentrations in the 0.1-1 percent range.
