Tungsten erosion and redeposition in the all-tungsten divertor of ASDEX Upgrade

Net erosion and deposition of tungsten in the ASDEX Upgrade divertor were determined after the 2007 campaign by using thin tungsten marker stripes. ASDEX Upgrade had full-tungsten plasma-facing components during this campaign. The inner divertor and the roof baffle were net W deposition areas with a maximum deposition of about 1×10^{18} W-atoms/cm² in the private flux region below the inner strike point. Net erosion of W was observed in the whole outer divertor, with the largest erosion close to the outer strike point. Only a small fraction of the tungsten eroded in the main chamber and in the outer divertor was found in redeposits in the inner divertor, while a large fraction was either redeposited at unidentified places in the main chamber or has formed dust.

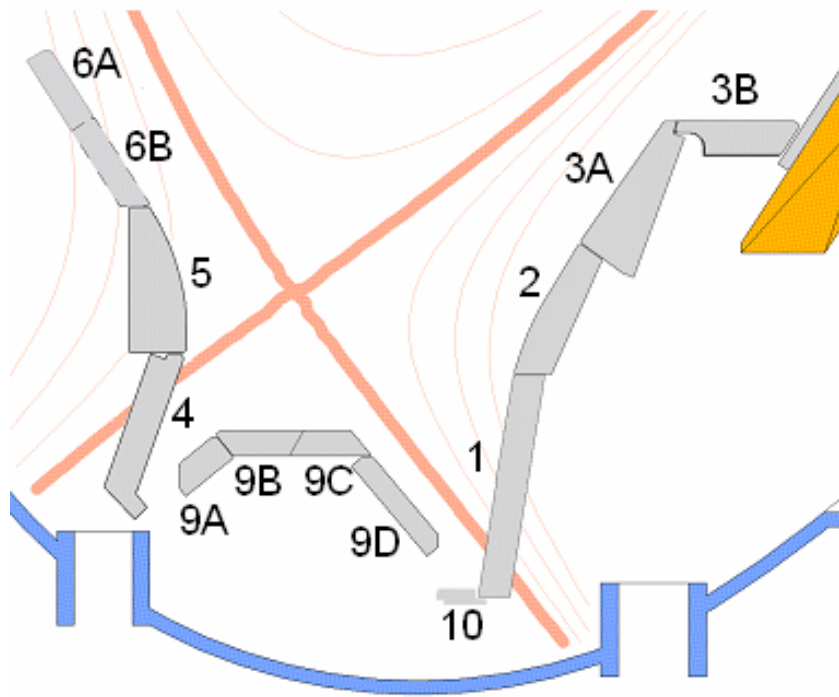
Fig. 1: Cross-sectional view of the ASDEX Upgrade divertor during the 2007 campaign. All tiles consist of PVD-W coated (3- 5 μm) graphite, except for the outer target tile (tile 1) which is VPS-W coated (200 μm) graphite.

During the 2007 campaign the divertor IIc was used, the cross-section of the divertor is shown in figure 1. The design of the divertor was slightly changed from the previous divertor IIb configuration in order to allow failsafe W cooling. All tiles consisted of W-coated fine grain graphite. The coatings were prepared by physical vapour deposition (PVD) and their thicknesses ranged from 3 to 5 μm . For the outer target (tile 1) a 200 μm thick W coating deposited by vacuum plasma spraying (VPS) was used. A detailed description of the development of W coatings for ASDEX Upgrade is available in [13,14,15].

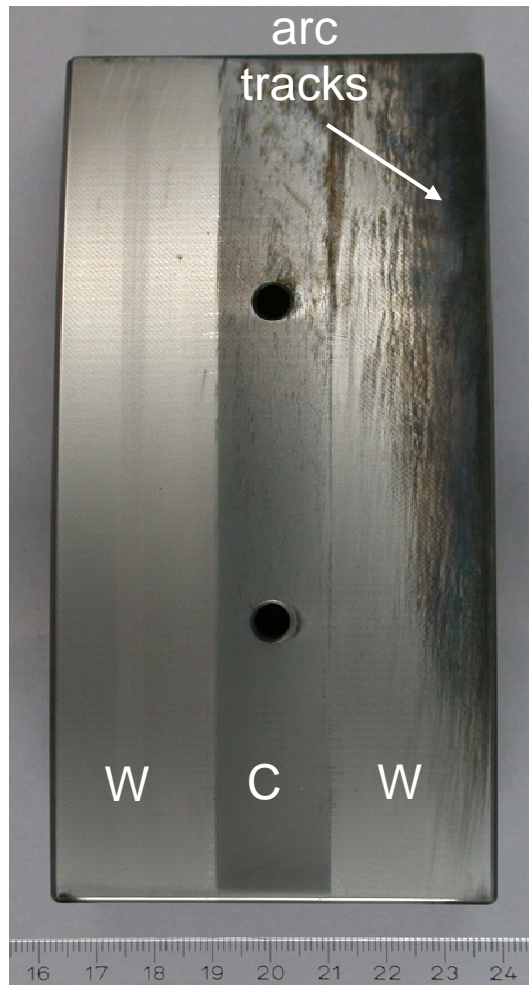
Fig. 2: Marker stripes on inner divertor tile 5 after exposure during the 2007 campaign. The markers consisted of a 300 nm thick W marker coating and an uncoated carbon area in the middle of the tile. The left hand side of the tile was plasma-shadowed, the right hand side was plasma-exposed. A large number of arc tracks was observed after exposure.

A full poloidal section of divertor tiles in sector 12 was coated with marker stripes [16]. The marker consisted of about 300 nm W on all inner divertor tiles (6A, 6B, 5, 4), all roof baffle tiles (9A, 9B, 9C, 9D), and on tile 10. Outer divertor tiles 2, 3A and 3B were coated with 500-600 nm W, and the outer strike point tile 1 had a 1.5 μm thick marker stripe. A 20 mm wide stripe remained uncoated on all tiles, i.e. consisted of the carbon substrate. This stripe was intended for measuring W redeposition. A view of tile 5 is shown in Fig. 2.

The inner divertor is a net tungsten deposition area. The largest deposition is observed on tile 4 below the strike point position in the private flux region. Tiles 6A, 6B and 5 show not only a poloidal, but also a toroidal distribution of tungsten deposition due to shadowing by neighbouring tiles. This is shown for tile 5 in Fig. 3 for the plasma-exposed and the plasma-shadowed part of the tile. This toroidal distribution was also observed in the occurrence and density of electrical arc tracks [22], see also Fig. 2. The dip in W deposition at $s \sim 210$ mm is in the area with strong arc activity (upper right hand side of the tile in Fig. 2). Tiles 6A and 6B also showed many arc tracks.

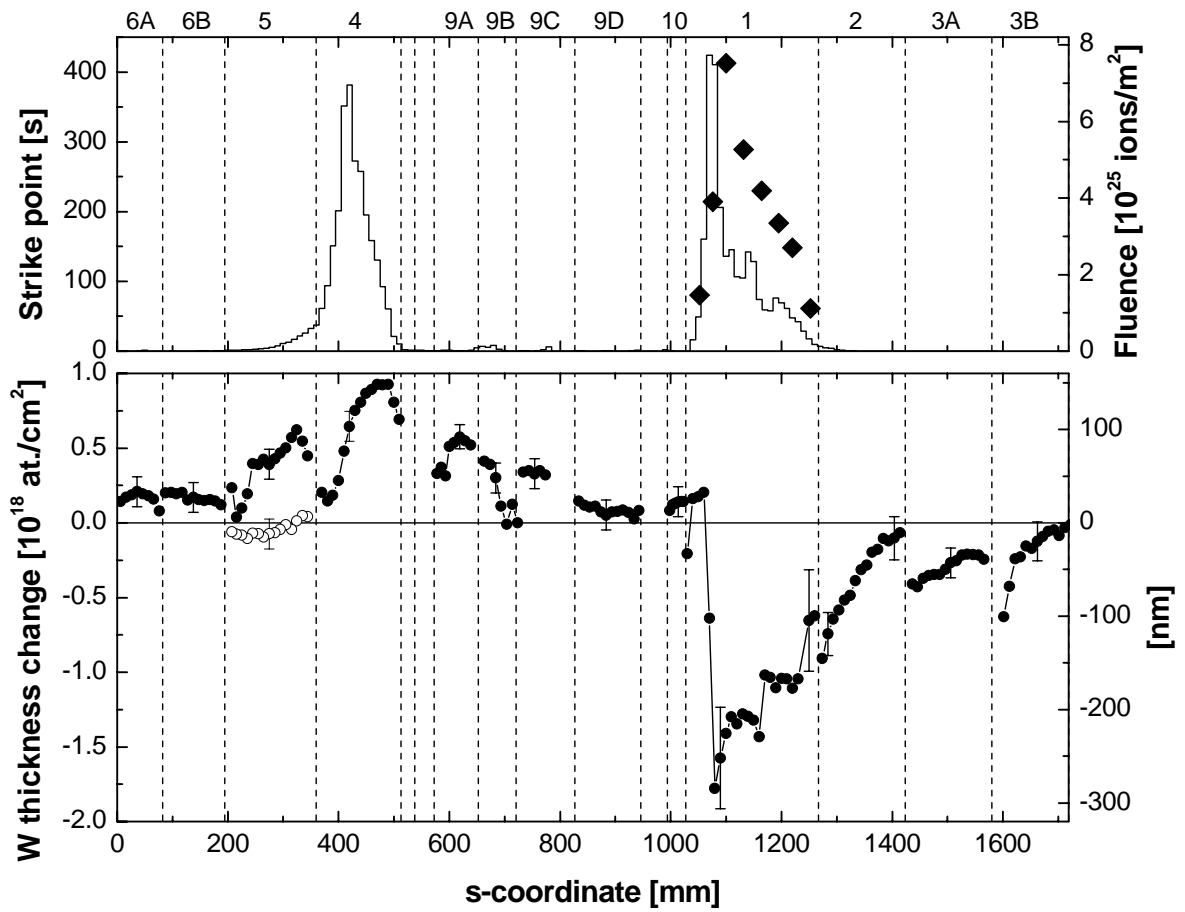
Fig. 3: Top: Distribution of strike point positions during the 2007 discharge campaign. Histogram: time of the strike point at a specific position; diamonds: Campaign-integrated ion fluence, determined by Langmuir probes. Bottom: Change of the amount of tungsten of the marker stripes on the divertor tiles, in 10^{18} atoms/cm². Negative numbers indicate net erosion, positive numbers net deposition. Typical error bars are indicated for all tiles. Two different toroidal positions are shown for tile 5: Solid dots are for the plasma exposed side which showed also many arc tracks (Fig. 2, right hand side of the tile), hollow dots are for the plasma-shadowed side of the tile (Fig. 2, left hand side of the tile). The scale on the right hand side (in nm) is obtained by using the theoretical tungsten density of 19.29 g/cm³. Tile numbers (see Fig. 1 for the detailed divertor geometry) are indicated at the top.

The positions of the inner and outer strike points are shown in Fig. 3 (top). The time histogram of strike point positions was derived from the magnetic reconstruction. The inner strike point was mostly on tile 4, with very few discharges having the strike point on tile 5 or 9B. The outer strike point was always on tile 1. The diamonds show the integrated ion fluence to the outer strike point tile 1, as derived from Langmuir probe data.

The change of the amount of tungsten on the marker stripes (i.e. net erosion/deposition) is shown in Fig. 3 (bottom). The amounts of W before and after exposure were determined with an accuracy of about 3%. Because the change of the amount of W is the difference between these numbers and the change can be small compared to the initial amount of W, the error for determining the change of the amount of W can get large. Typical error bars are shown in Fig. 3 for all tiles. Tile 1 has larger absolute error bars than other tiles because the marker stripe on this tile was thicker.

The roof baffle (tiles 9) is also a net re-deposition area for W, mainly on tiles 9A, 9B and 9C. Tile 9B showed a large number of arc tracks, which are probably responsible for the dip in the W deposition at $s \sim 710$ mm.

Almost the whole outer divertor is a net W erosion area. The largest erosion is observed at the outer strike point tile 1, where also the largest ion fluxes were observed. However, the adjacent tile 2 also shows a remarkable erosion. The maximum W erosion at the outer strike point is about 7×10^{14} W-atoms/cm²s = 0.1 nm/s. This is comparable to the observed erosion of W markers in the carbon divertor during the 2004-2005 operational phase, which was >0.06 nm/s [3]. The lowest few cm of tile 1 (close to the corner with tile 10) show a small

The net W erosion/deposition pattern shown in Fig. 3 can be integrated in order to achieve global numbers for W erosion/deposition. All numbers are normalized to a “standard” discharge campaign of 3000 s.

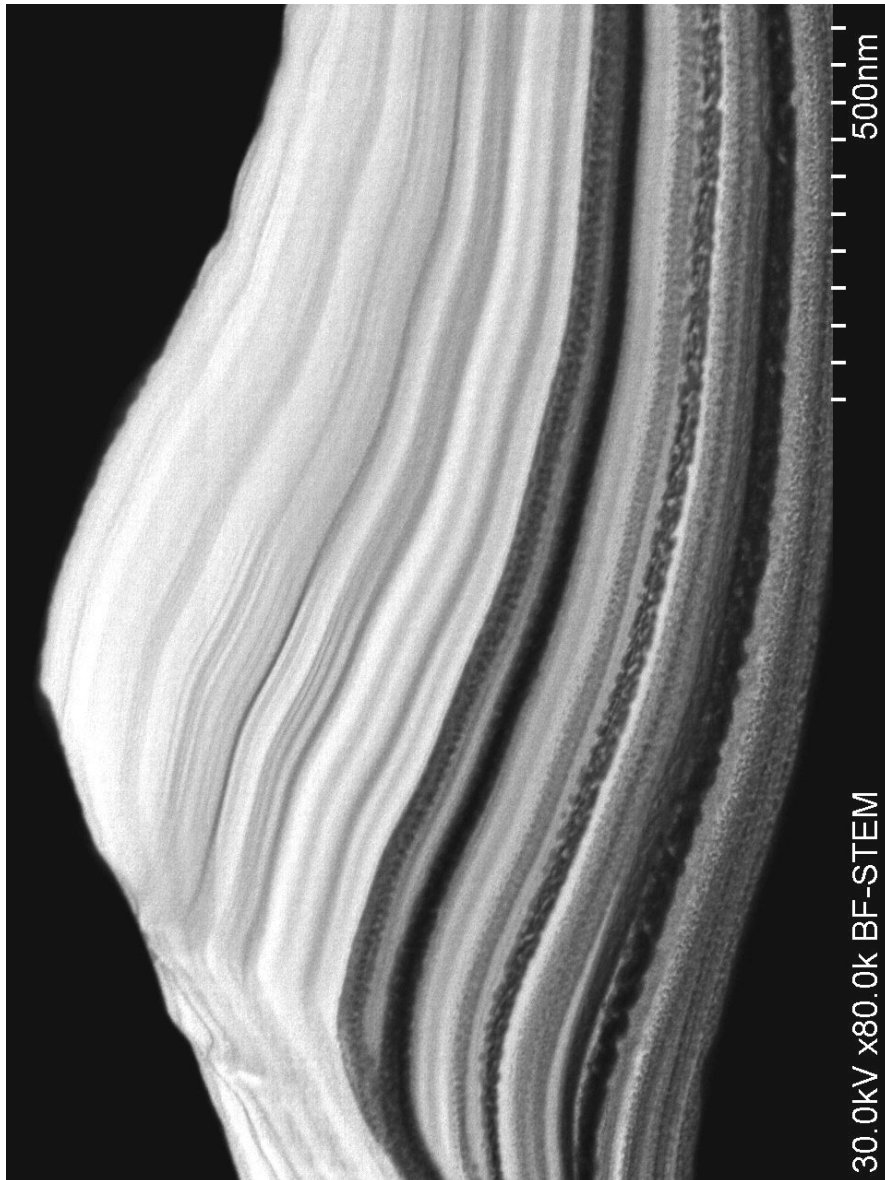
Fig. 4: Transmission electron micrograph from a redeposited layer on tile 4, s~510 mm. Low-Z elements (mainly carbon) appear bright, high-Z elements (mainly W) appear dark. The original W coating of the tile is on the left hand side. It is not transparent for the electrons, so that it appears black. The surface of the redeposited layer (on the right-hand side) was coated with a protective W coating and therefore also appears black.

A transmission electron micrograph of the lower corner of tile 4 (at $s \sim 510$ mm) is shown in Fig. 4. This area is exceptional, because it is the only area in the divertor with still remaining re-deposition of carbon [4]. The re-deposited layer has a stratified structure with a thickness of 500-700 nm. The bottommost layers were deposited at the beginning of the discharge campaign and appear bright, i.e. they have a smaller absorption for transmitted electrons and consist mainly of low-Z elements. As could be shown by SIMS measurements (see Fig. 5), and nuclear reaction analysis (NRA) [4] the low-Z elements are mainly carbon and deuterium, with some intermixed W. The top layers were deposited at the end of the discharge campaign and appear darker due to higher electron absorption. They therefore contain a higher concentration of W than the layers deposited at the beginning of the campaign.

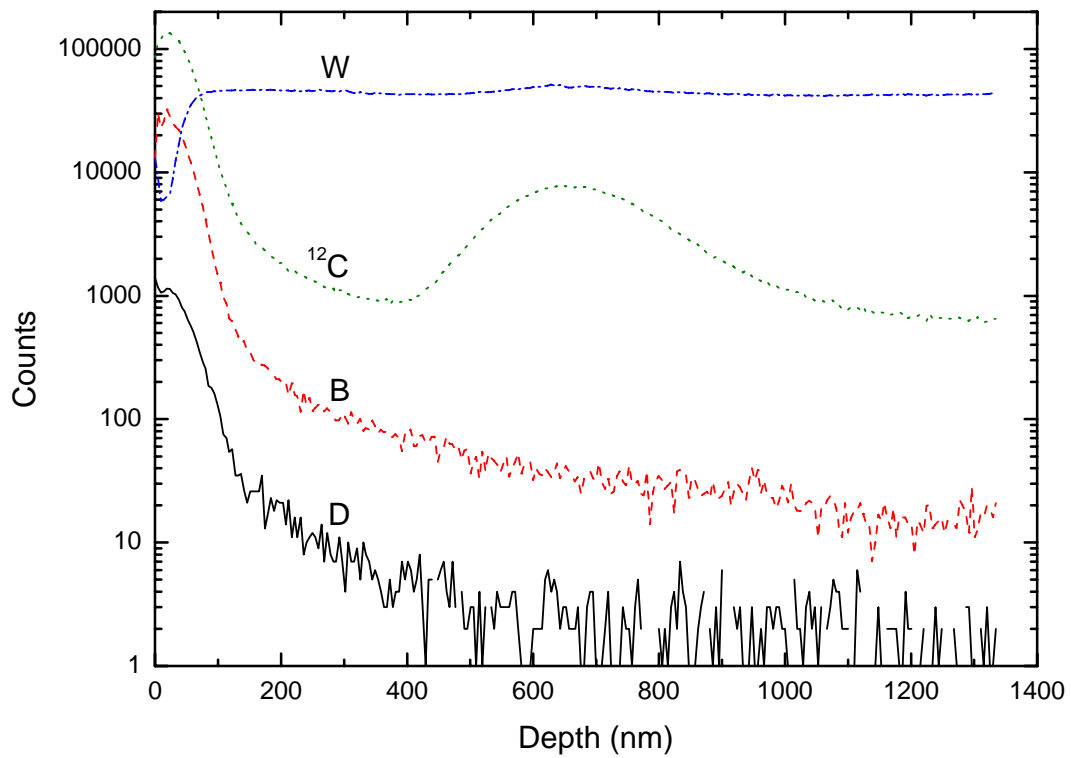
Fig. 5: SIMS depth profiles of D, B, ¹²C and W from tile 4B (the small “nose” on tile 4, see Fig. 1), $s = 528$ mm. The profile is from a regular PVD W coating with a thickness of more than $3 \mu\text{m}$ W.

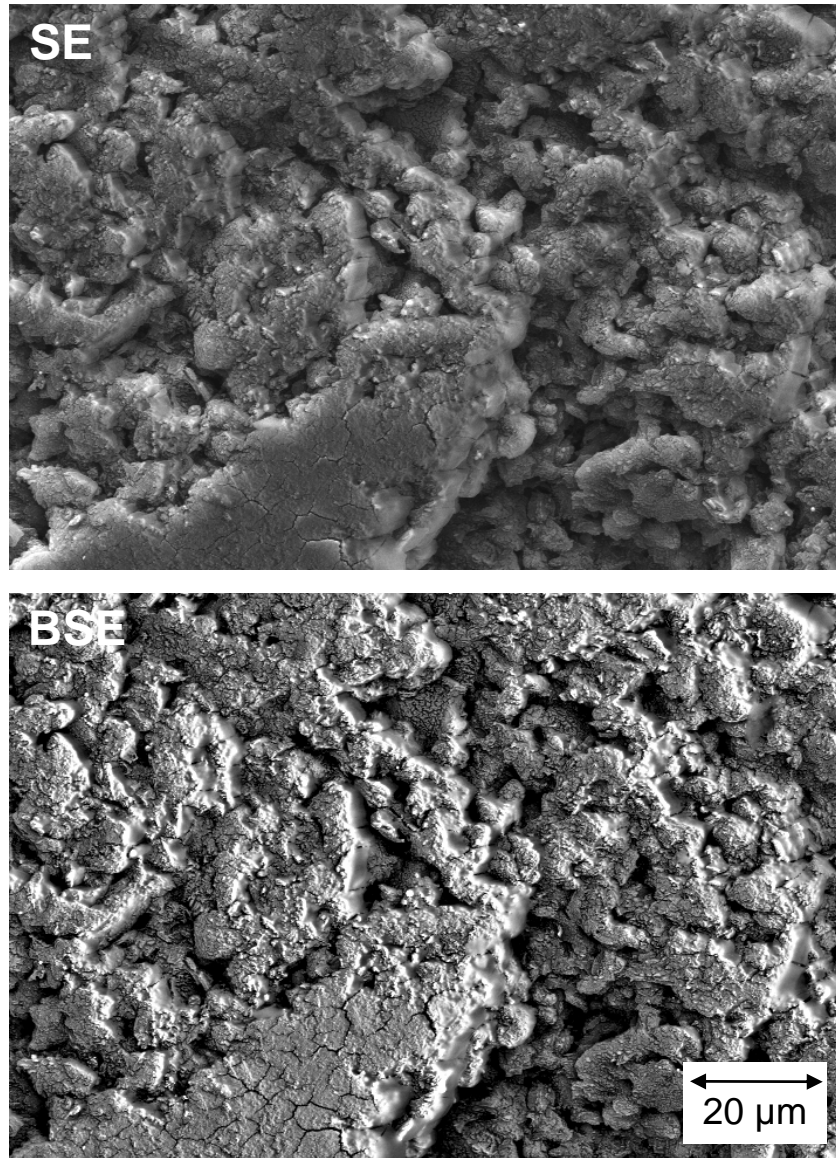
Fig. 6: Scanning electron micrographs of the surface of tile 6A, s~40 mm, after exposure. The area was initially uncoated carbon. Top: Secondary electrons (SE); bottom: backscattered electrons (BSE). High-Z elements appear bright in the BSE image.

Scanning electron micrographs of the surface of tile 6A are shown in Fig. 6. The shown area was initially uncoated and consisted of fine-grain graphite. After exposure the whole area is more or less evenly coated with W with a thickness of 25-30 nm ($1.5-2 \times 10^{17}$ at./cm²), see Fig. 3.

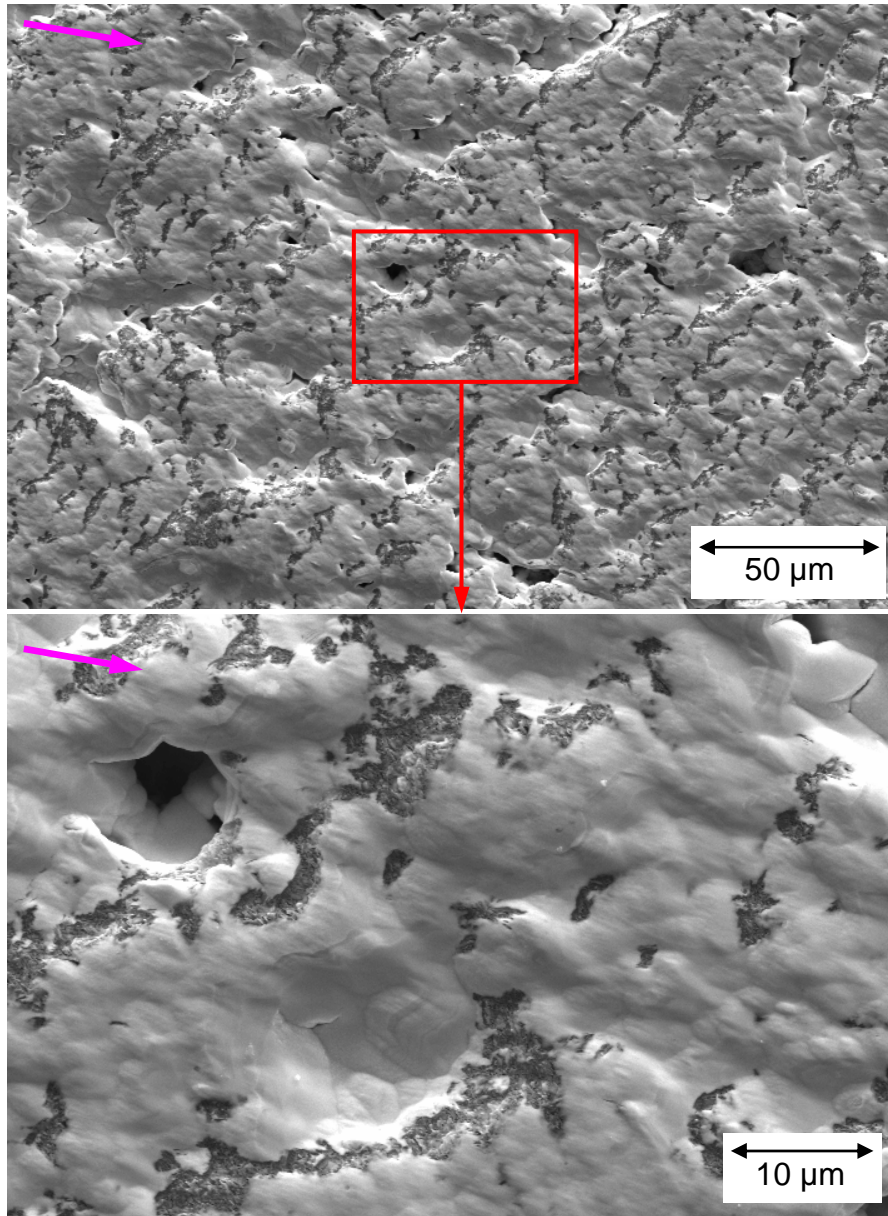
Fig. 7: Scanning electron micrographs of the marker layer after exposure, at two different magnifications. The marker layer is from the strongest erosion area on tile 1, s~1100 mm. The initial marker thickness was about 1500 nm, the mean erosion was about 250 nm. The arrows in the upper left corner indicates the direction of the magnetic field.

Scanning electron micrographs from the outer divertor area with the highest W erosion are shown in Fig. 7. The initial marker thickness was 1500 nm, and the mean erosion in this area was about 250 nm. The marker was fully eroded and the underlying carbon substrate was exposed at the leading surfaces of the microscopically rough surface, while the W layer still covered the carbon substrate at shadowed surfaces ('leading' and 'shadowed' surfaces are relative to the magnetic field). This indicates a very inhomogeneous erosion of the W marker, with a maximum erosion at plasma exposed areas which is more than 5 times larger than the mean erosion of the layer. Such an inhomogeneous erosion was already observed at tungsten marker layers in the outer divertor of JET [23], and in previous campaigns with marker layers in the outer divertor of ASDEX Upgrade [3]. This inhomogeneous erosion is difficult to understand, because the Larmor radius of both impurity and deuterium ions is larger than 100 μm : This is much larger than the surface roughness of a few μm , so that for the gyrating ions the surface should appear almost smooth. A possible explanation would be erosion by fast neutral particles, which don't have a gyro-motion. As was already shown in [6], the

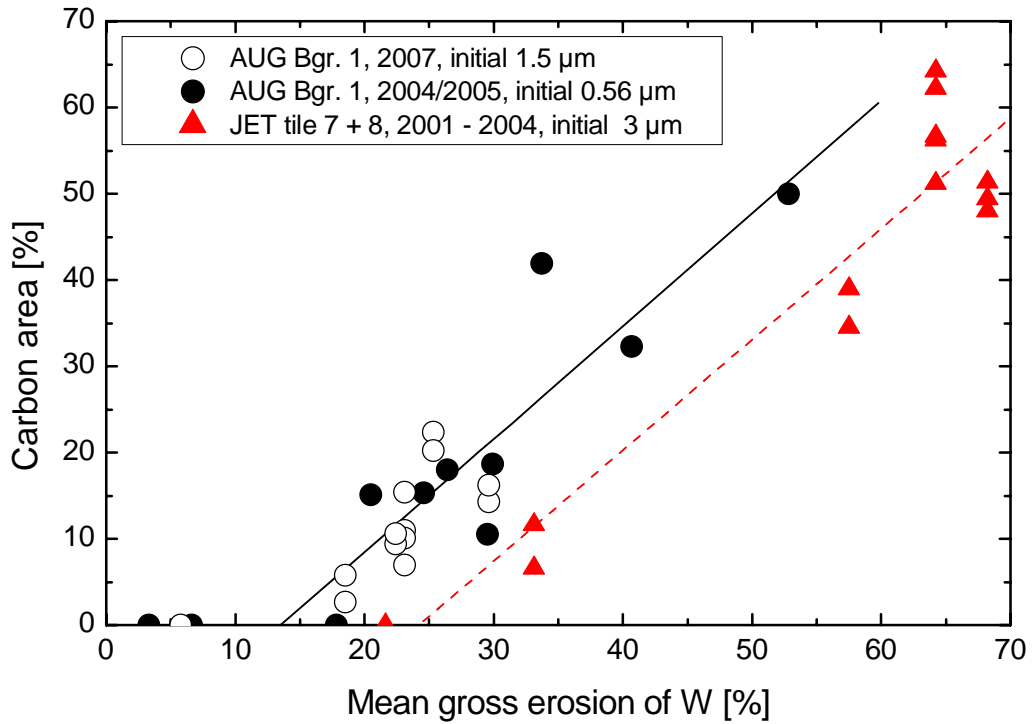
Fig. 8: Percentage of the surface area with full tungsten erosion and exposure of the underlying carbon substrate versus the mean gross erosion of W as fraction of the initial coating thickness. JET-data were obtained in the 2001 – 2004 campaign on outer strike point tiles 7 and 8 with an initial marker thickness of 3 μm W on CFC [23], AUG data were obtained with a marker in the 2004/2005 campaign with an initial thickness of 560 nm W [3] and with the current marker stripes.

The percentage of the surface area with full tungsten erosion and exposure of the underlying carbon substrate versus the mean erosion of W as fraction of the initial marker coating thickness is shown in Fig. 8 for W marker stripes from the outer strike point tile of JET [23] and ASDEX Upgrade. The ASDEX Upgrade data points were obtained at different poloidal positions of tile 1. The surface is still fully covered with W if the mean W gross erosion is smaller than 10-20% of the initial coating thickness. If the mean W gross erosion exceeds 10-20% of the initial coating thickness, then on some fraction of the surface full erosion of the W coating is observed. This fraction increases approximately linearly with the mean erosion. If about 50% of the initial W coating thickness has been eroded, then on about 40-50% of the surface area the coating is missing and the underlying carbon is exposed. The initial thickness of the W marker therefore must be at least 5 to 10 times larger than the mean gross W erosion in order to prevent total erosion of the marker on microscopic leading surfaces. For thinner layers the W marker will be fully eroded and the carbon substrate will be uncovered on some fraction of the surface. This inhomogeneous erosion therefore imposes a minimum coating thickness, if exposure of the underlying carbon substrate should be avoided. The initial coating thickness of the outer strike point tile 1 at ASDEX Upgrade is 200 μm , which is thick enough to avoid carbon exposure even after several discharge campaigns.
