Recent results of the cold tests performed on the stellarator W7-X coils

J. Baldzuhn, H. Ehmler, A. Hoelting, C. Sborchia, K. Hertel, L. Genini¹, T. Schild¹
Max-Planck Institut fuer Plasmaphysik IPP, EURATOM Association,
17491 Greifswald, Germany
(1) CEA/DSM/DAPNIA, Centre de Saclay, 91191 Gif-sur-Yvette, France

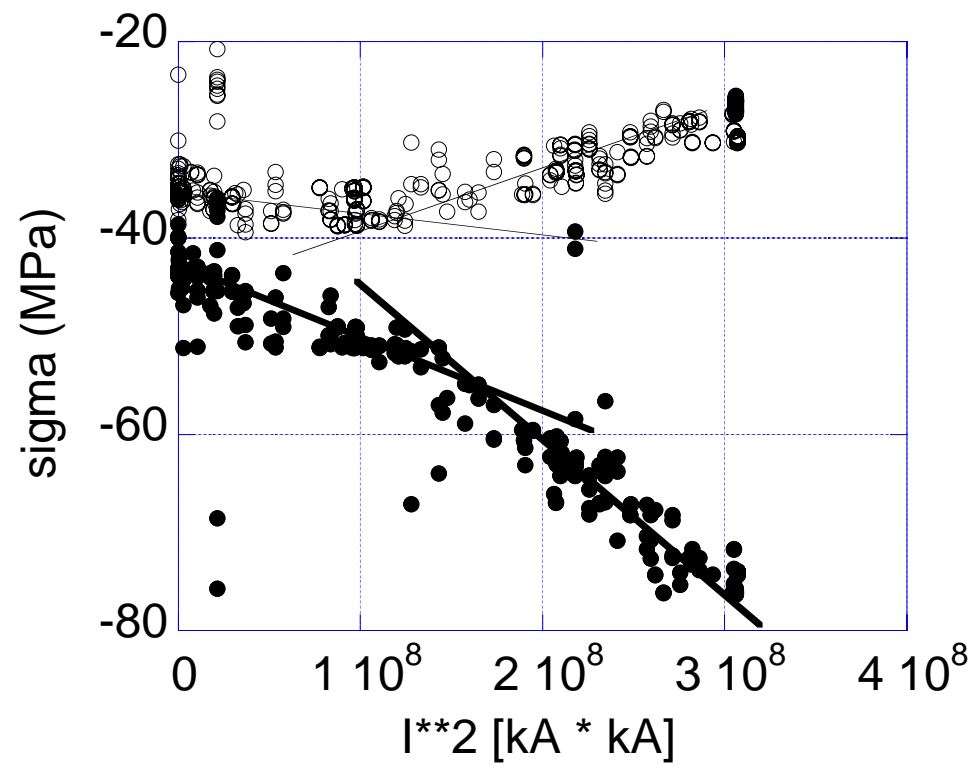
Fig 1: Principal stresses (σ) versus the squared coil current I^2 . The first principal stress is shown as dots, the second as circles. The solid lines show linear fits to the measured data.

The fig. 1 shows, as an example, the measured principal stresses versus the coil current I^2 . Obviously, it is not possible to fit the entire curves to one linear function. Much more, the slope of the curves changes at $I \approx 11$ kA, possibly indicating a re-organisation of the confining forces on the winding pack at this current value.

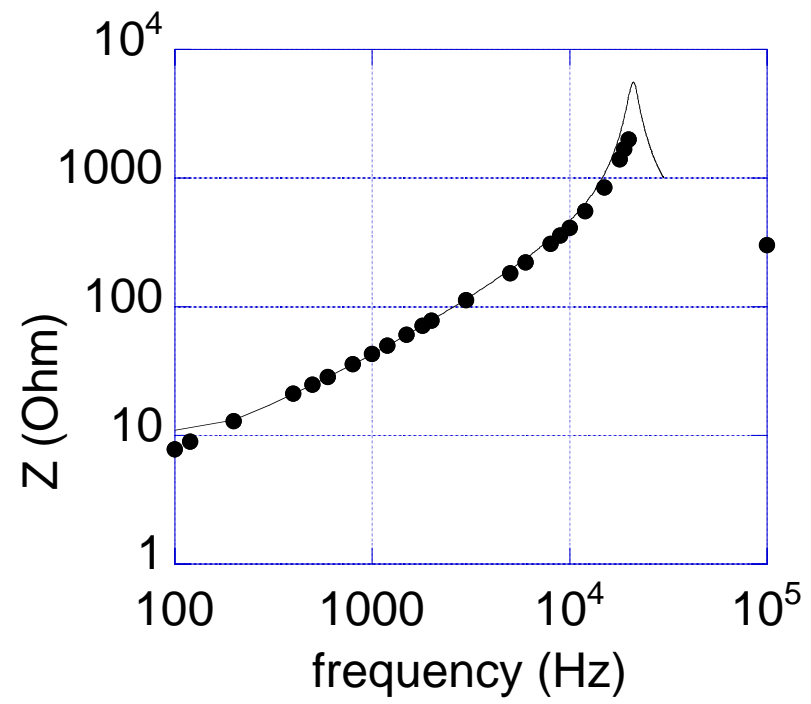
Fig 2: Measured (dots) and calculated (solid line) absolute value of the complex impedance Z versus frequency.

During the ac high-voltage tests of the coils, in parallel the complex impedance of the winding pack is evaluated as a function of the applied current frequency. The impedance is determined by a stray capacity between winding and casing in the range of several 10 nF, and by the fact that any current change in the winding pack will induce a current in the casing. Thus, the coils act as transformers with one secondary winding. To understand better the electric behaviour of this RLC network, analytical and numerical models of the coils are developed and compared to the measurements. This is of particular interest, if possible short-circuits inside the winding pack are searched. It was found, both by measurement and calculation, that the coil impedance changes strongly if a short-circuit is present. In particular, a pronounced resonance frequency at about 20 kHz (for the non-planar coils) is predicted and measured. The value of that resonance frequency changes strongly in the case of a short-circuit. However, the sensitivity of that method is rather limited for the case, that no "hard" short-circuit exists, but only an inter-winding current leak at higher electrical resistance. Fig. 2 shows the comparison of the measured and calculated absolute value of the complex impedance Z for the non-planar coils. Very good agreement is given for frequencies below 20 kHz, as well as for the location of the resonance frequency.

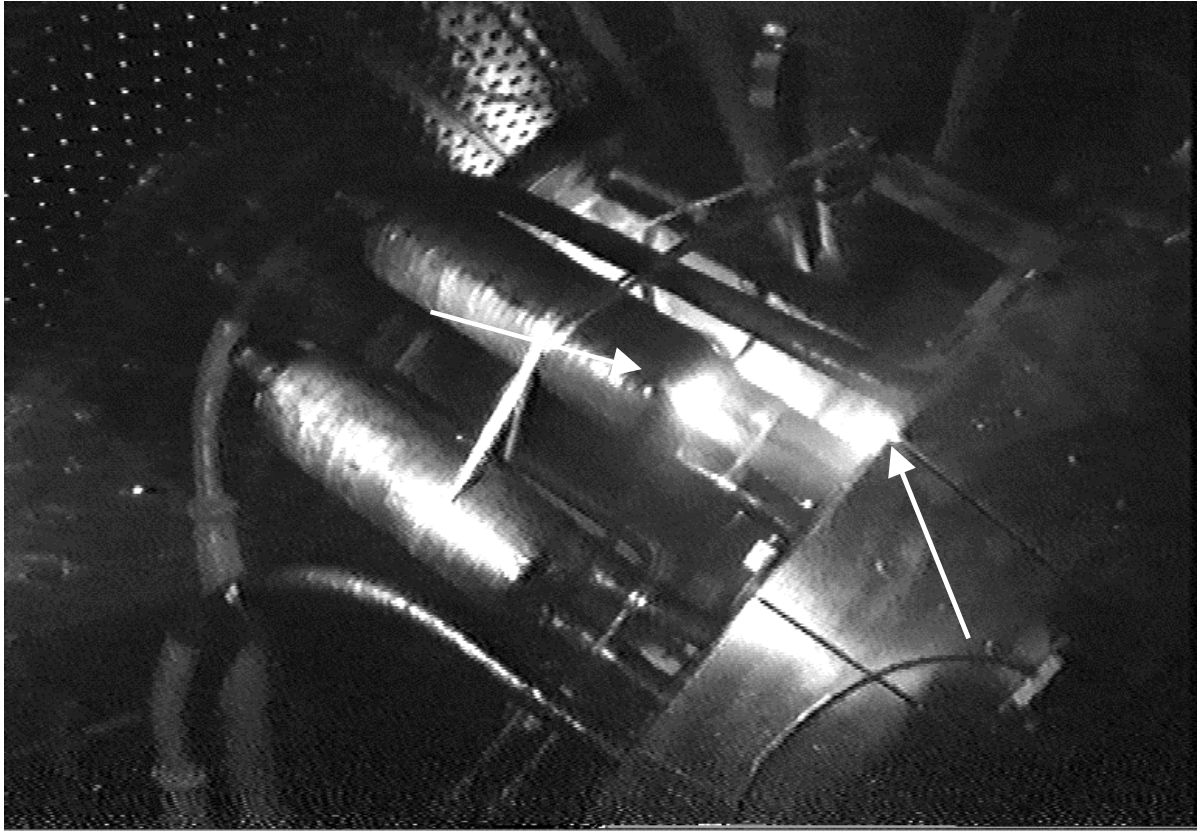
Fig 3: Photograph of a discharge during an unsuccessful Paschen-test. The arrows indicate the start and end of the discharge.

To investigate the high-voltage proof of the coil insulation under any background pressure conditions, Paschen-tests are performed. Those tests are presently done at CEA, but preparing Paschen-tests are also performed by the coil manufacturers, and in the future they will be performed directly before coil installation at IPP. By now, it turned out that the perfect surface insulation of the coils is very difficult to maintain. In particular the epoxy sleeves around the interlayer joints suffer from Paschen defects during the tests. This can be explained by the fact that they are hand-made, and a perfect covering of the complicated shape of the joints is difficult to realise. Vacuum impregnated epoxy sleeves, as they are also applied to the coils, normally do not suffer from those defects. In order to improve that situation, additional formed parts were developed which are attached to the joints. Thus, the hazard of discharges close to the Paschen-minimum could strongly be reduced. Fig. 3 shows a photograph taken during a Paschen-test on a planar coil. Shown are two interlayer joints, with a discharge between the right-hand joint to the coil casing.

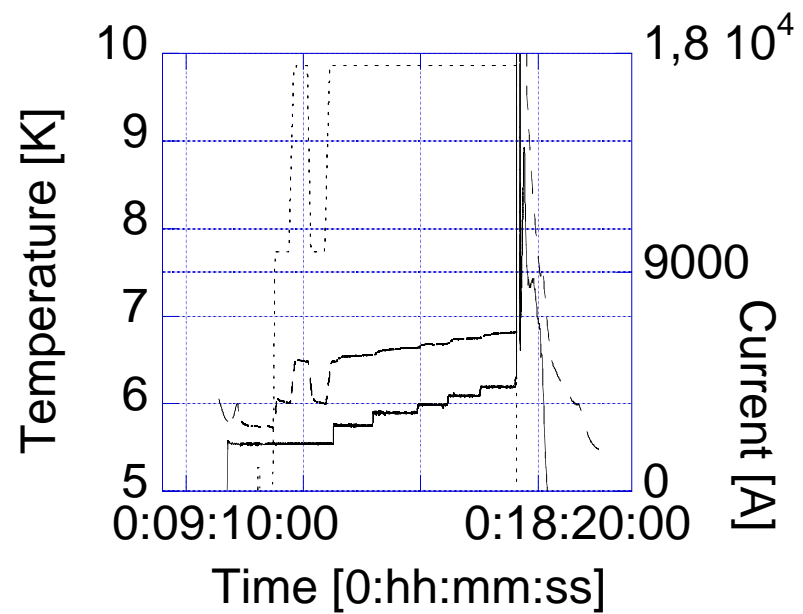
Fig 4: Time traces of the coil current (dotted line, right y-axis), the helium inlet temperature (solid line, left y-axis) and the helium outlet temperature (dashed line, left y-axis) versus time. The experiment start at 9:00 am. and ends with a quench at 18:20 pm.

Fig. 4 shows some measured time traces during a time interval of about 12 hours for such a quench test. The inlet helium temperature (solid line) is increased in small steps until a quench is reached (at about 18:00 h). The outlet temperature (dashed line) increases synchronically, always being about 0.6 K higher than the inlet temperature. This results from the heat load from the coil and the resistive heat from the electrical joints. The current (dotted line) is first ramped up and down several times to test the stability of the arrangement, and remains then at 17.6 kA until the quench is reached.

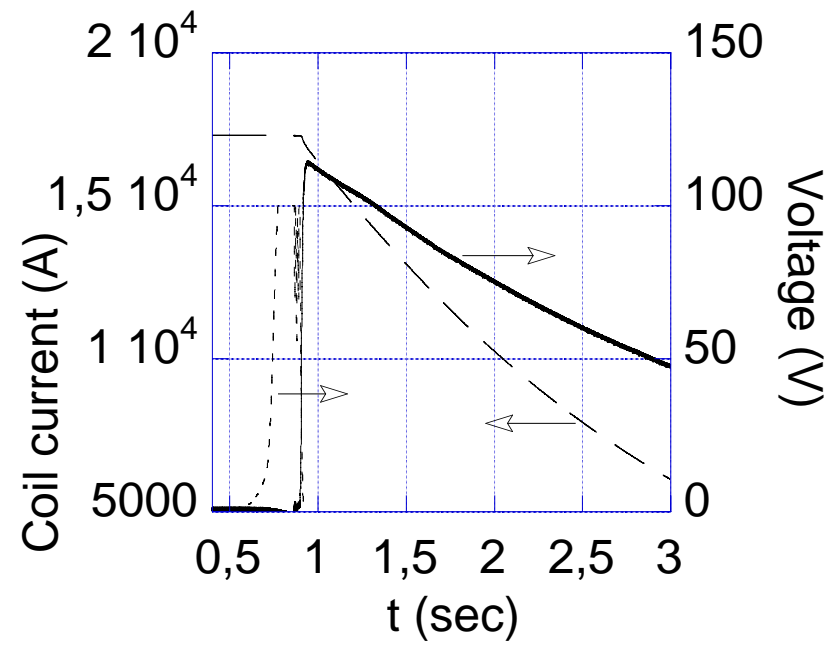
Fig 5: Time traces of the coil current (dashed line, left y-axis), total voltage drop across one coil layer (solid line, right y-axis), and compensated voltage (dotted line, right y-axis, voltage multiplied by 100) versus time. The quench is initiated at about 0.5 s, the quench alarm system triggers the current switches at about 0.7 s, the current decay starts at about 0.9 s.

Fig. 5 shows some measured time traces during a time interval of about 3 seconds directly before and after a quench. The quench occurs at about 0.9 s. The compensated resistive voltage (dotted line) starts to increase at ≈ 0.55 s, indicating the initiation of the quench. At ≈ 0.7 s the total resistive voltage drop reaches 500 mV and triggers the quench alarm threshold. After a time delay of about 150 ms, the high current switches are activated. They start the current ramp-down (dashed line) with an average time constant of 2.2 s. Simultaneously to the current ramp-down, the induced coil voltage (over one layer) reaches a maximum value of about 110 Volt (solid line) at the beginning and decays then exponentially, too. The typical induced voltage drops over the entire coil are about 400 V in the test facility. As expected, all quenches observed so far were initiated on the high-field side layers of the coils.
