Deposition of impurity metals during campaigns with the JET ITER-like Wall

Abstract

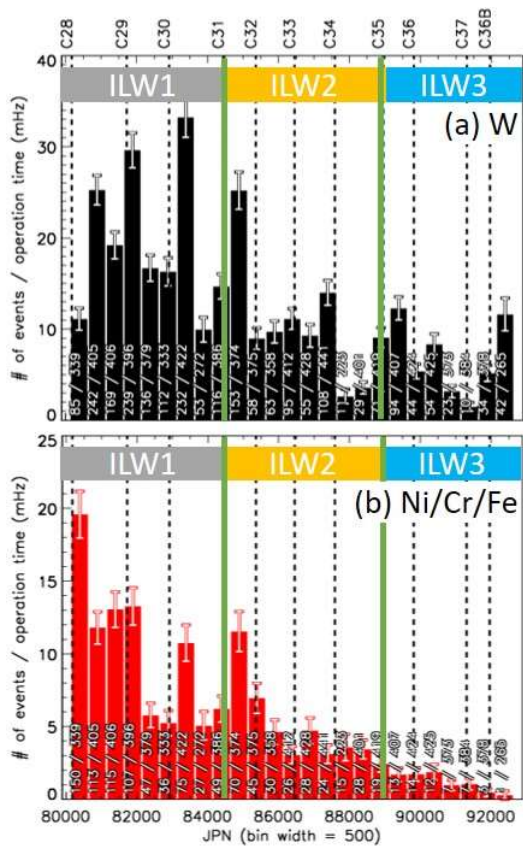
Figure 6: Transient impurity events for ILW1, ILW2 and ILW3 for (a) tungsten and (b) nickel, chromium iron particles. For each bar the number of TIEs for the given element(s) and total number of TIEs per 500 pulse bin width are shown.

Another metric for analysis of impurities is to consider transient impurity events (TIE), i.e., excursions in optical spectroscopy signals due to particles entering the plasma. The number of TIEs for W and Ni/Cr/Fe are plotted for characteristic spectral lines for each category against the pulse number during each campaign, as described in [21] and shown in Figure 6. It is clear that there is a steady decline in the average number of events from ILW1 to ILW2 to ILW3. There is also a peak in the early discharges for the ILW1 and ILW2

Figure 6: Transient impurity events for ILW1, ILW2 and ILW3 for (a) tungsten and (b) nickel, chromium iron particles. For each bar the number of TIEs for the given element(s) and total number of TIEs per 500 pulse bin width are shown.

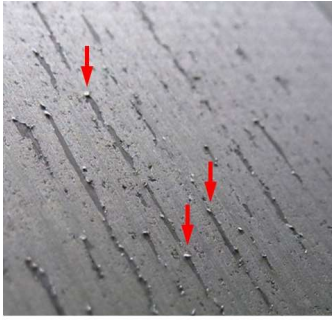
Figure 7: Photograph showing delamination of W coating on outer divertor tile.

Delaminations run along the direction of CFC laminations. Delaminated material tends to form into spheres at the edges of the delaminated region. Some examples are indicated by red arrows.

W coatings were also found to undergo cracking and delamination due to expansion mis-match in one direction between the coating and substrate as a result of rapid thermal cycling due to plasma interaction (which can be between 200° and 1000°C). This was particularly evident for divertor Tile 6s and Tile7s during ILW1 and ILW2 where some tiles were prone to coating failure due to a process issue for a specific coating batch. Therefore, between ILW2 and ILW3 operations some of these tiles were replaced. In total six out of forty-eight Tile 7s and twelve out of ninety-six Tile 6s were replaced, of which a total of eight removed were from the defective batch. Other reasons for replacements were due to cracking of tiles, large molten splats, design modifications or retrieval for *post mortem* analysis. Analysis of W TIEs suggests that the source is 10^{21} W atoms [21] whereas an estimate of cracking/delamination area from divertor PFCs could yield up to 10^{23} W atoms. This suggests that only a small percentage of particles travel to the plasma. There is evidence that suggests thermal cracking of coatings is associated with melting and formation of small spheres

alongside the cracks rather than ejection of particles. An example is shown in Figure 7. In addition tungsten particles encapsulated by deposits have been observed [8]. The analysis also shows that overall TIEs constitute a specific source decreasing with operating time which is inconsistent with our understanding of time evolution of W coating cracking issues in JET.

Figure 7: Photograph showing delamination of W coating on outer divertor tile.

Delaminations run along the direction of CFC laminations. Delaminated material tends to form into spheres at the edges of the delaminated region. Some examples are indicated by red arrows.
